Investigation report

C8/2008L

Airliner fire at Kemi-Tornio aerodrome on 11 December, 2008

EMB-145LU

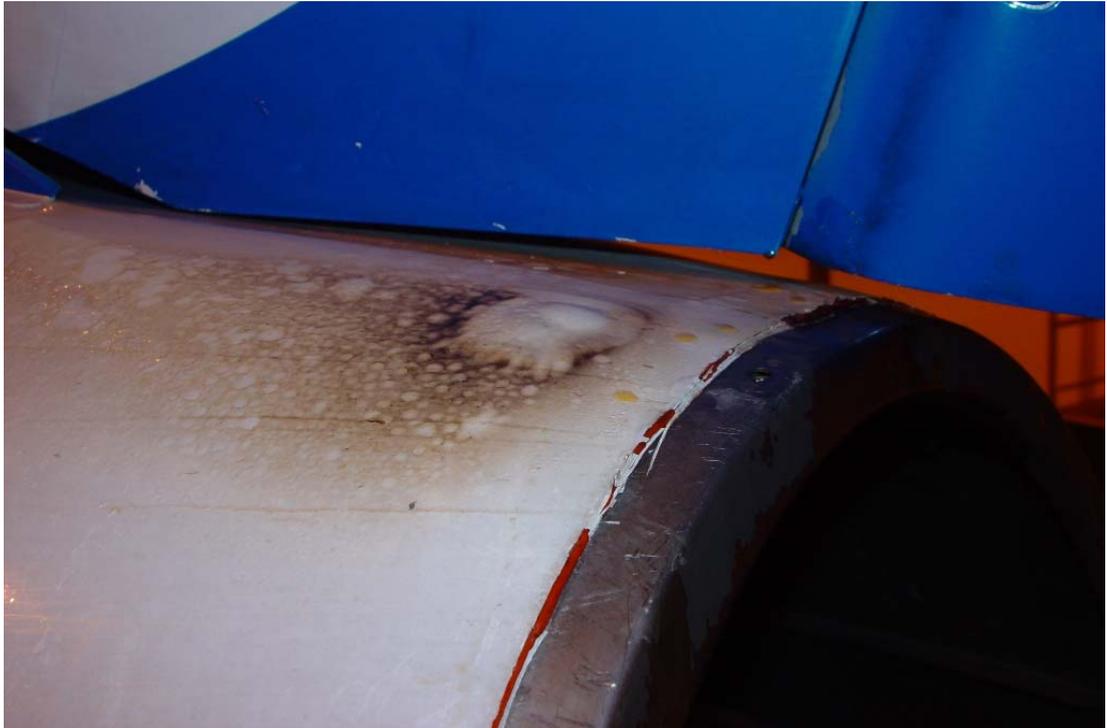
The fire caused visible damage to the structure of the APU compartment and the APU's electrical wiring. The APU was later replaced and the damaged APU was sent to REVIMA APU in France for inspection and repair. Faults and wear were detected but there were no fuel leaks, for example.

Figure 2. The external surface of the APU's cowling.

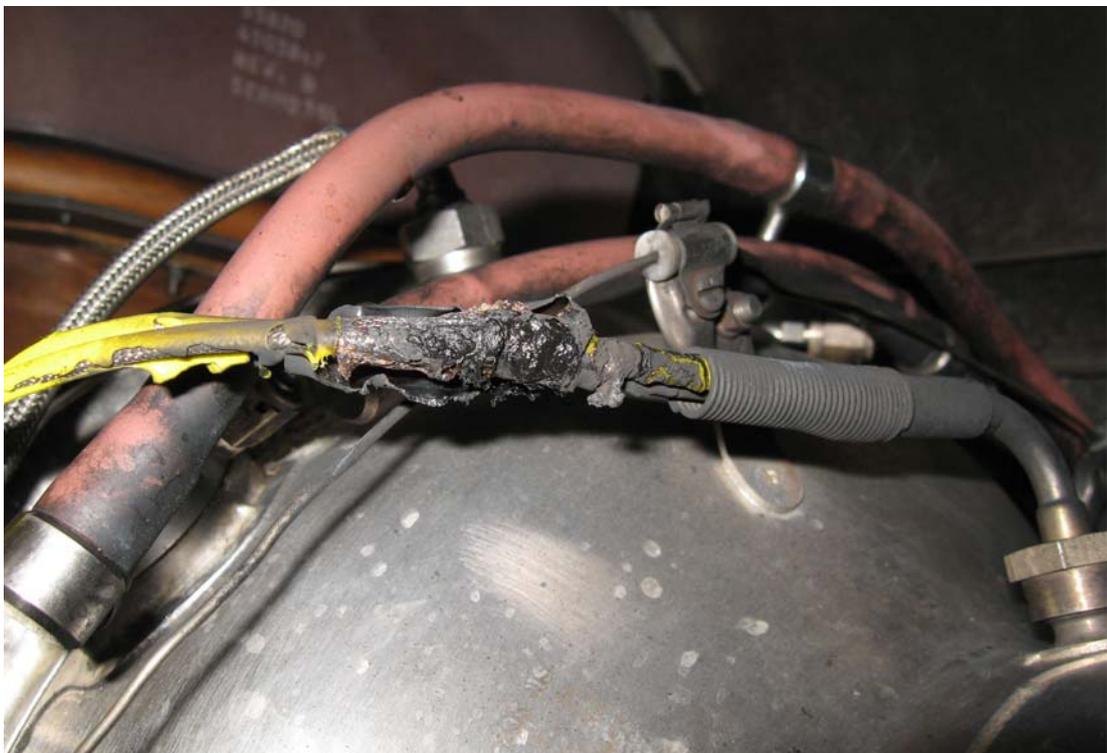
Figure 3. The Exhaust Gas Temperature (EGT) sensor's electrical wiring and the fire detector sensing element.

The flames that reached the APU compartment varied in strength. Other wiring and equipment parts between the flames and the fire detector sensing element reduced the exposure of the element. Since it was impossible to establish the conditions during the fire accurately enough, it is not possible to prove why a fire warning was not signalled. According to the test results it is possible that the fire detector sensing element may have partially functioned defectively in the incident. However, it is more likely that the sensing element was not exposed to sufficient heat at an adequately long distance. The investigators believe that analysis should be done on whether the E-145's APU fire detection system design is sensitive enough, because the flames that touched the fire detector sensing element in the APU compartment did not trigger a fire alarm. The

28. The APU's fire detection system did not trigger a fire warning even though the flames made contact with the fire detector sensing element.
29. When tested, the APU's fire detector sensing element met all of the authorities' requirements and, apart from one test, it passed all tests included in the element manufacturer's testing regime. The sensing element's insufficient exposure to the flames was probably the cause of the absent fire warning.
