INCIDENT

Aircraft Type and Registration:	Bombardier CRJ100ER, F-GRJO	
No & Type of Engines:	2 General Electric CF34-3A1 turbofan engines	
Year of Manufacture:	1999	
Date & Time (UTC):	17 January 2007 at 2134 hrs	
Location:	Runway 20, Southampton Airport	
Type of Flight:	Commercial Air Transport (Passenger)	
Persons on Board:	Crew - 3	Passengers - 33
Injuries:	Crew - None	Passengers - None
Nature of Damage:	None, precautionary removal of nose landing gear for inspection	
Commander's Licence:	Airline Transport Pilot's Licence	
Commander's Age:	47 years	
Commander's Flying Experience:	7,500 hours (of which 5,000 were on type) Last 90 days - 150 hours Last 28 days - 40 hours	
Information Source:	AAIB Field Investigation

Synopsis

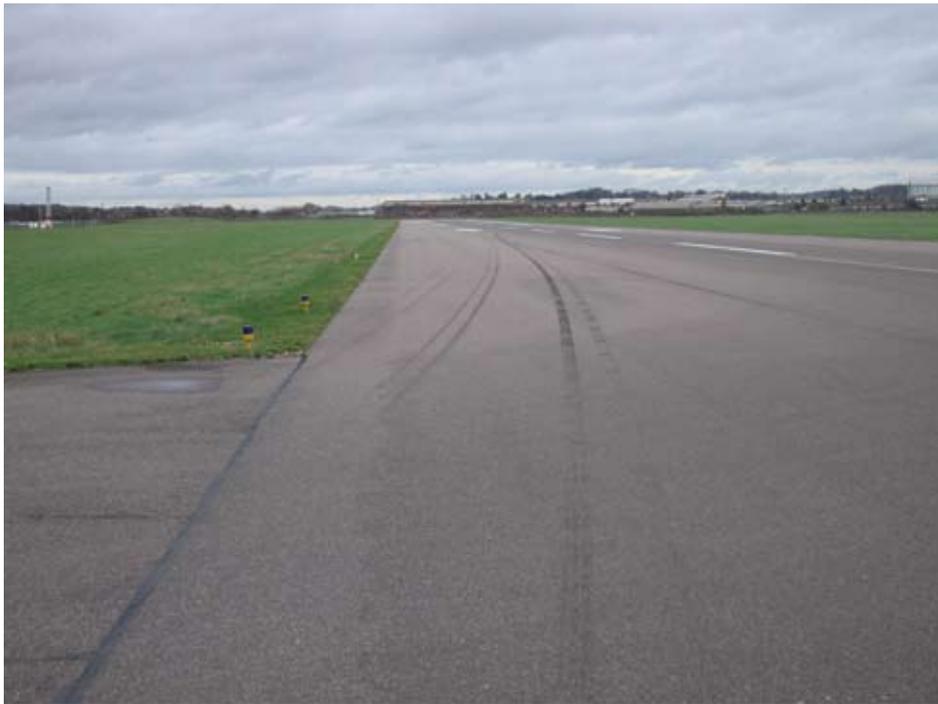
Figure 2 is an aerial photograph of the location in which the tyre marks are visible. In Figure 3 it can be seen that the marks from the nosewheels are closer to the marks of the right mainwheels than to the marks of the left mainwheels, indicating that the aircraft was ‘skidding’ slightly to the left. The marks from both the inboard and outboard left mainwheels were consistent with all four brakes functioning normally, and with differential braking to the left. There were heavy scrubbing marks from the two nosewheel tyres, and there was a distinct

In summary, the evidence from the tyres and ground marks was consistent with the aircraft veering to the right after landing, under the influence of ‘nose right’ steering of the nose gear, with heavy differential braking of the left mainwheels causing ‘scrubbing’ of the nosewheel tyres to the right.

Tyre marks, F-GRJO

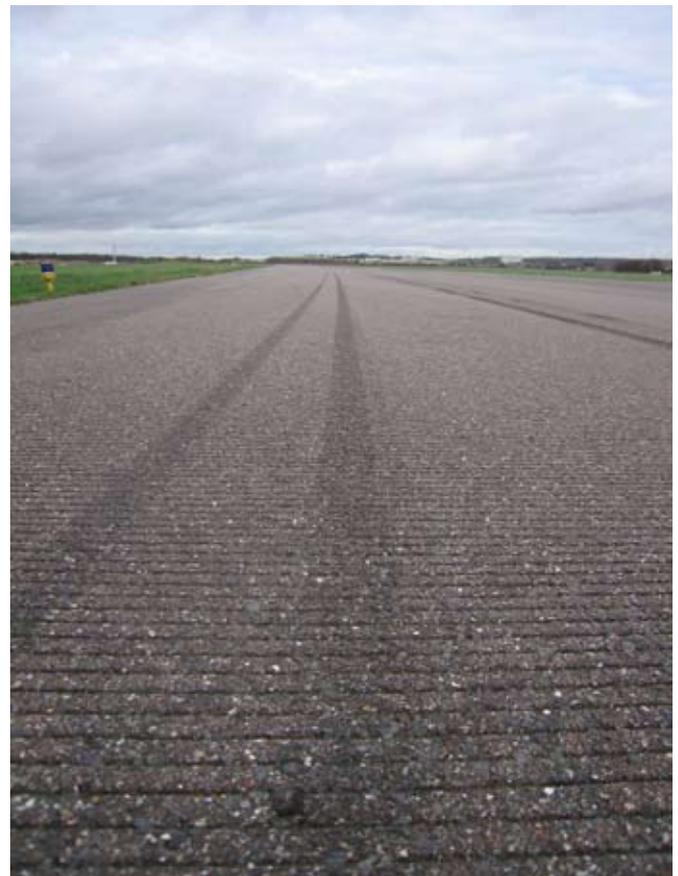
Figure 4

narrow line outboard of the mark, left by the tread of the left nosewheel tyre, see Figure 4. This line was consistent with the tyre chine (a circular ridge on the outboard side of the tyre designed to deflect water on wet runways) touching the runway.

Tyre marks - nosewheels

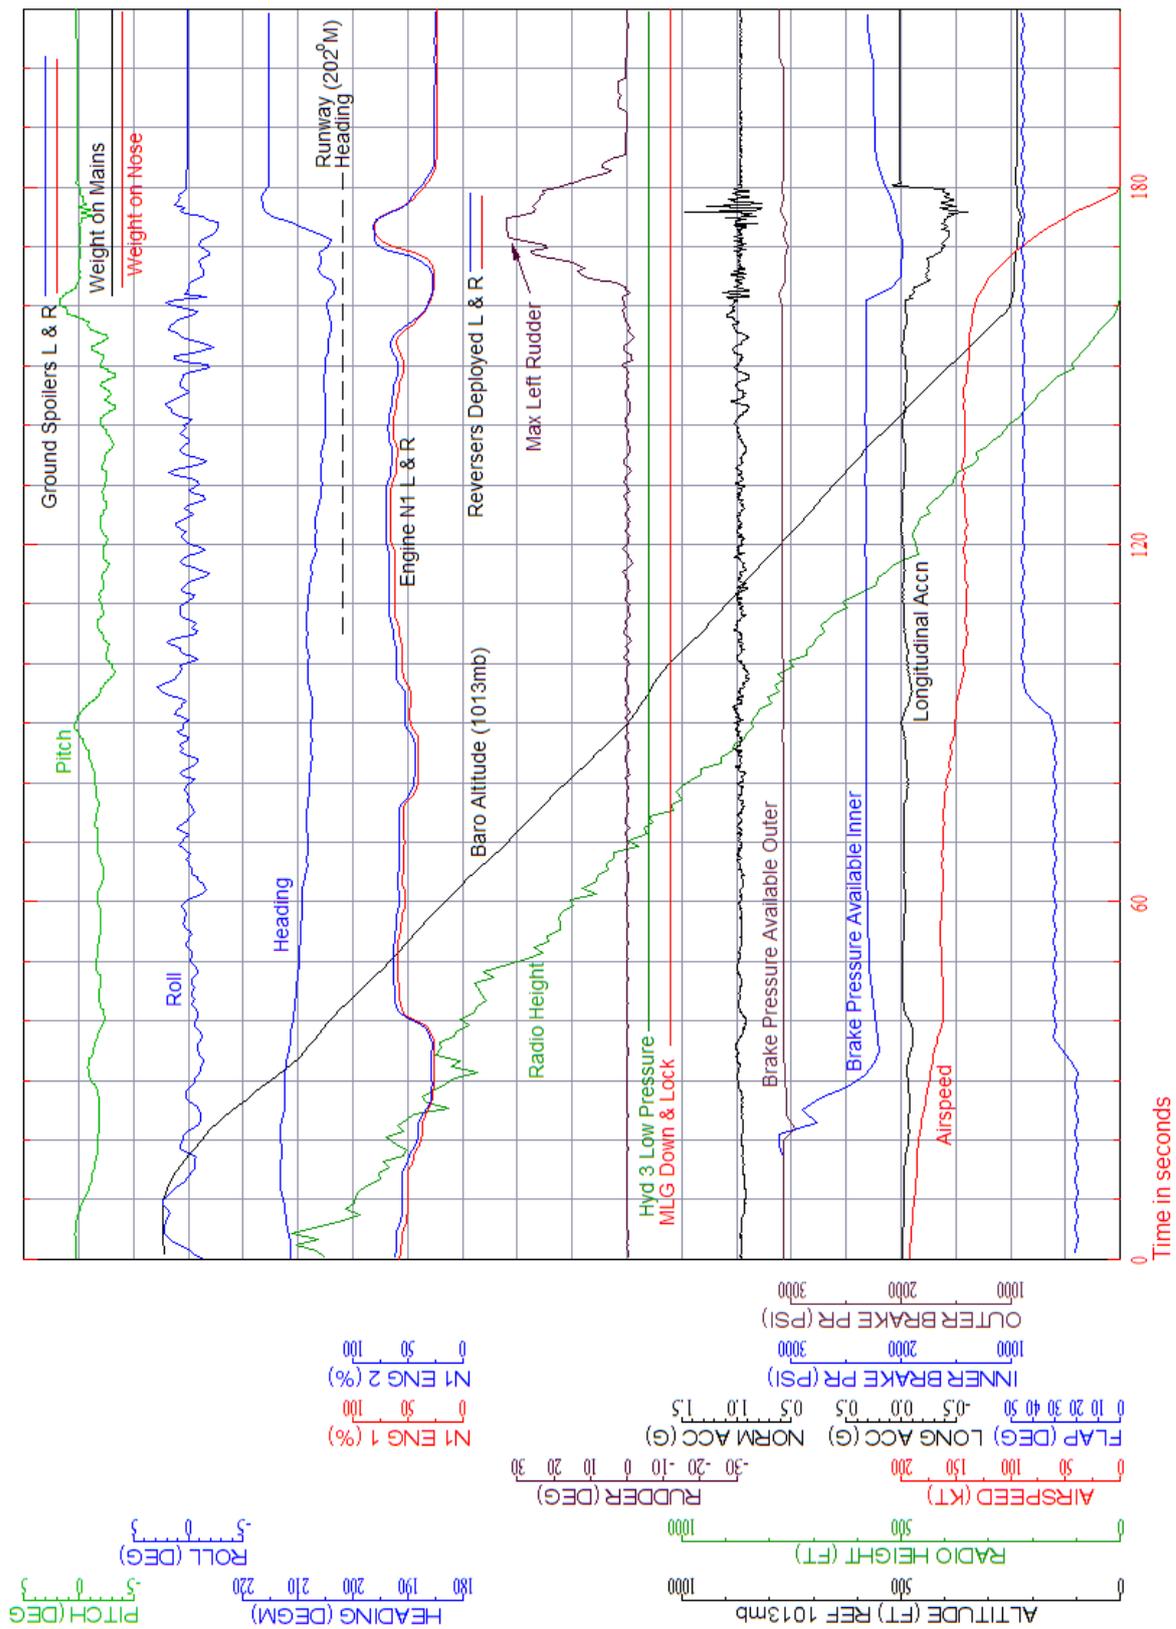
Figure 5
FDR plot, F-GRJO

The FDR recorded a number of parameters relevant to this investigation, including the brake 'pressure available' to the inboard and outboard wheel braking systems, together with discrete (ON or OFF) parameters for the presence of low hydraulic pressure on each of the aircraft's three hydraulic systems. Individual wheel brake pressures and data from the nosewheel steering system were not recorded. Pertinent parameters recorded during the approach and landing are shown in Figure 5.

The flight recorders showed that the initial approach was uneventful. At 2,000 ft amsl, with the autopilot engaged and Flap 20 selected, the aircraft intercepted the localiser from the left. It then captured and descended on the glideslope. Shortly after, at 1,830 ft amsl (1,786 ft aal), the landing gear was lowered and the inboard brake pressure available began to reduce from 3,000 psi. Outboard brake pressure available remained close to 3,000 psi. Flap 30 was selected.

Fifteen seconds elapsed before the landing gear indicated that it was locked down. Inboard brake pressure available had reduced to 2,200 psi by that time before beginning to recover slowly towards 2,300 psi. One second after the landing gear indicated 'down and locked' a No 3 hydraulic system low pressure warning was recorded on the FDR, also audible as a warning chime on the CVR. The crew selected the hydraulic page on the EICAS display just before the aircraft was cleared to land and two minutes before the aircraft touched down. The co-pilot commented that they would not have the inboard brakes and that the runway was short. The commander responded that the aircraft was not heavy and then advised the cabin attendant that they would be landing in one minute. The co-pilot further commented that they ought to analyse the situation and asked the commander if he

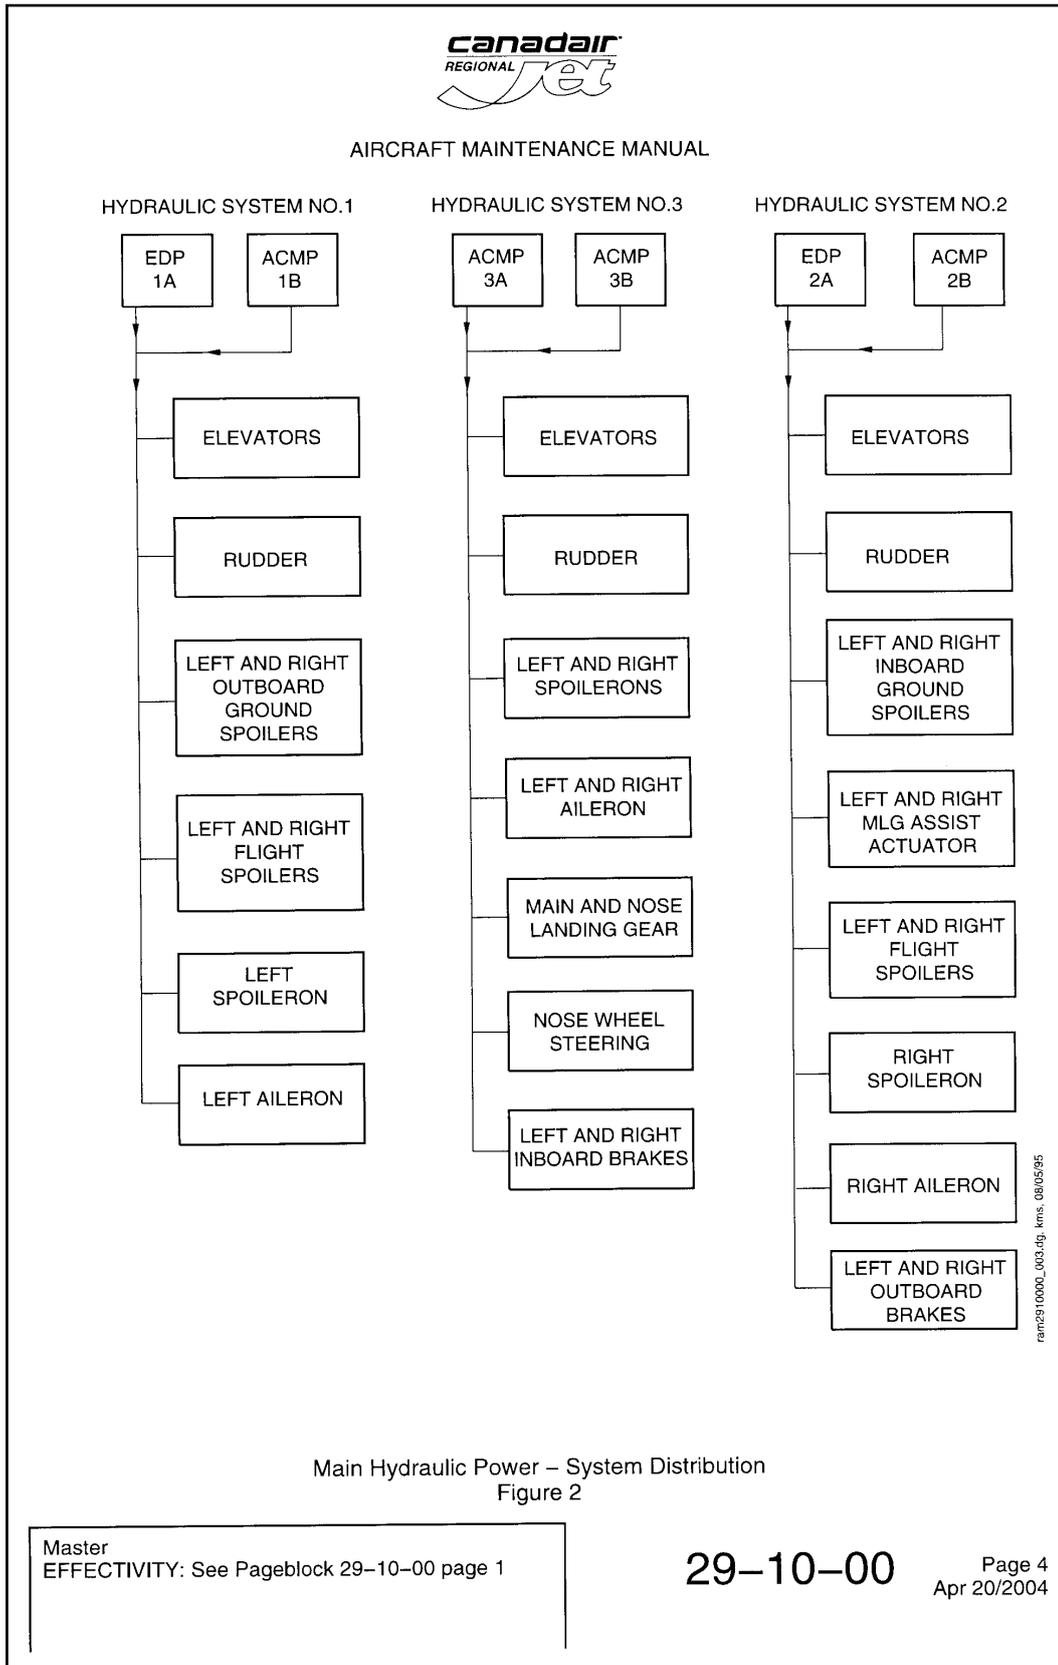
There are 3 hydraulic systems on this aircraft type. The No 3 hydraulic system has two electrically-operated pumps to provide power, pump 3A and pump 3B, and these are installed in the left and right wing-to-fuselage fairings respectively. A schematic of the hydraulic system is shown in Figure 6. From this it can be seen that the only hydraulic power supply for the nose gear door, the nose gear steering, and the landing gear retraction is from No 3 hydraulic system. The inboard brakes (both left and right) are also supplied from No 3 system. Figure 6 shows that the outboard brakes are powered by No 2 hydraulic system, and the inboard brakes by No 3 hydraulic system.

Hydraulic system schematic

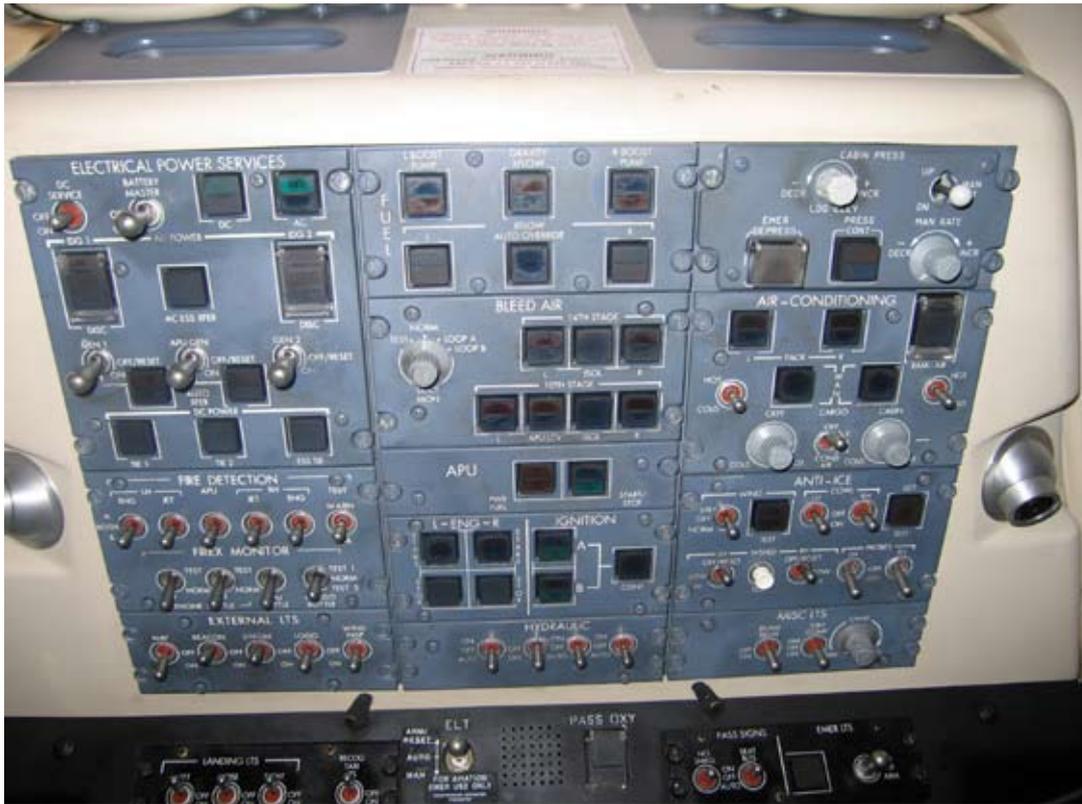
Figure 7
Overhead panel

There are selector switches for the hydraulic pumps on the overhead panel in the cockpit, as in Figure 7. The normal operating position for all four switches is down: Pump 1 AUTO, Pump 3A ON, Pump 3B AUTO, and Pump 2 AUTO.

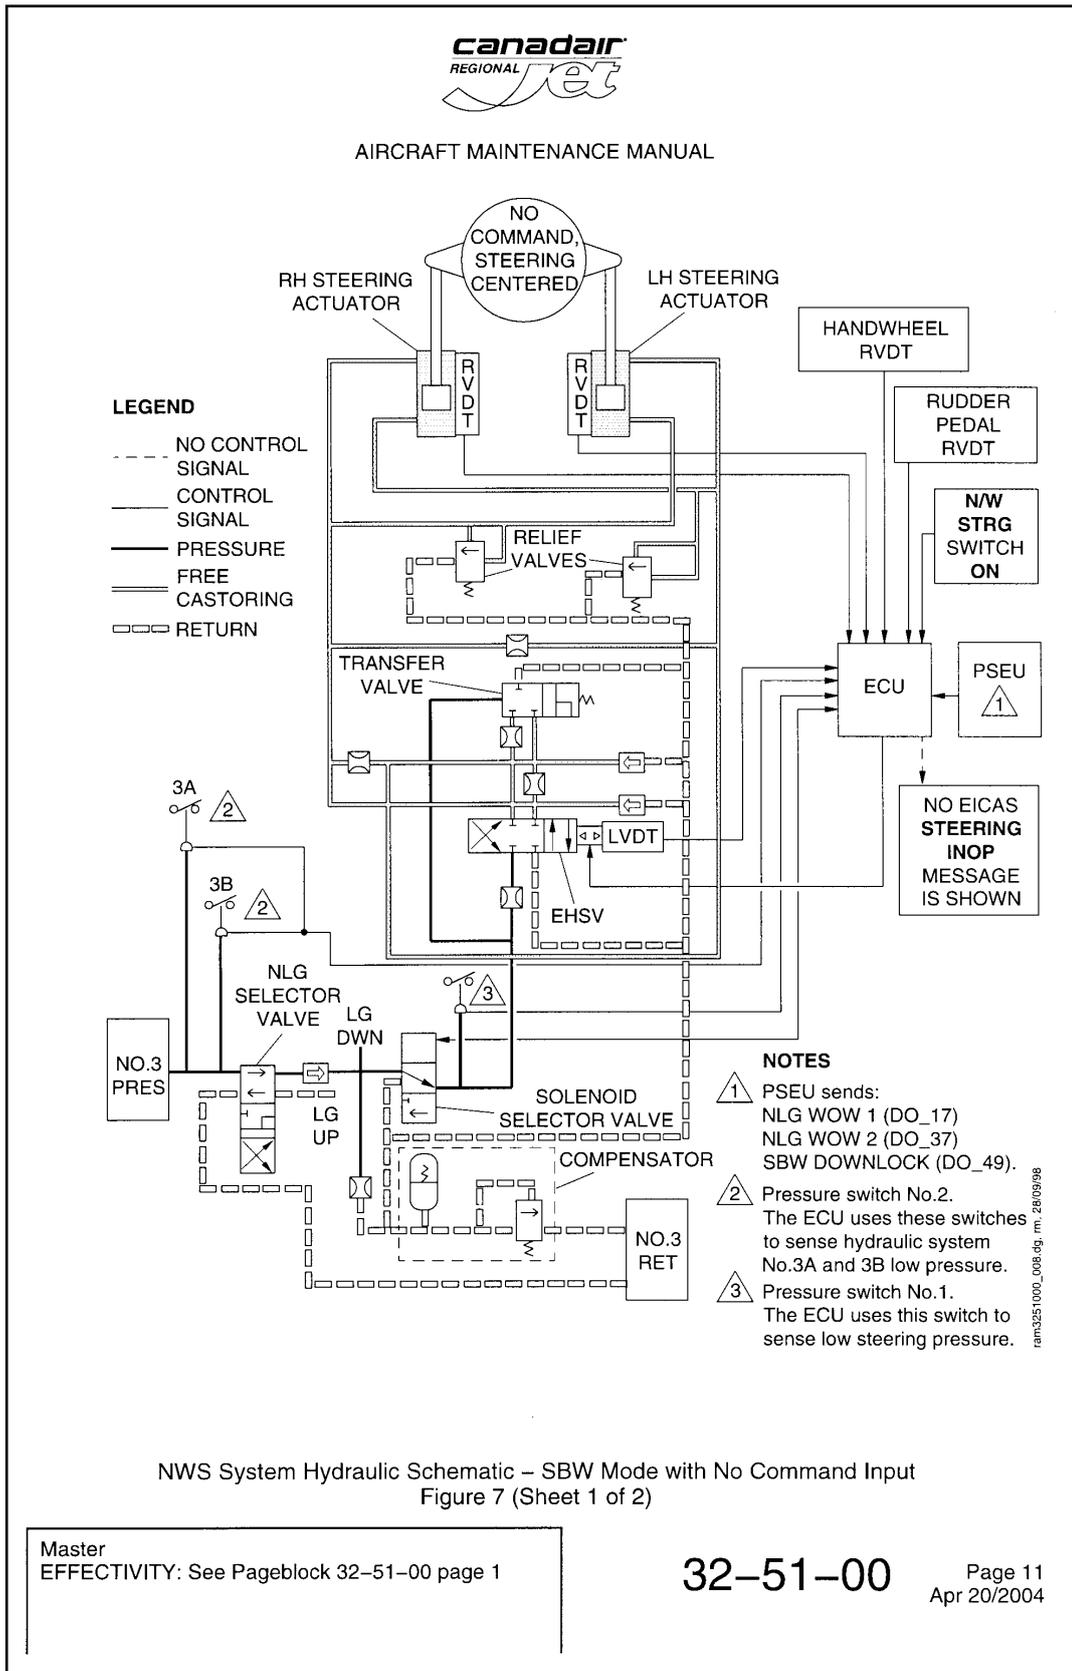
Figure 8
NWS schematic

The CRJ has a ‘steer-by-wire’ Nose Wheel Steering (NWS) system. The NWS system is electrically controlled and hydraulically powered (Figure 8). If the NWS is switched off, or if the NWS Electronic Control Unit (ECU) detects a fault, the system reverts to a free-castering mode. In this mode, valves isolate the hydraulic pressure in the two steering actuators and these actuators act as dampers; the nosewheels are then free to caster. The normal hydraulic pressure is 3,000 psi. With the NWS armed, the system operates normally for No 3 system hydraulic pressures between 1,650 and 3,000 psi, and reverts to free-castering mode at a pressure below 600 psi. For pressures between 600 and 1,650 psi (with the NWS armed) the system’s performance may be reduced.

The individual inspections of the components revealed nothing significant. However, the rig test revealed that, if the pressure was between 650 and 1,650 psi when the 'weight-on-wheels' switch was activated, then the nosewheel steered slowly to the right at a rate of about 1° per second. The torque was typically 3,000 lbf-in, which is almost an order of magnitude less than that for normal operation. Above 1,650 psi the steering system would steer normally; below 650 psi the system went into free-castering mode. The drift required that the steering system be switched ON, and for hydraulic power to be provided, effectively requiring either pump 3A or 3B (or both) to be ON. Such a drift would occur for all aircraft with this NWS system, the direction of the drift depending on the particular aircraft.

It is recommended that Bombardier Aerospace review this design of nose gear steering system, in the CRJ100 and other company products, to prevent uncommanded nose gear steering following a hydraulic failure.

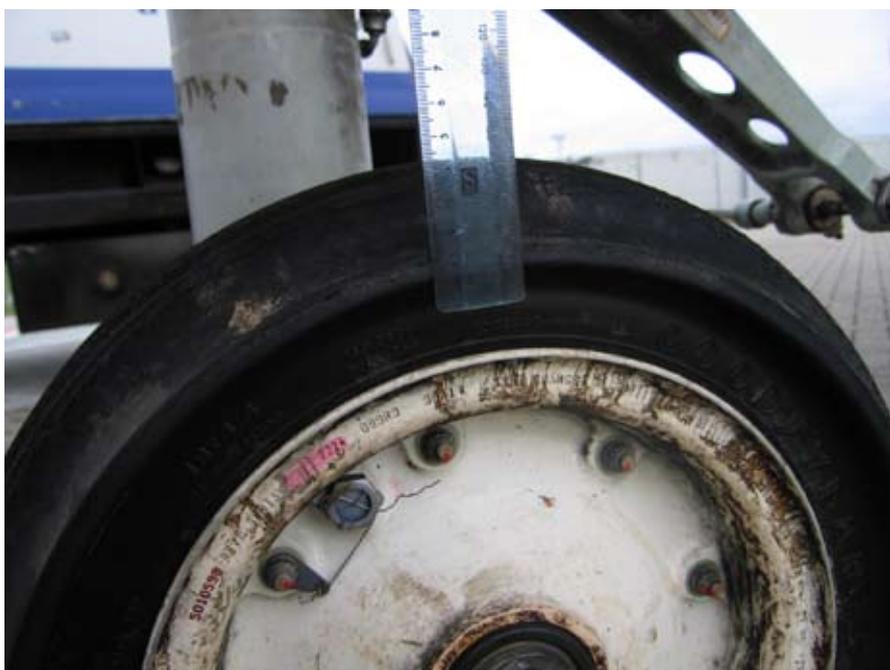
- a. The left nosewheel tyre was found to have regular transverse marks at approximately 12° to the wheel axis, and the tyre chine, which usually shows no signs of wear, had signs of heavy loading, see Figures 9 and 10. The orientation of the marks is consistent with both nosewheel tyres being highly loaded and ‘scrubbed’ to the right, opposing the aircraft’s motion. There were no significant marks on the chine on the right nose tyre.
- b. The nose gear leg and associated structure was inspected and no damage was seen.
- c. With the aircraft on jacks the nose gear steering system was functioned and the rigging values were checked, with nothing abnormal being

Figure 9 (left)
Tyre chine, left nosewheel

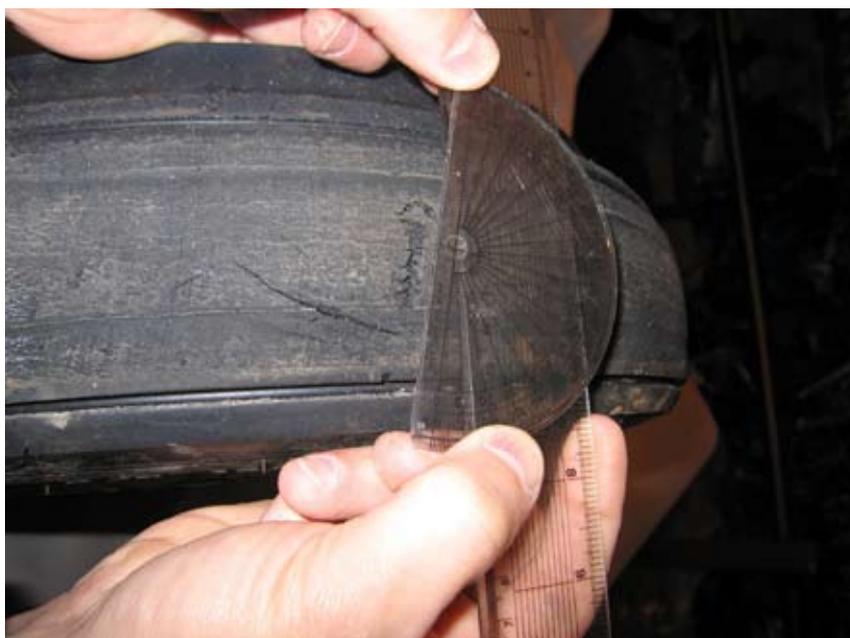
Figure 10 (right)
Tyre tread, left nosewheel
