SERIOUS INCIDENT

Aircraft Type and Registration:	Airbus A319-131, G-EUPZ	
No & Type of Engines:	2 International Aero Engine V2522-A5 turbofan engines	
Year of Manufacture:	2001	
Date & Time (UTC):	15 March 2009 at 1935 hrs	
Location:	London Heathrow Airport	
Type of Flight:	Commercial Air Transport (Passenger)	
Persons on Board:	Crew - 6	Passengers - 87
Injuries:	Crew - None	Passengers - None
Nature of Damage:	Damage due to overheat in the area behind flight deck panel 123VU	
Commander's Licence:	Airline Transport Pilot's Licence	
Commander's Age:	34 years	
Commander's Flying Experience:	6,929 hours (of which 77 were on type) Last 90 days - 116 hours Last 28 days - 39 hours	
Information Source:	AAIB Field Investigation

Synopsis

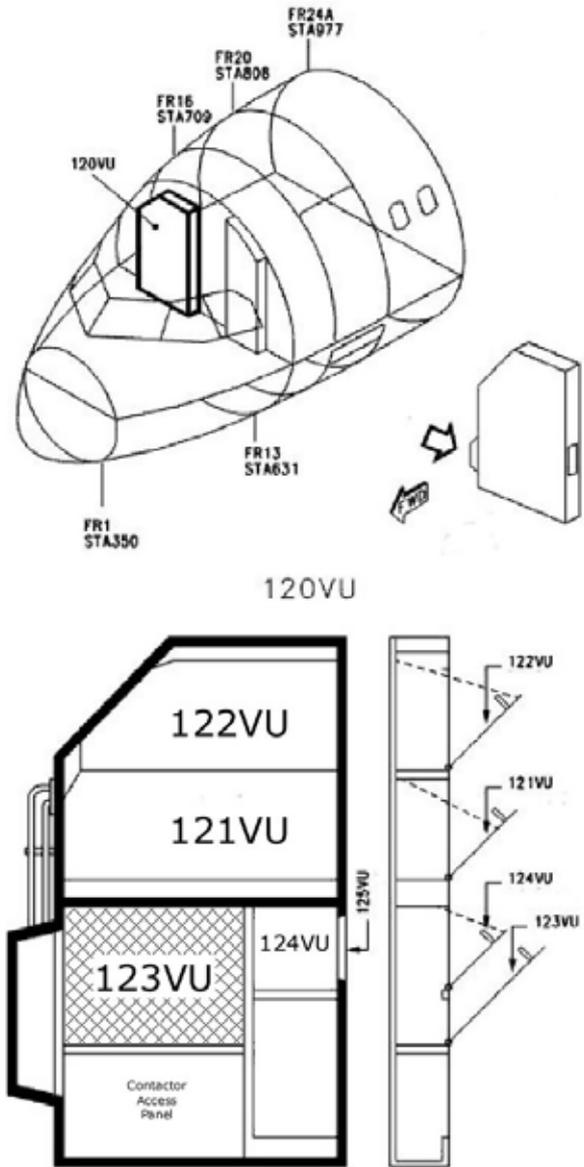
Figure 3

A visual inspection of the cockpit and the external faces of the CB panels did not reveal any signs of damage. On the rear right CB panel, 123VU (Figure 3), CB 11QA and 12QA had tripped and on opening the panel there was evidence that significant overheating had occurred, with extensive sooting. The fire damage was centred in the area around CB 11QA with damage to the AC Bus 1

Cabinet 120VU and panel 123VU location

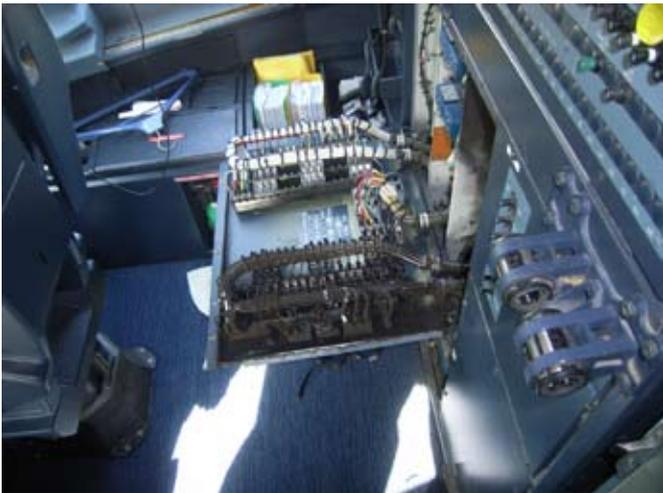
**Figure 4**

busbar that ran alongside these breakers. (Figures 4 and 5). The busbar had suffered extensive heat damage with areas of melting of the copper terminals.

General view of damage to panel 123VU

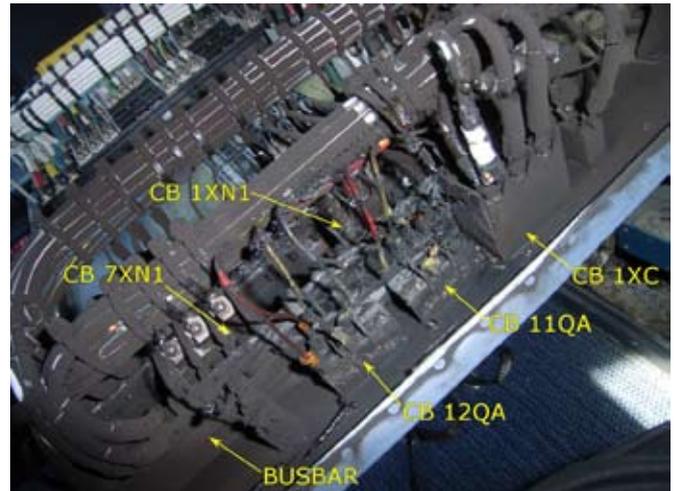
**Figure 5**

Damage to CB and AC Bus 1 busbar (panel 123VU)

Panel 123VU was removed from the aircraft and taken to a specialist forensic laboratory for a detailed examination under AAIB supervision. The damage to AC Bus 1 was most severe directly behind CB 11QA, with erosion of the busbar terminals and burning and distortion of the busbar insulation material in this area.

The damage from the fire was centred on CB 11QA and therefore it is most likely that this was the area where the electrical fault and the subsequent fire had initiated. Prior to the start of engine No 1, AC Bus 1 was being supplied by the APU generator though the closed BTC 1, with no reported faults. As engine No 1 started, generator No 1 started to provide electrical power to CB 11QA. This was prior to the closing of GLC1 and it was at this point that GCU1 detected a fault, causing BTC 1 to open and prevented GLC 1 from closing. This led to the loss of AC Bus 1 power and the associated ECAM fault messages and aural warnings. The electrical system response was indicative of a DP, triggered due to the detection of differing current flows in the electrical network. Following this initial event, BTC1, GLC1 were OPEN and the generator remained de-excited indicating that the GCU had detected a fault in Zone 2, and was either a fault somewhere within the electrical network or erroneous current flows in the network for less than 85 ms.

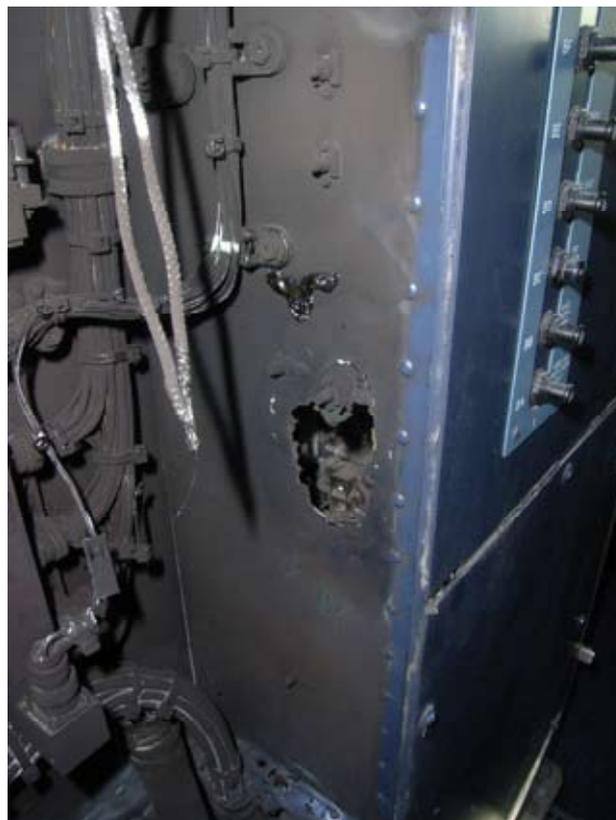
**Figure 6**

The aluminium structure directly to the left of CB 11QA had melted, creating a 70 mm by 50 mm hole, with a heat-affected zone extending 150 mm by 100 mm (Figure 6). This had resulted in some light sooting in the area behind panel 124VU.

Structural damage outboard of panel 123VU

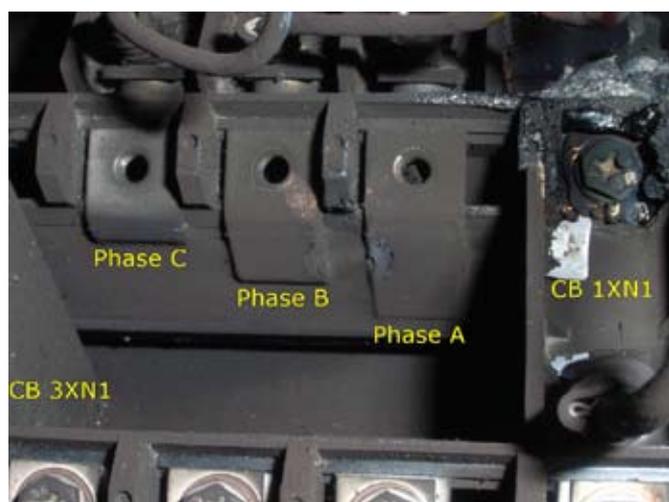
Figure 7

There was evidence of damage from arcing and some fibrous deposits between phases on some of the AC Bus 1 exposed connections (Figure 7).

During the detailed examination of panel 123VU, it became apparent that there was fibrous material, or ‘dust’, across various exposed busbar terminals. This ‘dust’ was sampled for its composition and assessed as to whether it could have been a factor in the electrical

Exposed AC Bus 1 connections

faults or the fire. The dust contained fibres, consisting of small mineral fragments and metallic flakes (mainly steel), and organic flakes of skin. Chloride levels in the dust were found to be high, when compared to normal office dust, and the laboratory report commented that this would lead to an increase in its conductivity.

The crew had already completed the ECAM checklist so the avionic cooling blower fan was now in OVERRIDE thereby removing the forced airflow through the 120VU cabinet. The arcing led to a highly ionised atmosphere behind 123VU, which was not dissipated by the airflow and would have contributed to further arcing. Dust was prevalent in the area behind the panel and on exposed phases on the AC bus bars. This would have contributed to the propagation of the fire by providing a combustible material and may also have contributed to the arcing as the 'creepage' distance between terminals was reduced by the contaminant.

The introduction of the new EWIS requirements, and the associated training, already highlights the need for good housekeeping and cleanliness of electrical connection systems in aircraft; its introduction into scheduled maintenance should reduce recurrence of electrical faults from foreign objects and debris.

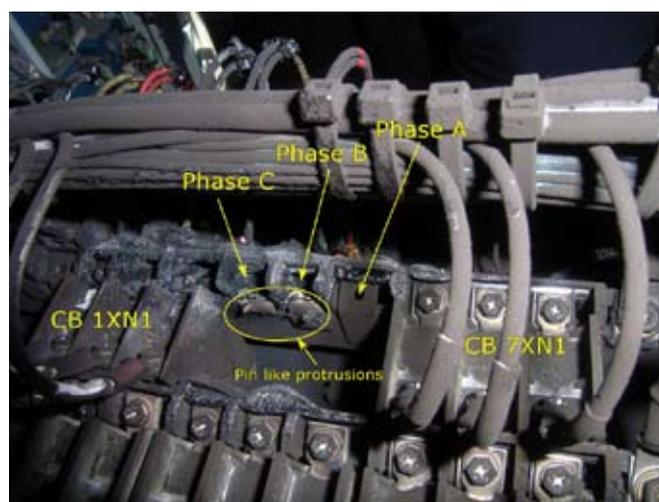
Figure 8

Two exposed terminals on AC Bus 1 had melted and there were ‘pin-like’ protrusions, which were products of the molten copper (Figure 8). A visual inspection of the unaffected wiring found it to be in a good condition and tests of the wiring did not show signs of degradation that could have caused the electrical faults or the fire. The remaining terminals and connections were found to be correctly installed and the examination did not reveal

Exposed AC Bus 1 connections – pin-like protrusion
