Tail strike on runway during night landing

Airplane	McDonnell Douglas MD-81 registered OY-KHP
Date and time	6 February 2010 at 18h25 ⁽¹⁾
Operator	Scandinavian Airlines System (SAS)
Site of accident	AD Grenoble-Isère (38)
Type of flight	Public transport of passengers Unscheduled international flight
Persons on board	Captain (PNF); Co-pilot (PF); 4 PNC; 127 passengers
Consequences and damage	Rear part of fuselage seriously damaged

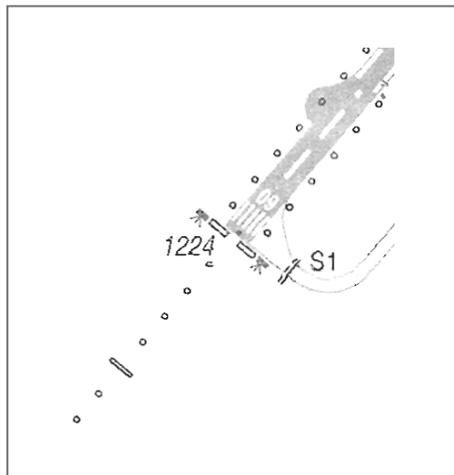
Symbol presented on the SIA aerodrome chart

Grenoble airport's lighting is simplified approach lighting. It covers a distance of 420 metres and has a crossbar located 300 metres from the runway threshold, as indicated on the aerodrome chart published by the SIA (French Aeronautical Information Service).

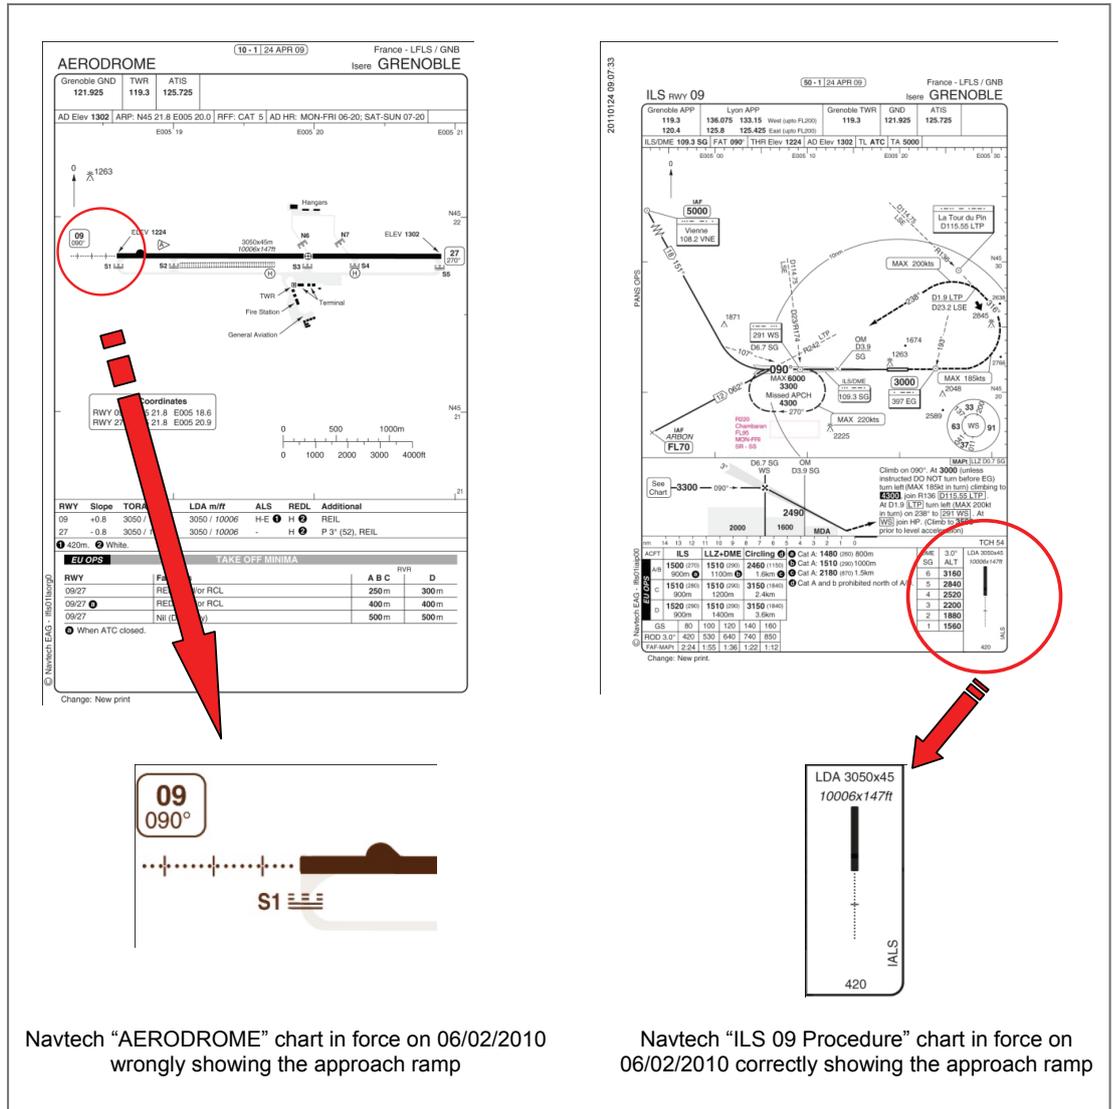
On the day of the accident, the "AERODROME" Navtech EAG chart indicated that the approach lighting system was at least 900 m long and had 3 crossbars, whereas in reality it was only 420 m and had only one crossbar.

The "ILS 09 Procedure" chart however showed the approach lighting system correctly.

Since the accident, this inconsistency has been corrected by Navtech.

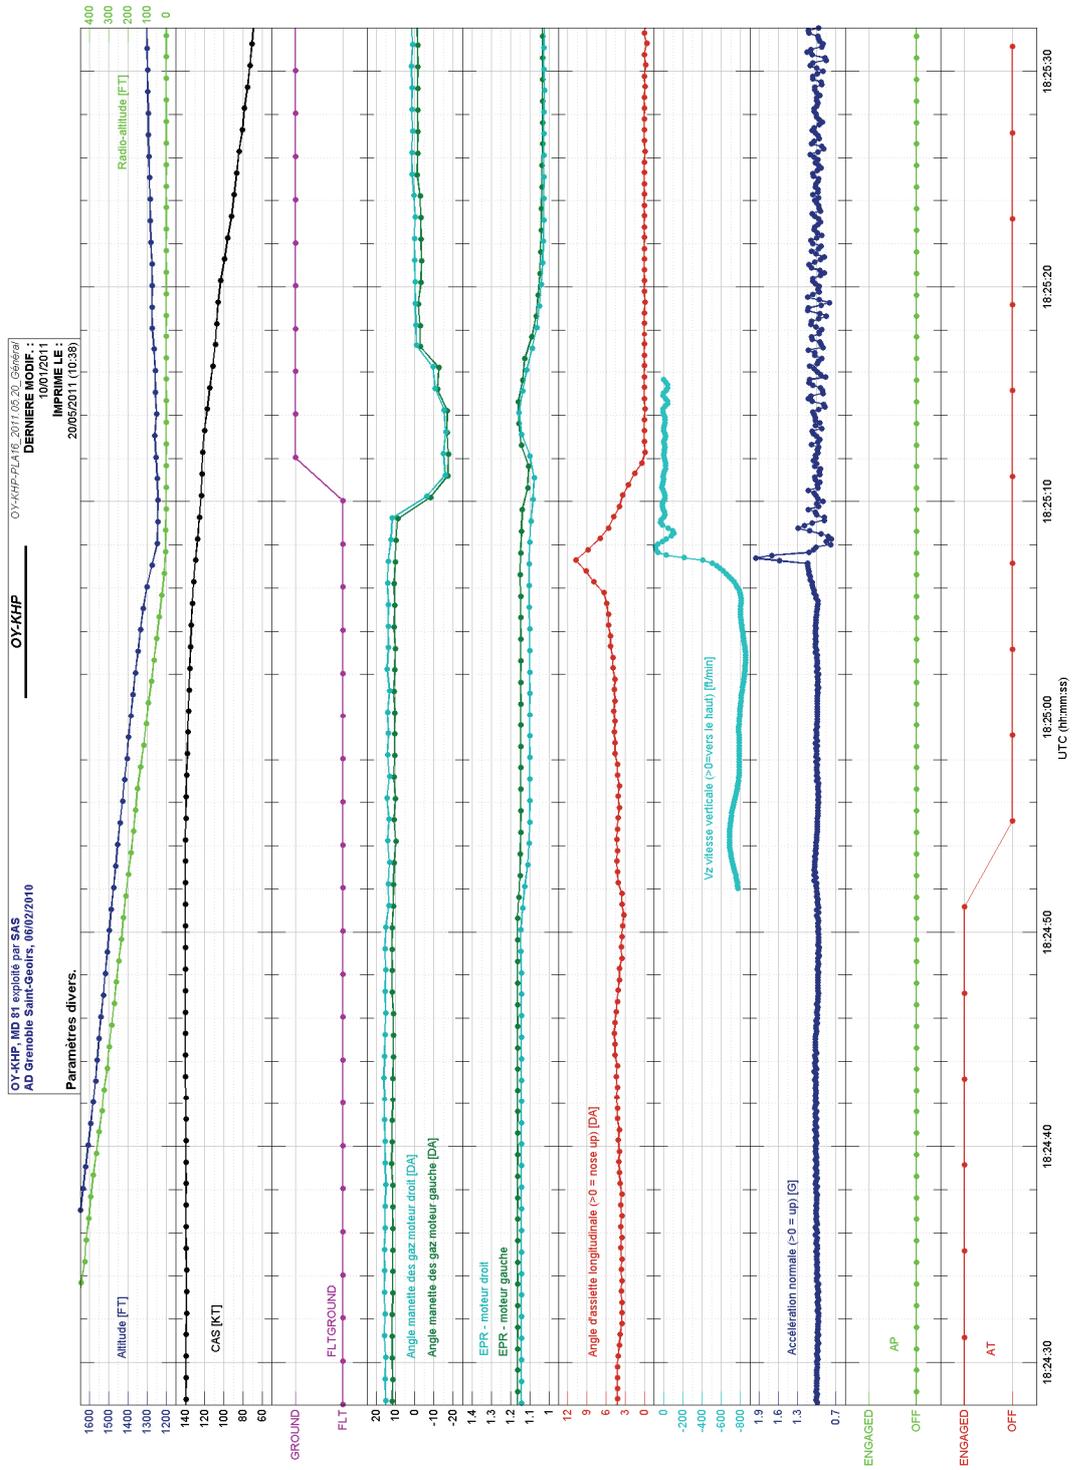
Appendix Graph of FDR parameters

At 100 ft, the IAS started to decrease and went below Vapp. The rate of descent increased and reached 850 ft/min. The pitch attitude was 4° nose up and began to increase slightly.

At a height of 30 ft, the airplane went slightly below the glide path and the IAS was Vapp - 4 kt.

At a height of 15 ft, the elevator was sharply moved to nose up, leading to a swift increase in pitch attitude.

Two seconds later, the rear of the fuselage touched the runway, with a pitch attitude of 10.7°. The marks left on the runway indicated a point of contact 166 metres before the touchdown zone. The vertical acceleration value reached a maximum of 1.95g. Two seconds later, the thrust levers were retarded and the thrust reversers were deployed. The airplane then taxied to the parking ramp.
