AIR PROXIMITY BETWEEN AN AIRBUS A318 AND A BOEING 737-900

Occurrence: 2007112
Classification: Serious incident
Date and time¹ : 6 December 2007, 19.39
Location of occurrence: Amsterdam Schiphol Airport

Aircraft registration: F-GUGI (AF3484)
Aircraft model: Airbus A318
Type of aircraft: Public transport aircraft
Type of flight: Scheduled passenger flight
Phase of operation: Missed approach
Damage to aircraft: None
Flight crew: 6
Passengers: 98
Injuries: None

Aircraft registration: PH-BXS (KLM1027)
Aircraft model: Boeing 737-900
Type of aircraft: Public transport aircraft
Type of flight: Scheduled passenger flight
Phase of operation: Takeoff
Damage to aircraft: None
Flight crew: 6
Passengers: 189
Injuries: None

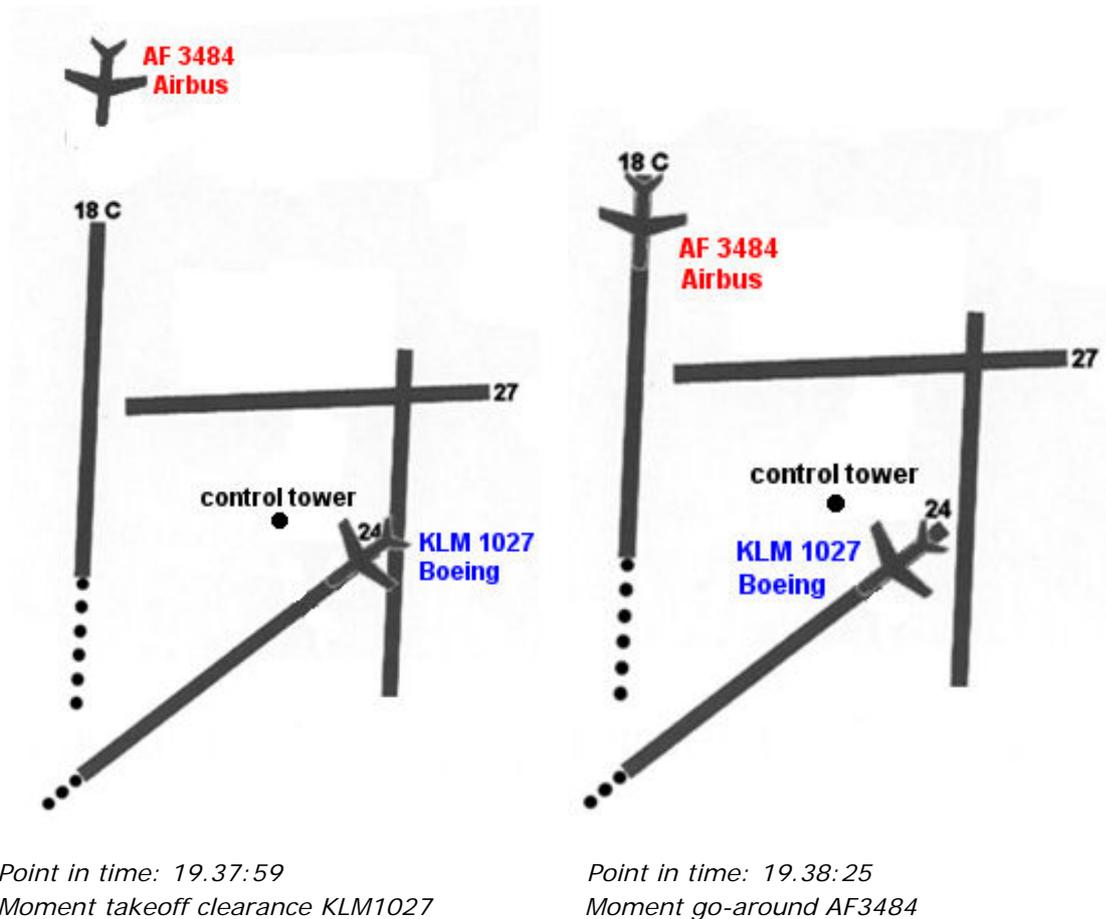
At 19.37:59 Runway Controller 2 provided KLM1027 with a takeoff clearance for Runway 24. According to the radar data, this happened as the AF3484 was at a distance of 0.7 NM (app. 1,3 km) from the threshold of Runway 18C. The Boeing, a few metres over the landing runway and in its final stage of the approach, initiated a go-around instead of executing a landing manoeuvre, (see Figure 1). The flight recorder data shows that the go-around was initiated when the aircraft had descended to approximately 15 feet above the runway. At that time KLM1027 had already commenced its takeoff run and had reached a speed of 79 knots³. Both runway controllers expected AF3484 to land, or assumed that it actually had landed, and turned their attention to the remaining traffic.

Figure 1: schematic of runway layout with direction of flight of Airbus and Boeing

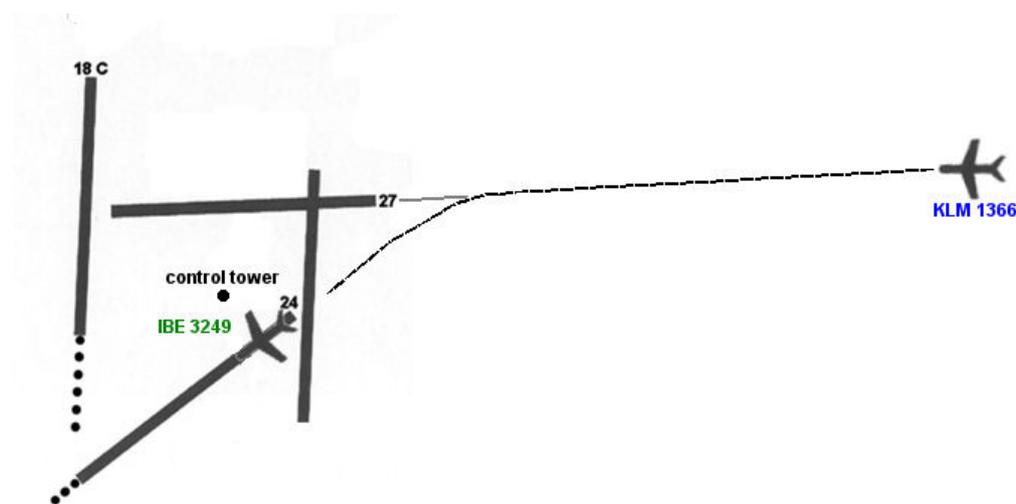
At 19.37:15 the crew of a Fokker 100, flight number KL1366, were on the approach to Runway 27 and requested to land on Runway 24. Runway Controller 1 indicated that this might be possible, but that some time was needed before he could give a decisive answer. At 19.38:45, 46 seconds after KLM1027 was provided with its takeoff clearance for Runway 24, the next aircraft in sequence, IBE3249, received takeoff clearance for Runway 24 (see Figure 2). At 19.39:05, 20 seconds after IBE3249 received its takeoff clearance, KLM1366 was approaching Runway 27 and received clearance for a so-called 'break off' for a final approach to Runway 24. At 19.40:14 KLM1366 received landing clearance for Runway 24. This landing required co-ordination between both runway controllers and had to fit in between the sequence of air traffic taking off.

Figure 2: schematic of position of KL1366 at moment of takeoff clearance for IBE3249. Point in time 19.38:45

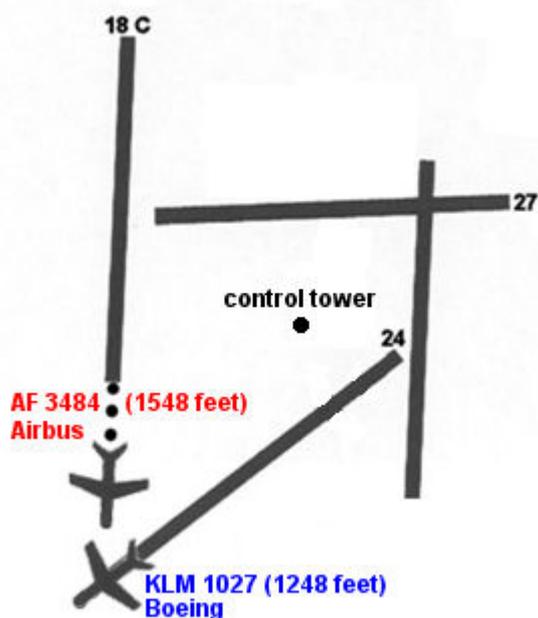
Figure 3: schematic of KLM1027 crossing in front of AF3484. Time 19.39:17 (source LVNL)

At the crossing point of the aircrafts' flight paths, KLM1027 had an altitude of 1248 feet. Six seconds afterwards, AF3484 passed the crossing point at an altitude of approximately 1300 feet. See Figure 3.

The fact that a collision did not occur was due to the lateral separation of both aircraft at the moment KLM1027 crossed in front of AF3484 at the same altitude. At that moment the distance between both aircraft was 460 metres.⁹ After KLM1027 had passed, the vertical separation increased with approximately 50 - 100 feet, compared to the situation without TCAS commands.
