Stick Shaker Activation during Rotation

Airplane	Boeing 737-300 registered F-GIXD
Date and time	10 January 2011 at around 12 h 30 UTC ⁽¹⁾
Operator	Europe Airpost
Site of accident	Montpellier Méditerranée aérodrome (34)
Type of flight	Ferry flight
Persons on board	Captain (PF); Co-pilot (PNF)
Consequences and damage	None

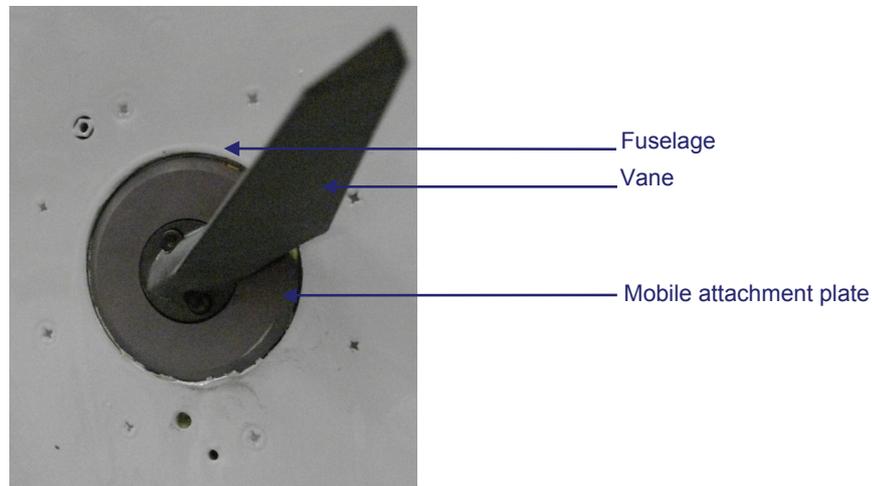
Left AOA sensor

Examination of the left AOA sensor revealed the presence of several layers of paint on the base of the mobile part, the attachment plate and the seal between the attachment plate and the aeroplane. In some places, up to three coats of paint were identified: yellow - white - yellow.

Photo taken at the time of the reception inspection before the second painting operations

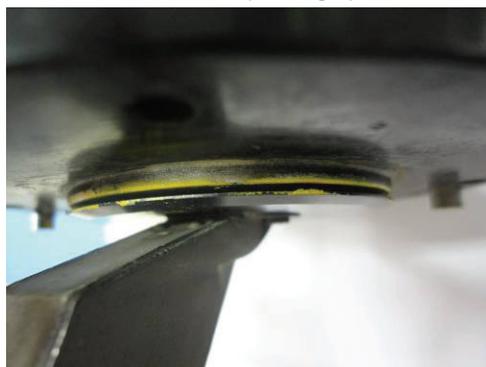
AOA sensor
Photo taken during examinations

The blocking of the AOA sensor is most likely due to the presence of white paint between the base of the mobile part, the fuselage and the attachment plate.

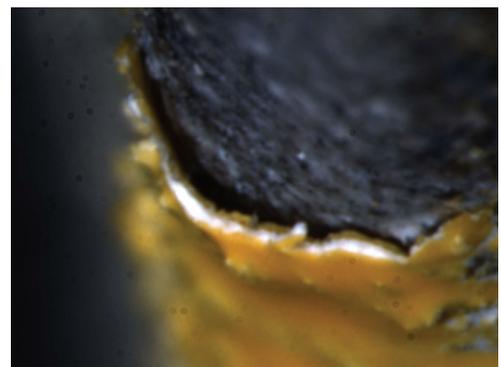
Different layers of paint

These layers of paint seem to result from different painting operations performed on the aeroplane: previous yellow paint, white paint added in Montpellier, yellow paint added in Toulouse.

- **that EASA ensure that manufacturers develop in their approved documentation some specific procedures for protection and verification of the external sensors during painting operations.**
