**SERIOUS INCIDENT**

<b>Aircraft Type and Registration:</b>	Fan Jet Falcon 20E, G-FRAI
<b>No &amp; Type of Engines:</b>	2 General Electric Co CF700-2D-2 turbofan engines
<b>Year of Manufacture:</b>	1972 (Serial no: 270)
<b>Date &amp; Time (UTC):</b>	9 August 2012 at 0915 hrs
<b>Location:</b>	Runway 23, Durham Tees Valley Airport
<b>Type of Flight:</b>	Commercial Air Transport (Passenger)
<b>Persons on Board:</b>	Crew - 2                      Passengers - 1
<b>Injuries:</b>	Crew - None                      Passengers - None
<b>Nature of Damage:</b>	Foreign object damage to engines
<b>Commander's Licence:</b>	Airline Transport Pilot's Licence
<b>Commander's Age:</b>	39 years
<b>Commander's Flying Experience:</b>	3,066 hours (of which 1,005 were on type) Last 90 days - 78 hours Last 28 days - 27 hours
<b>Information Source:</b>	AAIB Field Investigation

**Synopsis**

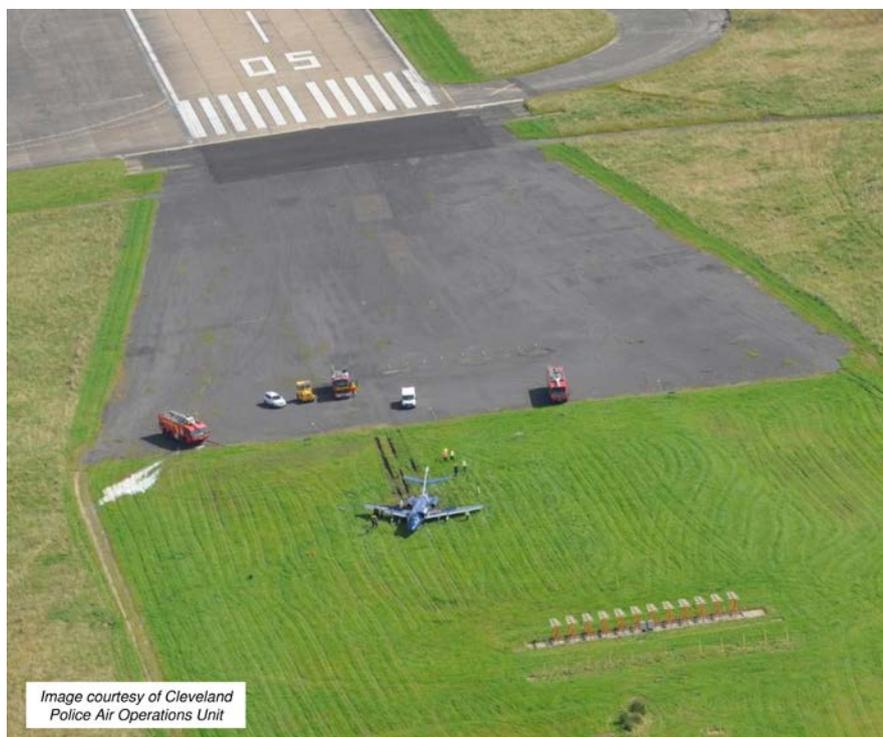
The aircraft came to rest within the RESA, on a soft grass surface 54 m beyond the end of the Runway 23 strip (Figure 1). The aircraft's tyre marks were discernible on the concrete-surfaced section of the runway and on the stopway and strip, both of which had an asphalt surface covered by scattered loose gravel. Inspection of these tyre marks showed no evidence of mainwheel skidding or locking.

The aircraft sank above the mainwheel axles into the soft grass surface and slewed to the right, onto a heading of 244° M, due to softer ground beneath the right main

landing gear. A small quantity of fuel leaked from the right wing fuel tank vent, due to the resting attitude of the aircraft. Mud and stones were ingested into both engines. The right inboard brake unit had seized and was removed to allow the aircraft to be recovered.

**Figure 1**  
Incident site
