Civil Aviation Administration
of China

Report No.: 20100914YFZQ

CSC A319/B-6054 Stall During Approach

Investigation Report of Serious Flight Incident

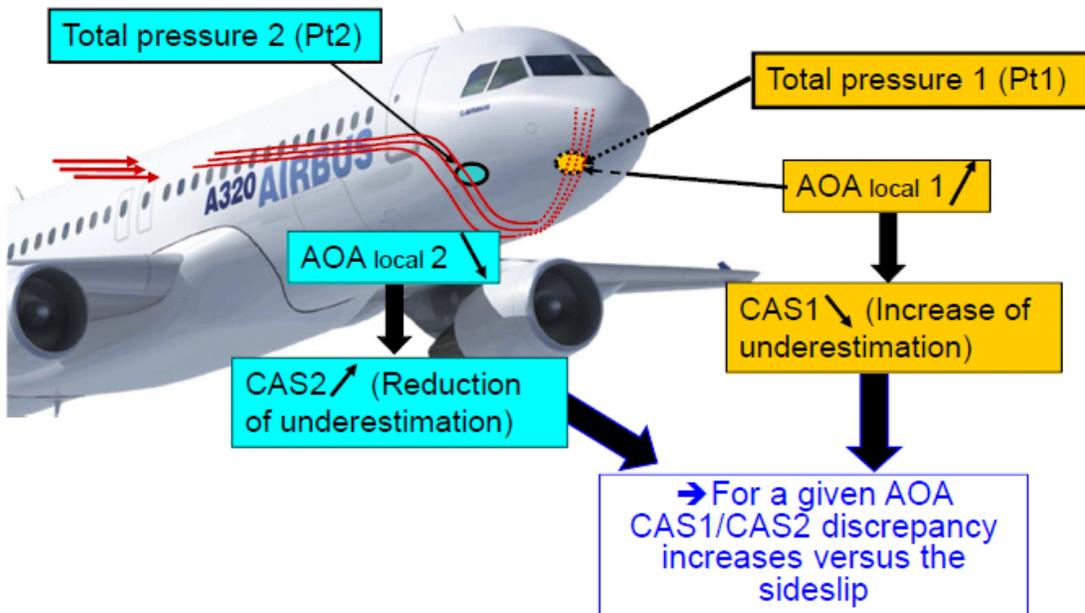
CAS is derived from full pressure and static pressure. If the AoA exceeds its sensor's effective working range, the full pressure accuracy will decrease as the AoA increases, making CAS significantly below its actual level as the AoA increases, which causes huge deviation. At the same time, sideslip can also significantly impact the CAS. (Refer to the following chart)

Besides, for the given AOA, the deviation between CAS No.1 and 2 is related to sideslip. At the time of the incident (09:29:56), sideslip also occurred. This further explains why the deviation between CAS No.1 and No.2 was over 10kt, which caused FAC's failure to apply all the three ADR data.
