**Deviation below manoeuvring airspeed on final, go-around,
triggering of Alpha Floor protection**

| Aircraft | Airbus A320-214 registered F-HEPE |
| Date and time | 3 April 2012 at 12 h 56 ⁽¹⁾ |
| Place | Tel Aviv Ben Gurion Airport (Israel) |

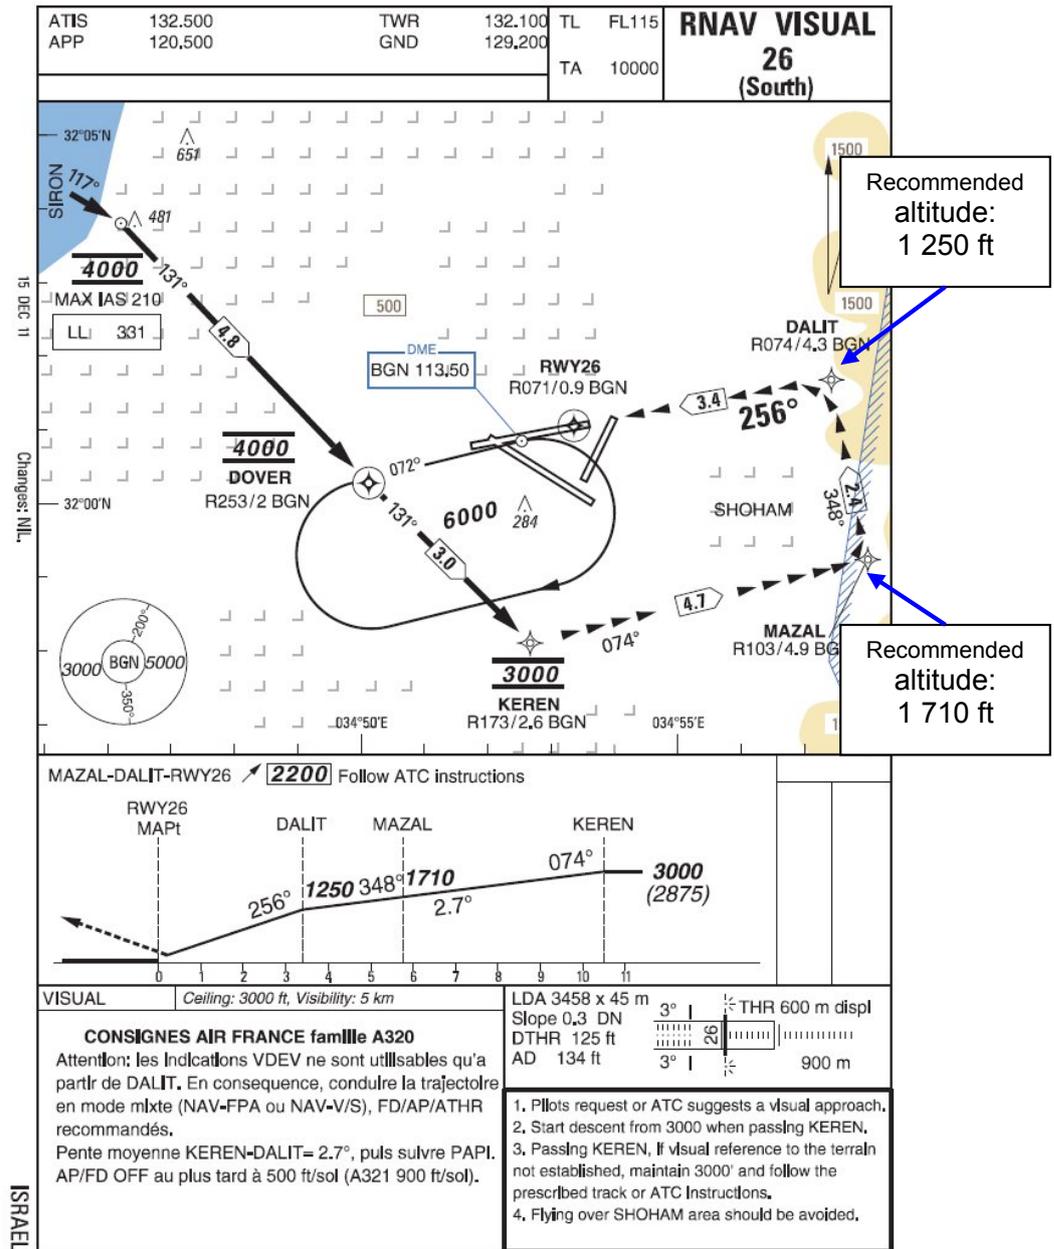
At 12 h 49, the Tel Aviv controller cleared the crew to make an approach to runway 26 via KEREN point (see chart below), according to the RNAV VISUAL procedure.

Air France approach chart for the RNAV VISUAL procedure on runway 26 from the south valid on the date of the event

*Attention : les indications VDEV⁽⁶⁾ ne sont utilisables qu'à partir de DALIT. En conséquence, conduire la trajectoire en mode mixte (NAV-FPA ou NAV-V/S), FD/AP/ATHR recommandés.
Pente moyenne KEREN-DALIT=2,7°, puis suivre PAPI. AP/FD OFF au plus tard à 500 ft/sol.*

On A320 family aeroplanes, it is technically impossible to code several descent paths in the FMS. Air France did not wish to code a continuous descent path from KEREN to avoid possible GPWS warnings. The airline chose to code the profile only from DALIT, which explains why the VDEV was not usable before this point.
