AS332L Super Puma, G-TIGB

AAIB Bulletin No: 8/2003	Ref: EW/C2002/2/6	Category: 2.1
Aircraft Type and Registration:	AS332L Super Puma, G-TIGB	
No & Type of Engines:	2 Turbomeca Makila 1A turboshaft engines	
Year of Manufacture:	1982	
Date & Time (UTC):	28 February 2002 at 1130 hrs	
Location:	70 nm northeast of Scatsa, Shetland Islands	
Type of Flight:	Public Transport	
Persons on Board:	Crew - 2	Passengers - 18
Injuries:	Crew - None	Passengers - None
Nature of Damage:	Damage to tail pylon and tail rotor blades	
Commander's Licence:	Airline Transport Pilot's Licence	
Commander's Age:	51 years	
Commander's Flying Experience:	11,100 hrs (of which 2,000 were on type)	
	Last 90 days - 130 hrs	
	Last 28 days - 45 hrs	
Information Source:	AAIB Field Investigation

Synopsis

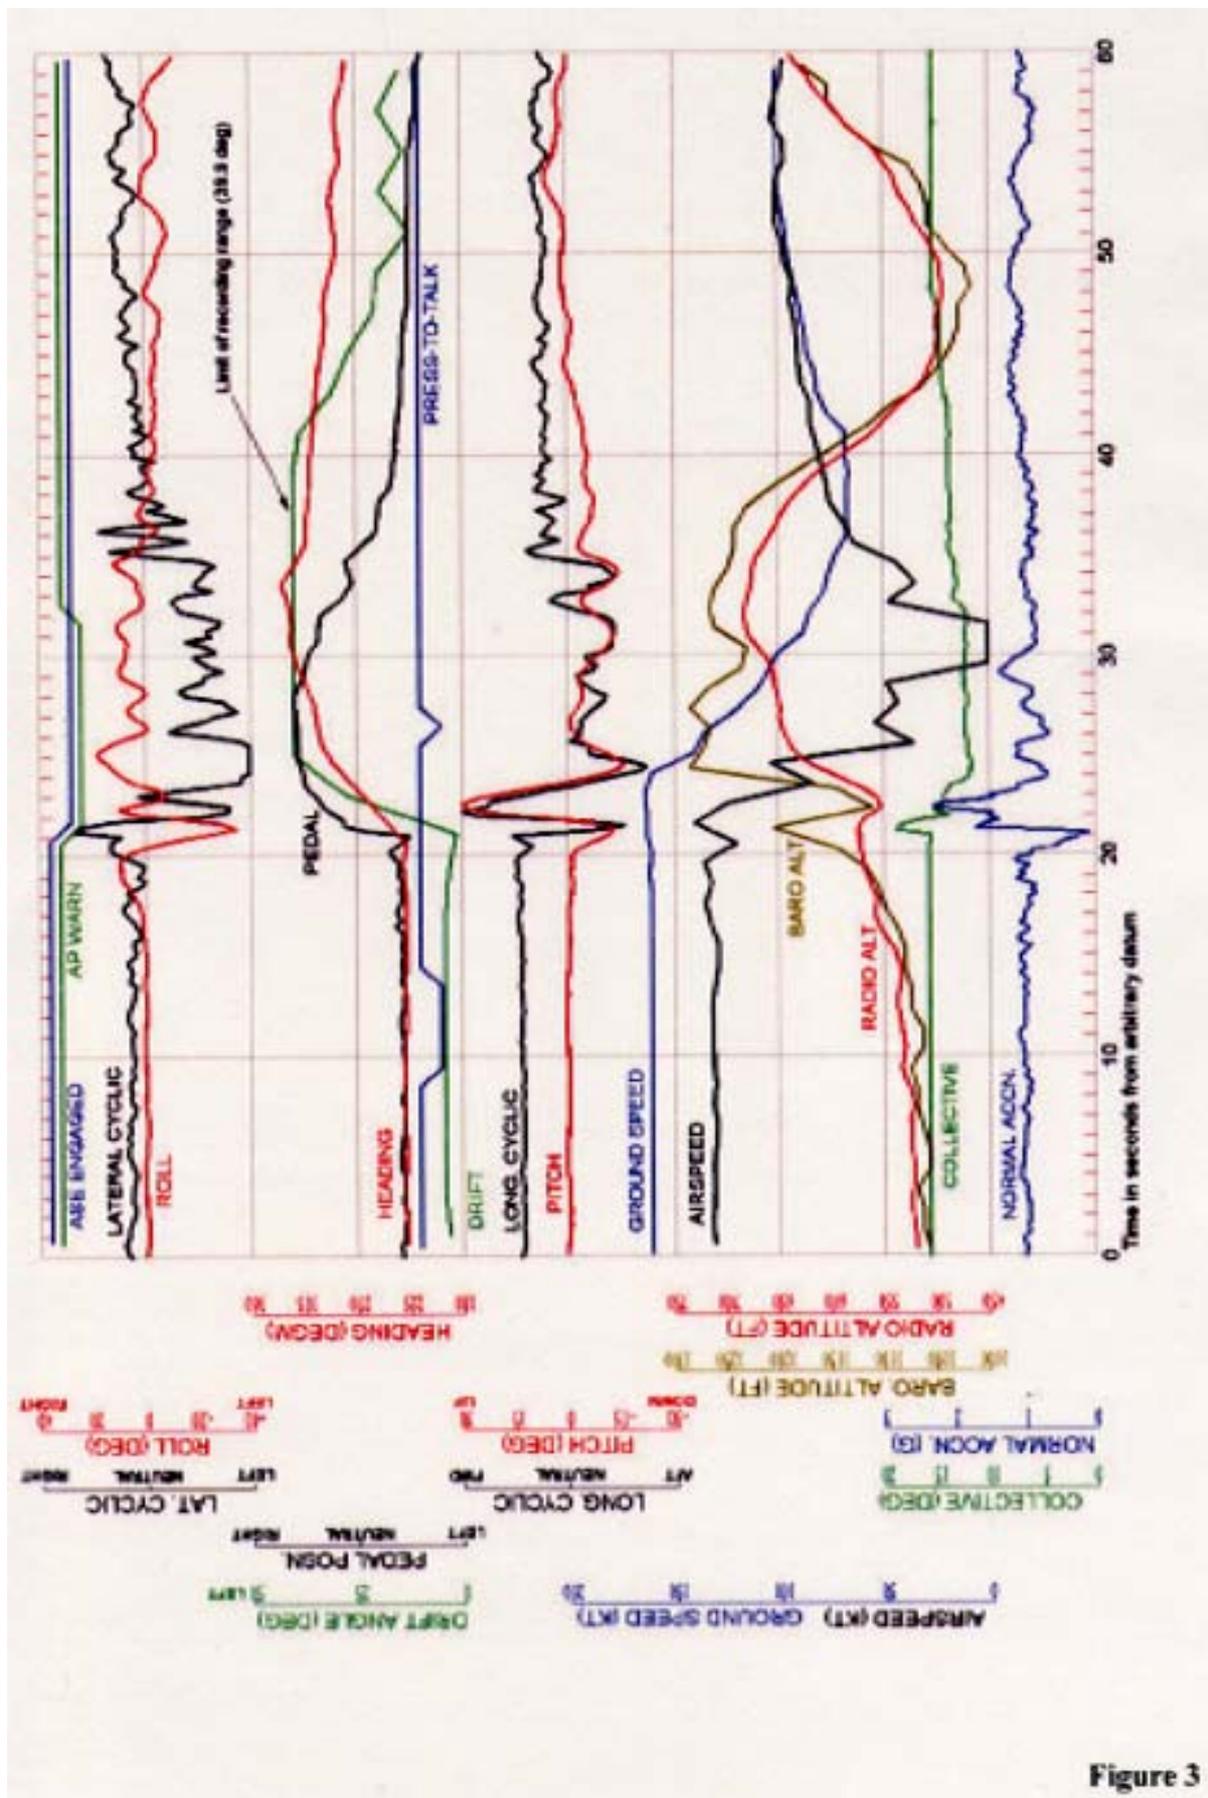
Figure 3

The onset of the event, at position N 60° 57.4' E 000° 54.2', was marked by a gradual increase in both recorded radio height and pressure altitude. The pressure altitude increased at a faster rate than radio altitude and indicated that atmospheric pressure was reducing at that point. Towards the end of this increase, the helicopter rolled to 9.5° right and, in just under 2 seconds, to 34° left whilst pitching 13.4° nose down and yawing to the right. All three channels of both autopilot lanes disconnected, the autopilot FAULT amber caption illuminated for 10 seconds as a result, and normal acceleration values varied from 1g to zero and up to 1.7g over the same period. Right and aft cyclic was applied together with right yaw pedal. Over a period of 0.75 seconds, the helicopter's heading increased through 250°M (21° to the right of the original heading) and, as it continued to yaw right and roll to 10° right, the pitch attitude increased to 29.8° nose up. The helicopter began to climb and a maximum normal

Over the following three seconds, its heading increased through 300°M and it continued to climb and yaw to the right. Pitch attitude then reduced to a minimum of 15.9° nose down, before being corrected with aft cyclic, whilst the roll attitude varied from 8° left to 18° right, each excursion being opposed by lateral cyclic inputs. The collective pitch was lowered from 15° to 12°, and right yaw pedal was maintained. With this right yaw input applied, the corrective lateral cyclic movements ranged from full left to half of full left travel. Also, during this time, recorded airspeed values fluctuated between 123 kt and 83 kt and the ground speed reduced by 20 kt to 120 kt. (Airspeed values recorded would have been affected significantly by pitot / static system errors, as aircraft drift² angles in excess of 39.9° were evident at that time. The maximum recording range capability of the CVFDR system for drift angle is +/-39.9° and this capability was exceeded during the upset).

Over a further period of eight seconds, the helicopter continued to yaw right, to a maximum heading of 333°M. Pitch attitude variations then reduced in amplitude, followed by those of roll attitude. Recorded airspeed values reduced to zero at the highest point of the climb (680 feet radio altitude) before beginning to increase as the aircraft pitched nose down. A gradual left turn was commenced in the descent, as airspeed began to increase, and progressively less left cyclic and less right yaw pedal was applied. Whilst accelerating through 75 kt airspeed, ground speed reached a minimum value of 66 kt and the drift angle began to reduce below 39.9°. It was also evident, from the differences between the recorded values of radio and barometric altitude, that the aircraft was leaving the area of reduced pressure that marked the onset of the event.

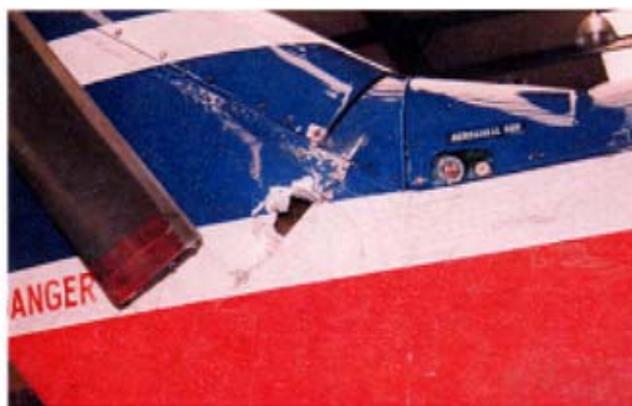
It was apparent that all five tail rotor blades had contacted the pylon on its right side, towards its leading edge. This point corresponds to the thickest part of the aerodynamic profile of the structure and, consequently, this region of the pylon is in closest proximity to the tail rotor disk in its normal running position. Thus, contact was made by the upper, or suction surface, of the tail rotor blades at their tips. The pylon structure had been penetrated to a depth of around 25 mm, creating a gash approximately 150 mm in length. Most of this area of the pylon is constructed with a single thickness skin, with two light stringers attached to the internal surface; however, at the forward end is a doubler that covers a reinforcing angle at the edge of the tail rotor driveshaft decking. This angle had not been severed, although it had suffered severe distortion to the extent that a P-clip at the edge of the decking, which carries electrical cables from the tail rotor gearbox chip detector and IHUMS transducer, had been dislodged. However, the cables were intact, as was the driveshaft fairing. It was apparent that the relatively stiff structure in the region of the angle had been responsible for most of the damage sustained by the rotor blades.

View of right hand side of pylon showing damage

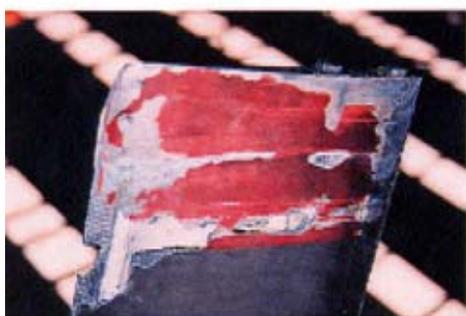
Externally, the extent of the damage appeared to be similar for all five blades. Two of them had suffered chordwise cracks at approximately two thirds span, measured from their roots. A slight kink was evident in the leading edges of these blades. One blade had suffered delamination along much of its trailing edge, and all of the blades had small fragments of material removed from their trailing edges close to the tips. Details of typical damage, and the damage to the pylon, is presented in Figure 6.

Typical contact damage

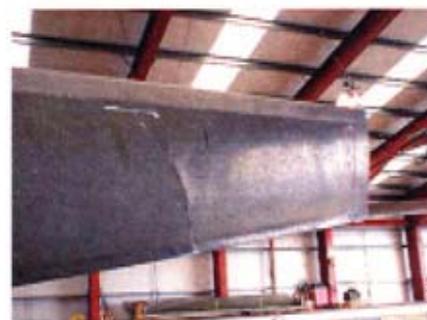
Outer surface of blade, showing chordwise skin fracture due to bending

It was determined that contact with the pylon had caused bending and twisting of this blade near the tip and that this had resulted in cracking of the skin and fracture of the CFRP web. Additionally, the impact and bending had promoted disbonding of the CFRP and GRP webs, as well as causing separation of the trailing edge skins. It was apparent that the two spanwise webs had conferred additional rigidity to the blade, compared with the A1 standard, and that this had limited the degree of bending which occurred on contact with the pylon. The webs had also helped to keep the two blade skins together, reducing the extent of disbonding of the foam core along the span of the blade. The presence of the titanium erosion shield around the blade tip also appeared to have helped significantly in holding the blade skins together. It was initially considered that once the damage had occurred, aerodynamic loads would have served to extend the damaged areas; this appeared to have been minimal and it was concluded that no further significant loss of material had occurred following the initial event. The evaluation of the tail rotor blade damage could only be qualitative; however, it was apparent that it was inherently stronger than earlier standards of blade. There had been no significant propagation of damage for the remainder of the flight following the encounter and this was, therefore, a strong endorsement of the measures taken to improve the blade, which displayed good impact performance and survivability.

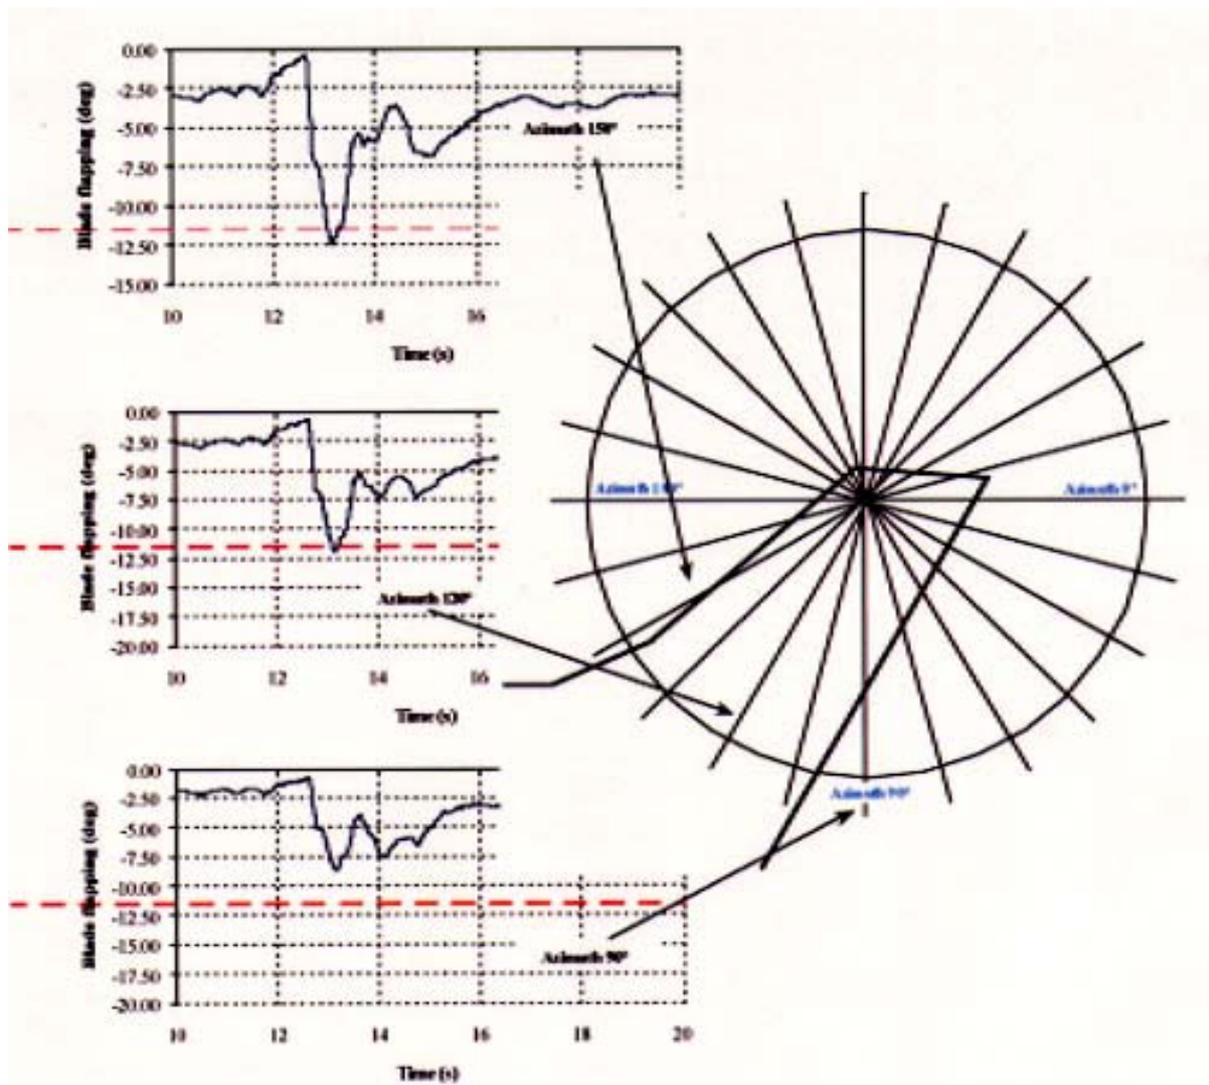
FIGURE 9 Tail rotor blade flapping angles due to gust and yaw pedal deflection
(Contact occurs at 11.5^o)

9. It is apparent from this that contact occurred during the second 'pulse' of the gust, by which time considerable right yaw pedal had been applied. The manufacturer has stated that the pylon and tail rotor geometry is such that contact will occur when the flapping angle of the blades exceeds 11.5° . The manufacturer also stated that measurements had been taken on another AS332L, which was subjected to a turn with maximum right pedal deflection whilst in the hover. A balsa wood block attached to the pylon for the purpose of the test was shaved to within 50 mm of the pylon surface. Additional data from the manufacturer indicated that if the predicted maximum dynamic flapping angle of 5.5° , which occurs at the point of blade stall, is added to the 4° of static flapping to be expected at a typical cruise speed, then a total maximum flapping angle would be 9.5° . As this would give a clearance of 43 mm between the tail rotor blades and pylon, it thus appeared that the nature of the gust accounted for the additional minimum of 2° required for the blade tips to make contact with the pylon.
