Final Report No. 2278

concerning the serious incident (AIRPROX)
involving the B738 aircraft, registration TC-JGV,
operated by Turkish Airlines
under the ATC call sign THY1QM
and the F100 aircraft, registration OE-LVL,
operated by Tyrolean Airways
under the ATC call sign AUA582W
on 31 March 2014
at Geneva airport (LSGG) / GE

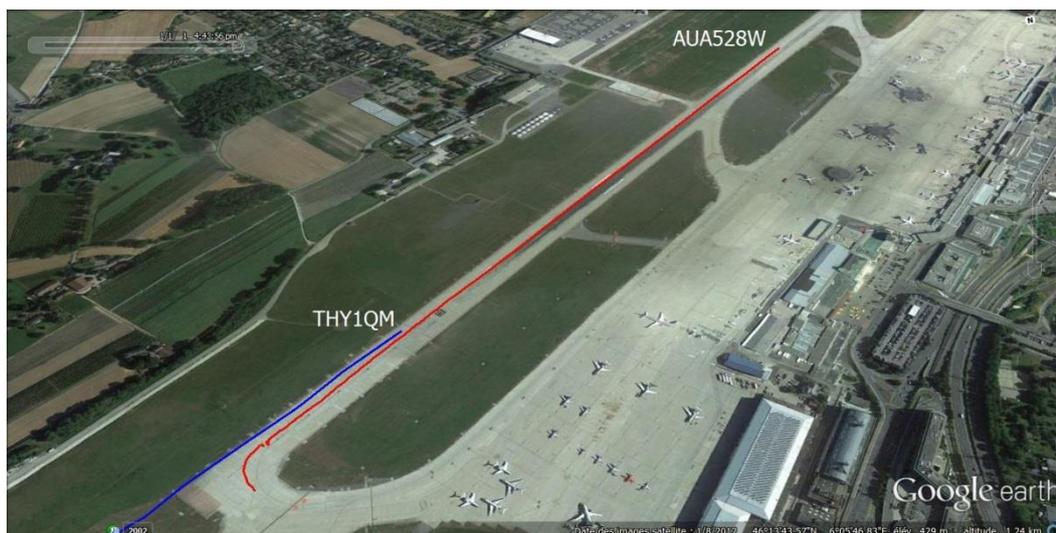
At 15:43:56 UTC, THY1QM crossed the threshold of runway 05 and was 1206⁷ m from AUA582W; the prescribed minimum separation is 2400 m. The aircraft were travelling at the same ground speed of 134 kt and from this moment the distance between them increased. The two pilots of THY1QM mutually confirmed that the aircraft which was taking off had indeed lifted off and continued the approach. It then seemed to them that the reduced separation minima were complied with.

Fig. 1: Trajectories and positions of THY1QM (blue, threshold 05) and AUA582W (red) at 15:43:56 UTC

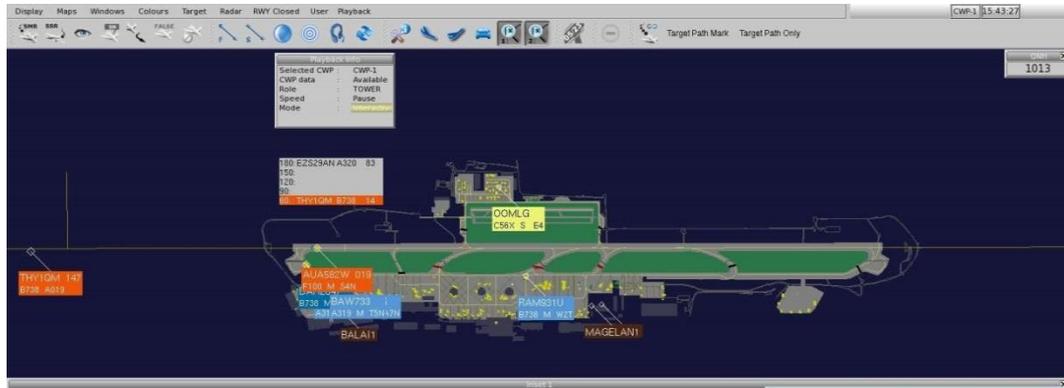
At 15:43:27 UTC, when THY1QM was on approach and 30 seconds from the runway 05 threshold and AUA582W was initiating its take-off, the RIMCAS system issued a phase 1 (orange) alert. Fifteen seconds later, at 15:43:42 UTC, the alert changed to phase 2 (red). THY1QM was at a height of 200 ft and 1215 m from AUA582W which was in take-off roll phase.

Fig. 4: Phase 1 RIMCAS alert (orange)

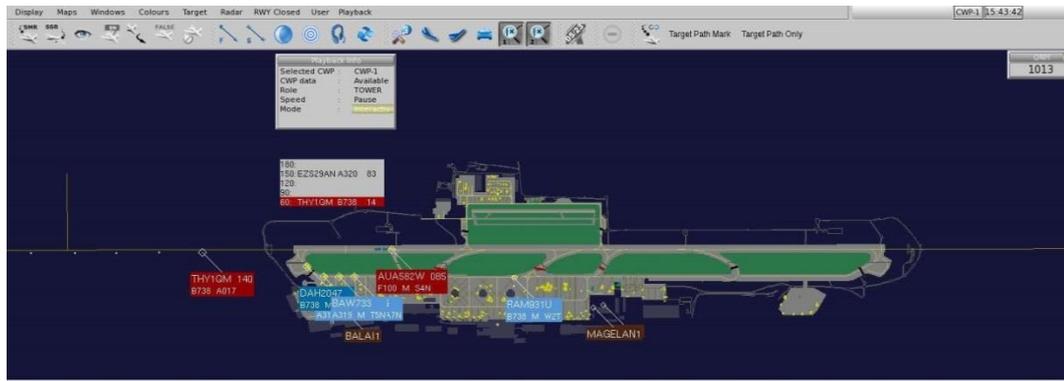
Fig. 5: Phase 2 RIMCAS alert (red)

The stress caused by the dangerous convergence of THY1QM and AUA582W lead to the controller perceiving the relative motion of the aircraft wrongly, since he thought that separation was being restored when the phase 2 RIMCAS alert was triggered. The difference in ground speeds was then still 55 kt; it was not until 14 seconds later that the convergence ended.

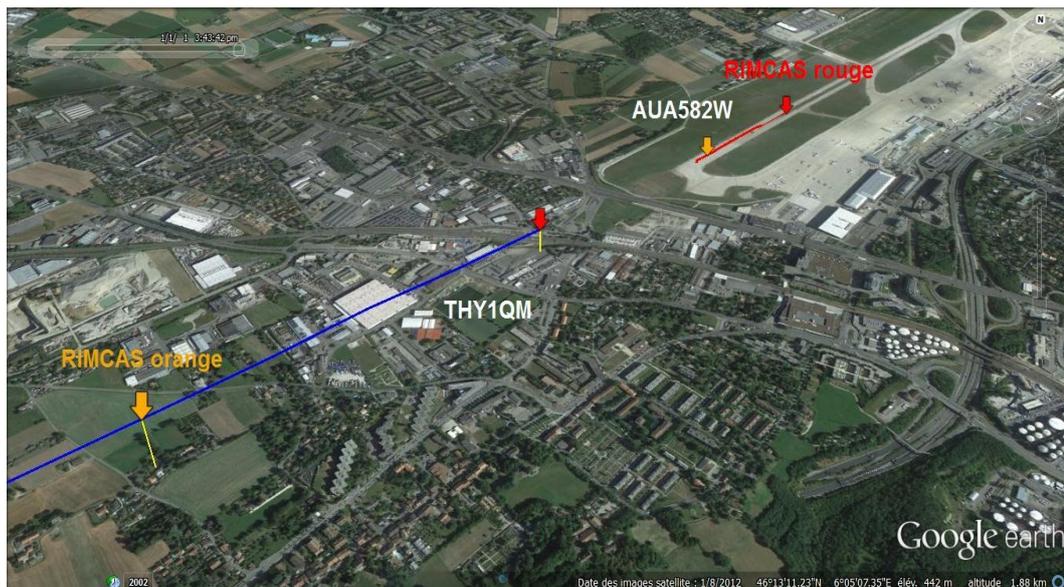
Fig. 6: RIMCAS alerts issued at the time of the serious incident

When low-visibility procedures are not in force, the phase 1 RIMCAS visual alert 1 (orange) is designed to activate when an aircraft on approach which is 30 seconds from the runway threshold becomes the cause of a potentially dangerous convergence with an aircraft/vehicle on the runway. In the conflict which is the subject of the serious incident, the calculated convergence was never virtual because the distance between the two aircraft at the time that THY1QM crossed the runway threshold could only be less than the minimum prescribed separation of 2400 m.

This disparity is explained by the fact that the RIMCAS system is based on the TCPA time, which is dependent on the ratio of distance between the two aircraft and their relative speed rather than their separation alone. When conditions allow the application of reduced separation minima, the controller must make sure that incoming traffic is separated by 2400 m from departing traffic. He therefore refers to a distance, whereas the RIMCAS system operates on the basis of time. As attested by the dangerous convergence of the serious incident under investigation and those mentioned above, the imminence of an inevitable loss of separation is not necessarily reported or even correctly reported by a RIMCAS alert.

The Federal Office of Civil Aviation (FOCA) should ensure that the parameterisation of the RIMCAS system (Runway Incursion Monitoring and Conflict Alert Sub-System) is reviewed so that the safety net is effective for weather conditions other than those of low visibility.
