# **Final Report No. 1905 of the Aircraft Accident Investigation Bureau**

**concerning the incident (Airprox)**

between AFR5825 and N83CP

on 16 September 2004

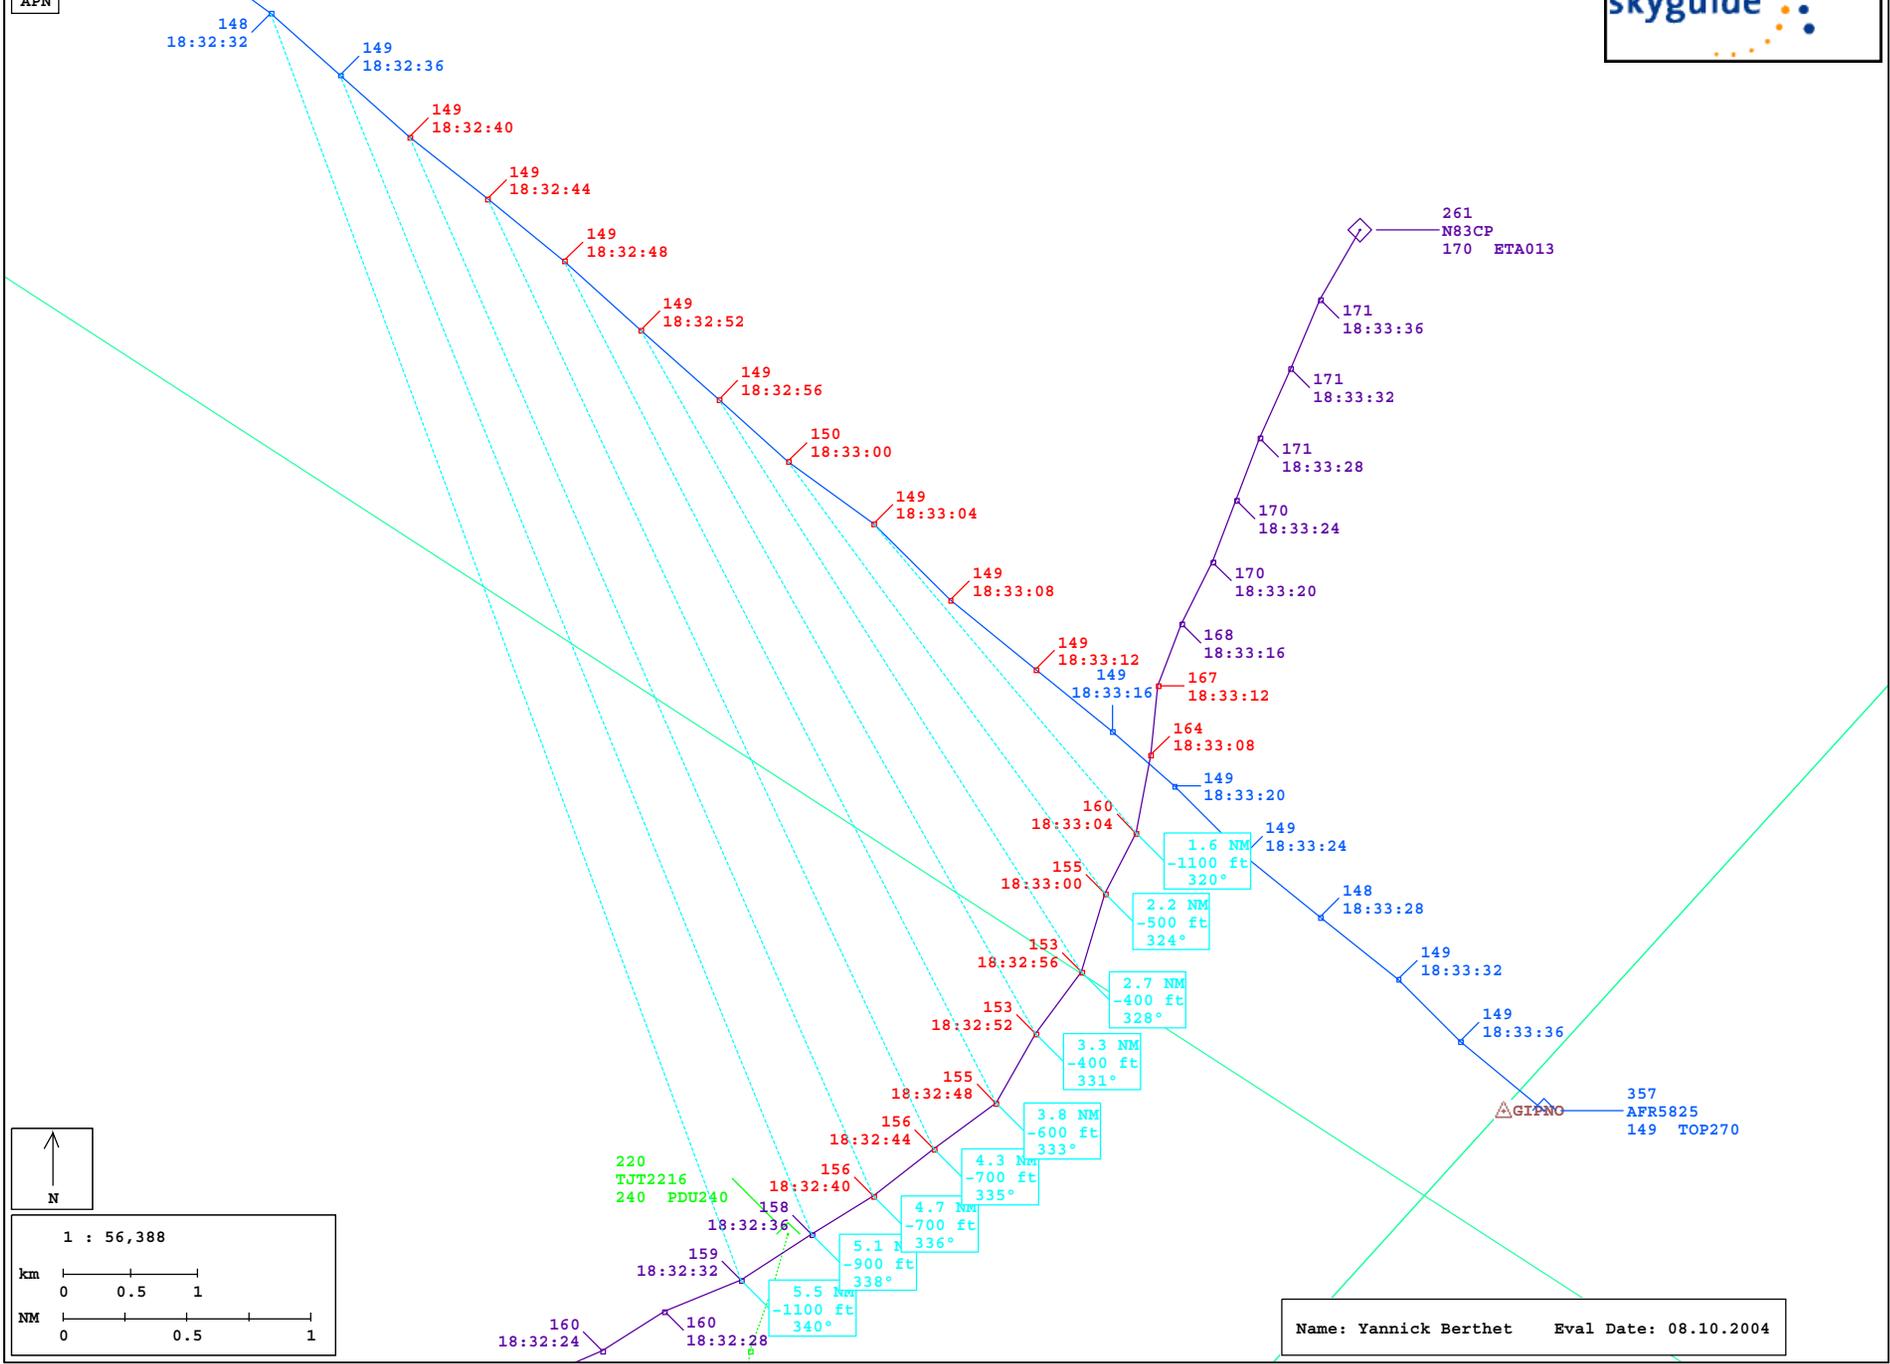
Analysis: Airprox N83CP / AFR5825 Time [UTC]: 16.09.2004 18:33:43

- According to the radar plots, the minimum distance between the converging routes of the two aircraft was a lateral separation of 2.7 NM and an altitude difference of 400 ft.
