**SERIOUS INCIDENT**

<b>Aircraft Type and Registration:</b>	1) Boeing 737-800, EI-FJW 2) Airbus A320-214, OE-IVC
<b>No &amp; Type of Engines:</b>	1) 2 CFM56-7B26E turbofan engines 2) 2 CFM56-5B4/3 turbofan engines
<b>Year of Manufacture:</b>	1) 2016 2) 2016
<b>Date &amp; Time (UTC):</b>	13 August 2018 at 0948 hrs
<b>Location:</b>	Runway 06 at Edinburgh Airport
<b>Type of Flight:</b>	1) Commercial Air Transport (Passenger) 2) Commercial Air Transport (Passenger)
<b>Persons on Board:</b>	1) Crew - 7                  Passengers - 159 2) Crew - 6                  Passengers - 180
<b>Injuries:</b>	1) Crew - None              Passengers - None 2) Crew - None              Passengers - None
<b>Nature of Damage:</b>	1) None 2) None
<b>Commander's Licence:</b>	1) Airline Transport Pilots Licence 2) Airline Transport Pilots Licence
<b>Commander's Age:</b>	1) 42 years 2) 37 years
<b>Commander's Flying Experience:</b>	1) 6,800 hours (of which 6,650 were on type) Last 90 days - 160 hours Last 28 days - 30 hours  2) 10,000 hours (of which 9,000 were on type) Last 90 days - 200 hours Last 28 days - 70 hours

<b>Information Source:</b>	AAIB Field Investigation

**Synopsis**

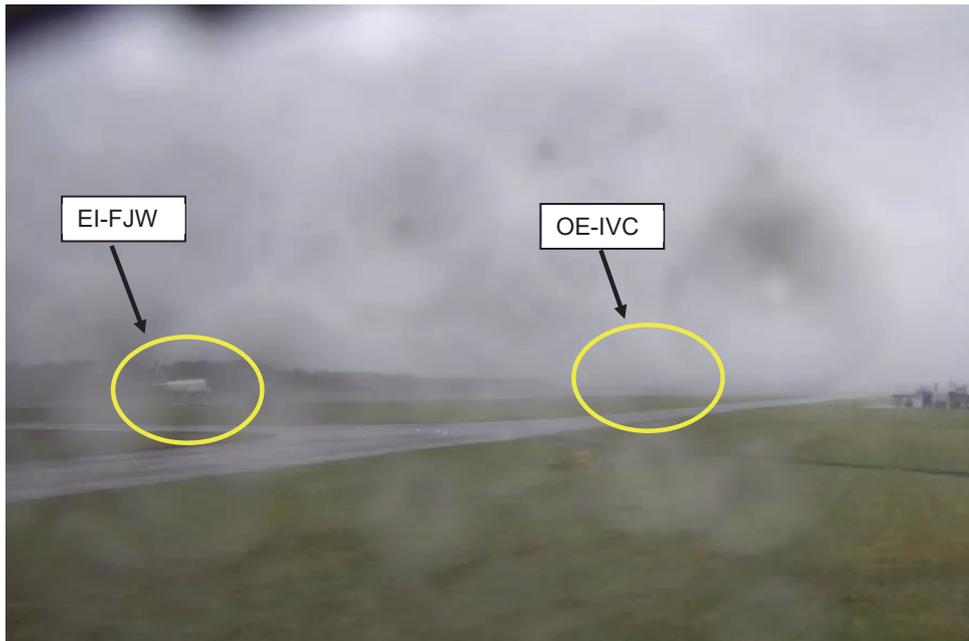
**Figure 2**

As EI-FJW was over the runway at the same time as OE-IVC was completing its takeoff roll, the event was classed as a runway incursion by the air navigation service provider (ANSP). At the closest point of approach, the two aircraft were separated by approximately 875 m, with OE-IVC being at 60 ft aal when EI-FJW touched down. Figure 2 shows a CCTV view looking down the runway which, although partially obscured by rain on the camera, shows both EI-FJW and OE-IVC visible in the frame.

CCTV showing both aircraft over the runway

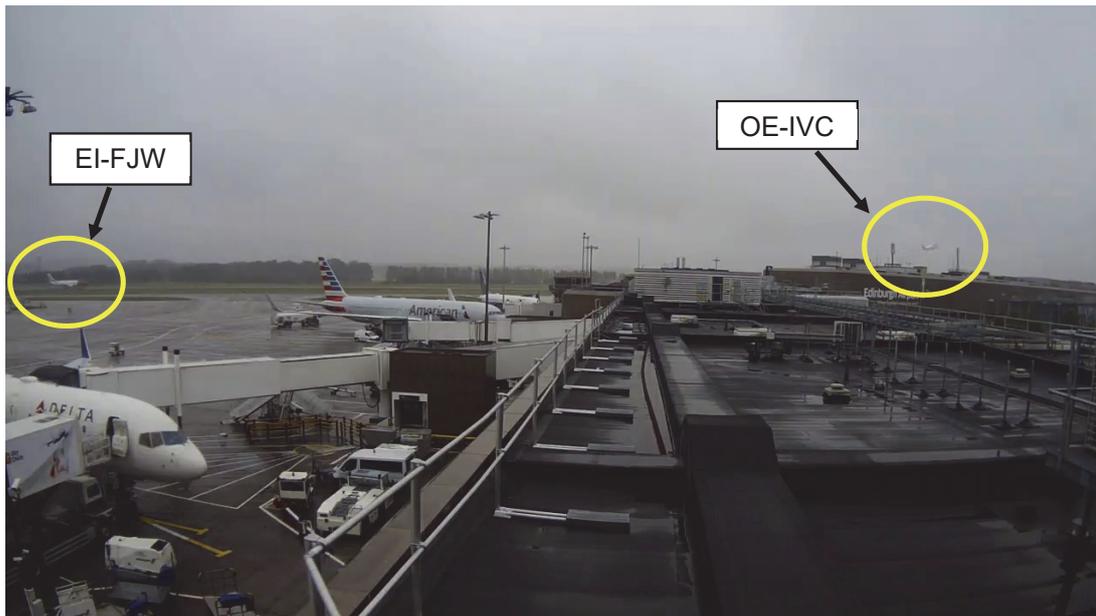
**Figure 6**

CCTV screenshot of the event showing both aircraft

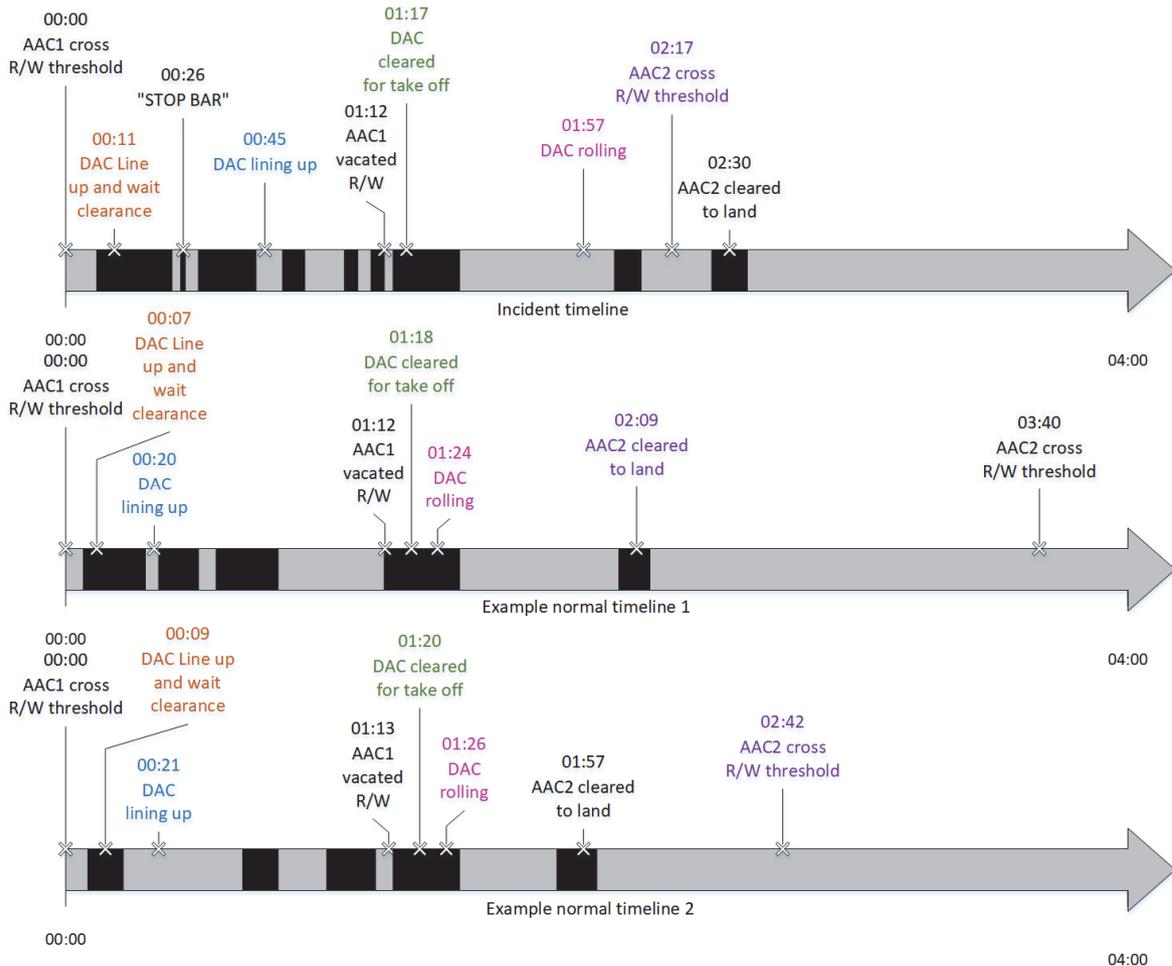
**Figure 7**

Incident timeline compared to normal examples

The comparison shows three significant timeline differences between the incident and the two normal examples:

- In the incident example, the approach speed of EI-FJW resulted in the aircraft arriving at the runway threshold quicker than in the examples.
- In the normal examples, the time between line up clearance being issued and starting to line up was 12 to 14 seconds as opposed to 34 seconds in the incident.

- In the normal examples, the time between receiving takeoff clearance and starting the takeoff roll was six seconds compared to 40 seconds in the incident.
