Engine Power Loss in Ice Crystal Conditions

by Jeanne Mason,
Senior Specialist Engineer,
Engine Performance and Operability,
Propulsion Systems Division

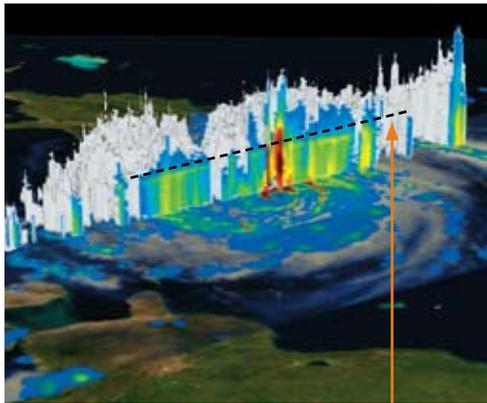
Figure 1

SATELLITE/RADAR IMAGE OF A HURRICANE CONVECTIVE STORM

This NASA Tropical Rainfall Measurement Mission (TRMM) combined satellite radar image shows a vertical cross-section of a convective storm. The image shows the freezing level clearly by the “bright band” where ice particles become coated with melted water and are excellent reflectors of radar energy. Below the freezing level, liquid water is highly reflective. Above the freezing level, while the concentration of moisture may still be high, the cloud is mostly composed of frozen ice particles with radar reflectivity below 20dBZ (units of radar energy). Small ice crystals are irregular in shape and poor reflectors of radar energy. These small ice crystals are believed to be associated with engine power-loss events.

On-board weather radar can detect large particles such as hail, rain, and large ice crystal masses (snowflakes). Small particles, such as ice crystals in high concentrations near thunderstorms, are invisible to on-board weather radar, even though they may comprise the majority of the total mass of a cloud (see fig. 1).

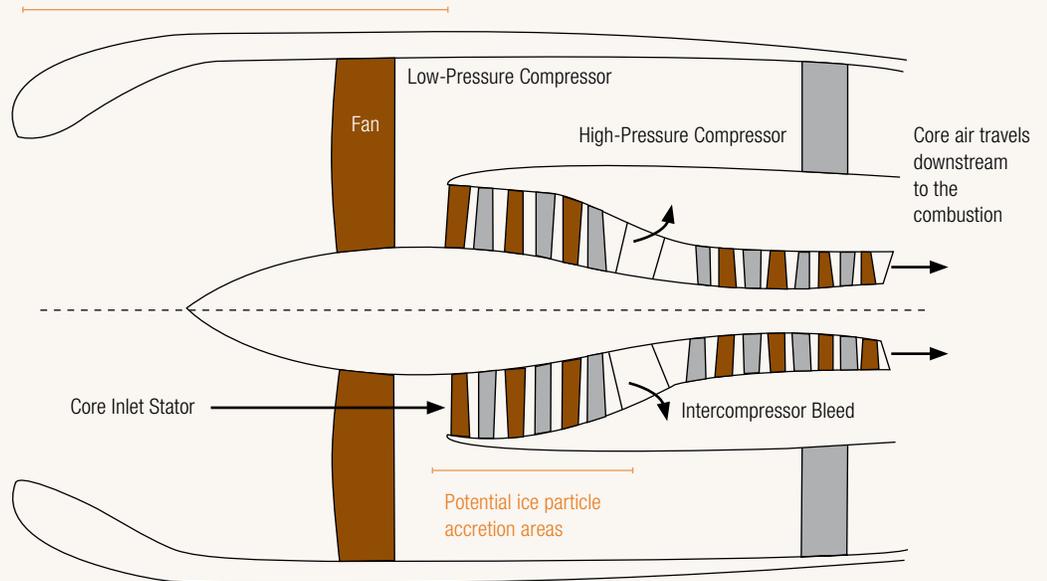
Figure 2

It is now believed that ice crystal icing can occur deep in the engine where surfaces are warmer than freezing (see fig. 2). Both older generation jet engines and the new generation of jet engines (high bypass ratio engines with electronic engine controls) can be affected by ice crystal icing.

HOW ICE CRYSTALS ACCRETE IN A JET ENGINE

Researchers hypothesize that ice particles enter the engine and bounce off surfaces colder than freezing (inlet, fan, and spinner). Once reaching surfaces warmer than freezing in the core, some of the small particles can melt and create a film of water on the surface to which additional incoming ice crystals can stick. This process gradually reduces the temperature of the surface until ice can begin to build up.

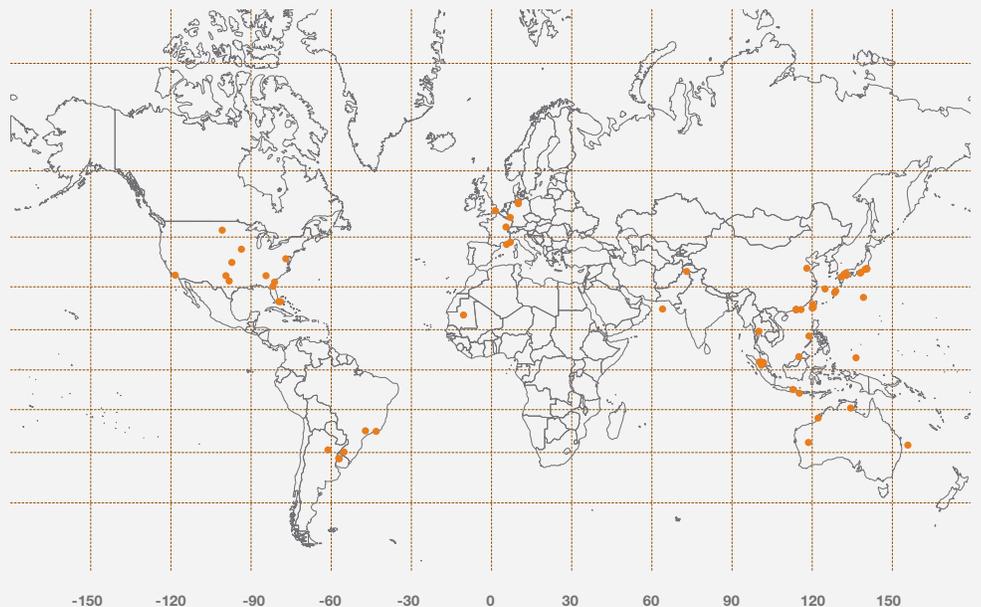
Figure 3

LOCATIONS OF ICE CRYSTAL POWER-LOSS EVENTS

While most ice crystal power-loss events that have been studied to date have occurred in Asia, events have been noted in most parts of the world. Note: Latitude and longitude information is not available for all 100 events. This chart actually shows 67 events, some of which are overlaid. Not all events are Boeing airplanes.

in this region. Higher temperature air can hold more water. There is a heavy concentration of ice crystal power-loss events between 20 and 40 degrees north latitude with a few events farther than 45 degrees from the equator (see fig. 3).

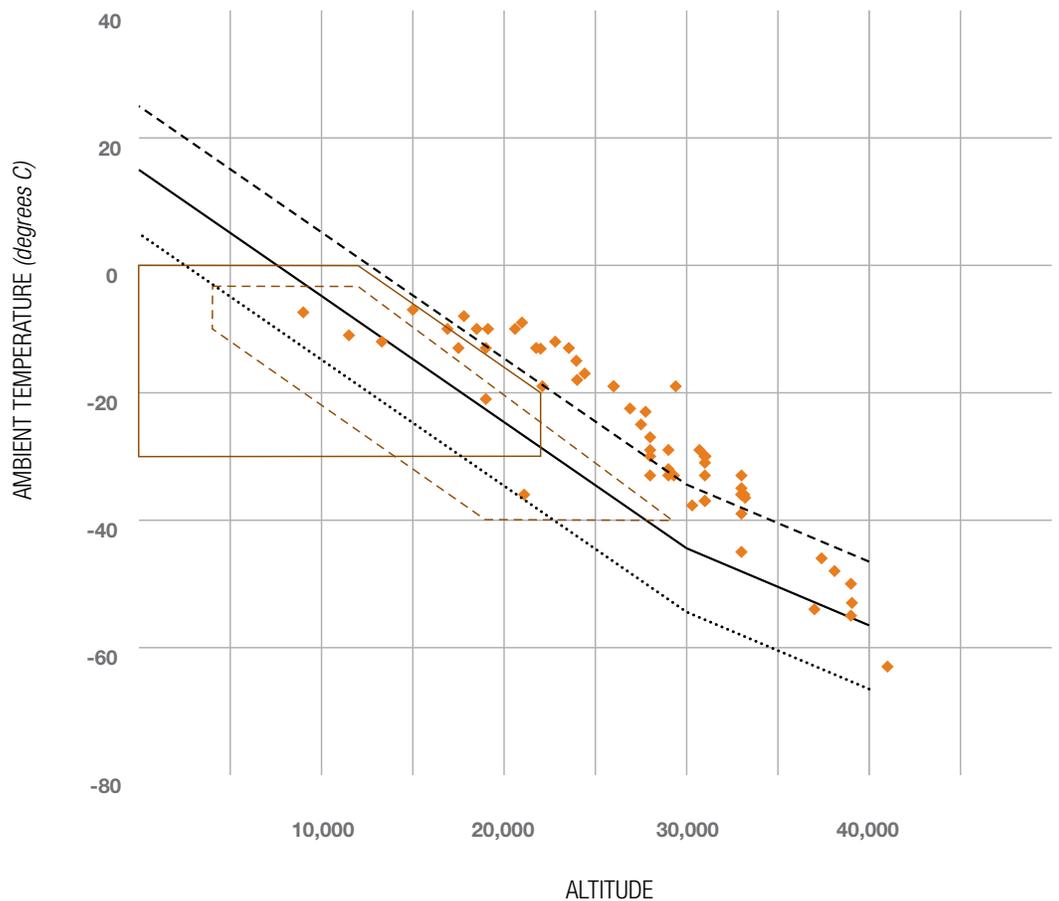
Figure 4

ALTITUDE AND TEMPERATURE OCCURRENCE OF ENGINE POWER LOSS

Temperatures for the majority of the events for which data is available are significantly warmer than standard day temperatures, and also fall outside of the current icing design envelopes for supercooled liquid water.

- *High altitudes and cold temperatures.* Commercial airplane power-loss events associated with ice crystals have occurred at altitudes of 9,000 to 39,000 feet, with a median of 26,800 feet, and at ambient temperatures of -5 to -55 degrees C with a median of -27 degrees C. The engine power-loss events generally occur on days when the ambient temperature is warmer than the standard atmosphere (see fig. 4).

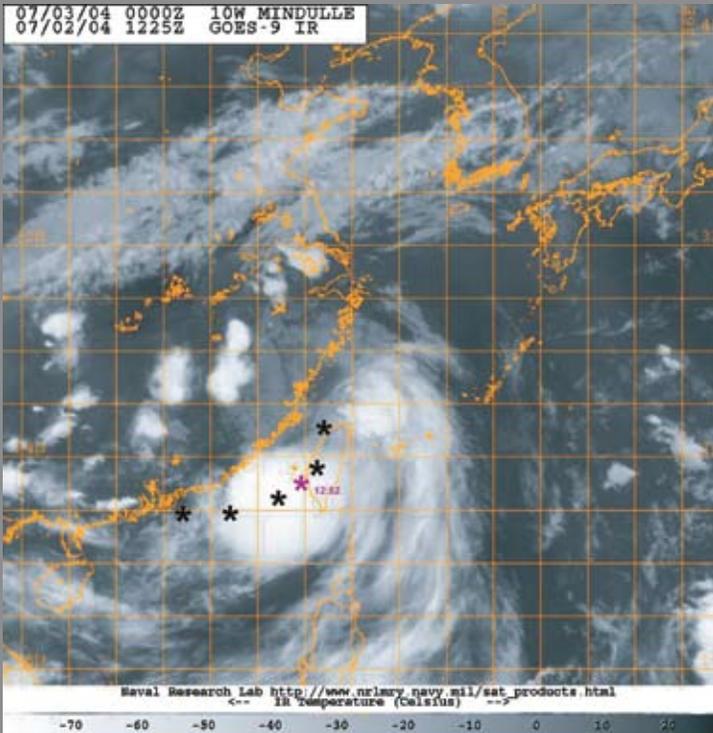
INFRARED IMAGE WITH AIRPLANE TRACK

In this infrared satellite image from about the time of an engine event, bright white indicates colder cloud, and therefore at high altitude. The airplane penetrated the upper altitudes of a fully developed typhoon, yet the pilot did not see any flight level radar returns.

The asterisks represent the aircraft path from left to right on descent into Taipei, with the event noted in purple.

- A commercial airplane on descent, flying in convection conditions, experienced a TAT anomaly. (The anomaly is due to ice crystals building up in the area in which the sensing element resides, where they are partly melted by the heater, causing a 0 degrees C reading. In some cases, TAT has stabilized at 0 degrees C during a descent, and may be noticeable to pilots. In other cases, the error is more subtle, and not a reliable-enough indicator to provide early warning to pilots of high concentrations of ice crystals.)

- At 38,000 feet (-42 degrees C), the pilot encountered moderate turbulence and noted some lightning in the vicinity.
- A brief power-loss event occurred at 30,000 feet — the engines restarted quickly.

- There were no radar echoes at the altitude and location of the airplane.
- An absence of a response from the ice detector indicated that no supercooled liquid was present.

- The pilot reported heavy rain at -25 degrees C.
- Initial report of rain on the windscreen was later determined to be ice crystals, and confirmed by the pilot to have a unique sound.
