ACCIDENT

Aircraft Type and Registration:	Airbus A320-232, G-EUUF
No & Type of Engines:	2 International Aero Engine V2527-A5 turbofan engines
Year of Manufacture:	2002
Date & Time (UTC):	26 June 2006 at 1645 hrs
Location:	Taxiway Kilo, London Heathrow Airport
Type of Flight:	Commercial Air Transport (Passenger)
Persons on Board:	Crew - 7 Passengers - 83
Injuries:	Crew - None Passengers - None
Nature of Damage:	Damage to right engine and to tractor
Commander's Licence:	Airline Transport Pilot's Licence
Commander's Age:	51 years
Commander's Flying Experience:	16,022 hours (of which 4,122 were on type) Last 90 days - 186 hours Last 28 days - 37 hours
Information Source:	AAIB Field Investigation

Synopsis

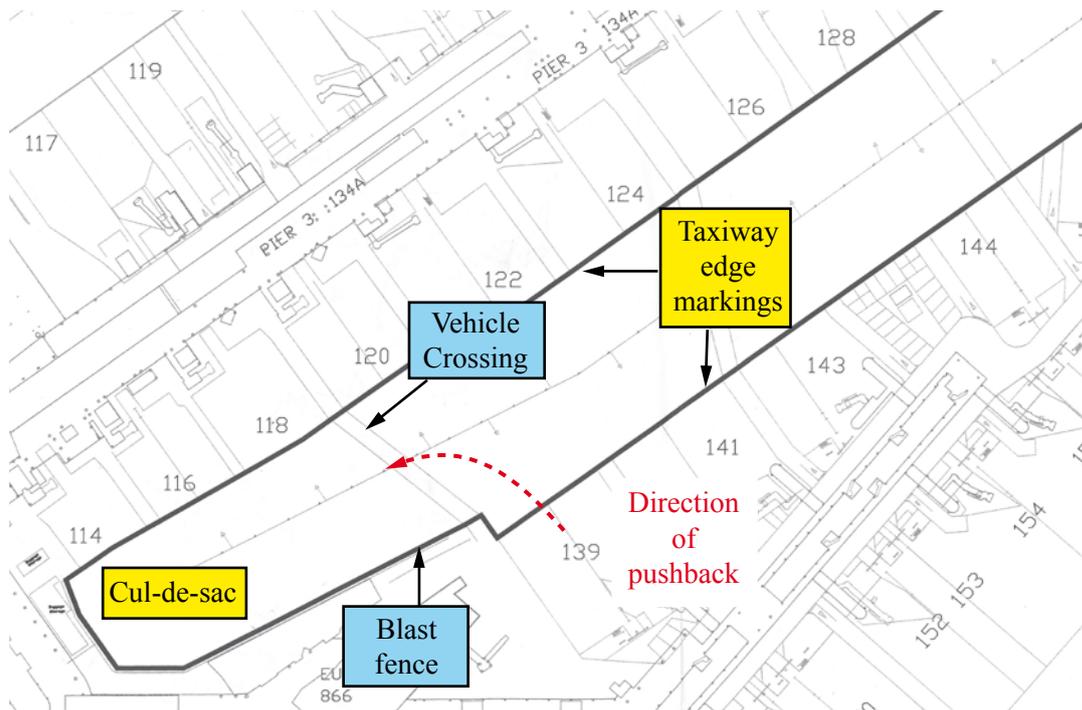
Figure 1

Plan of cul-de-sac, showing pushback details

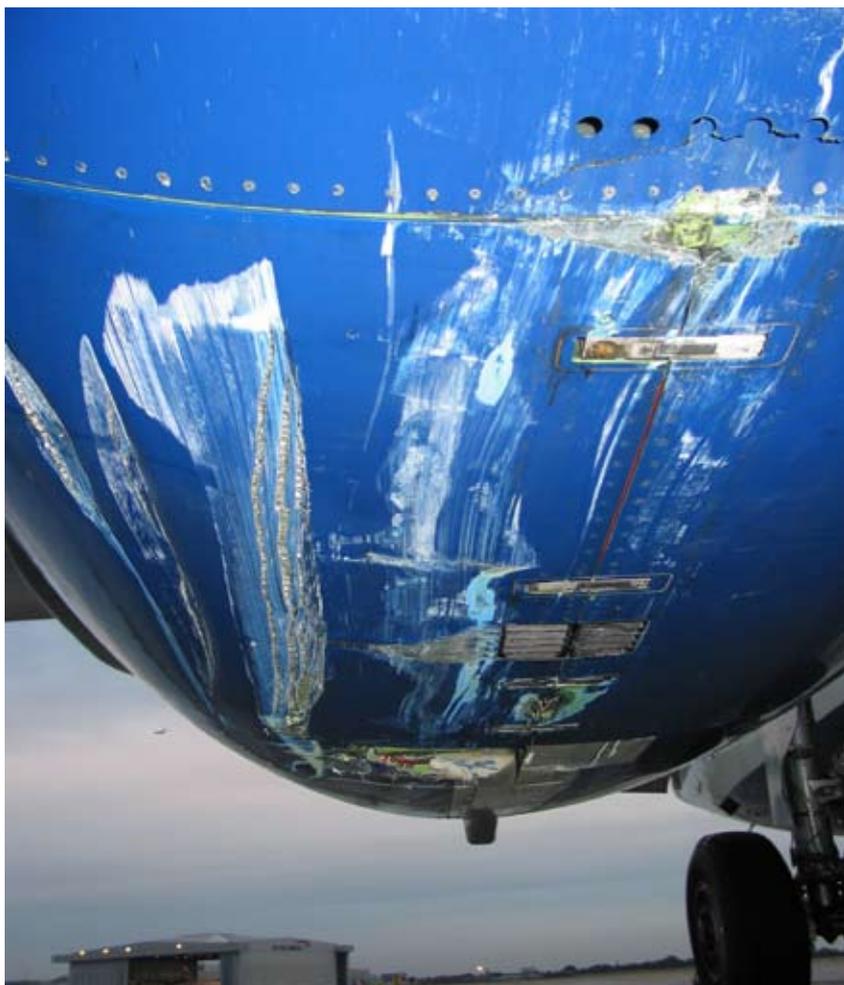
Figure 2

The underside of the engine inlet cowl, fan cowl and thrust reverser ‘C’-duct of the aircraft’s No 2 (right) engine were badly damaged (Figure 2) from contact with the rear of the tractor. Scoring on the lower right side of the engine cowls correlated with blue paint transfer and score marks on the tractor legs. From these marks, it was deduced that the tractor had been positioned on the right side of the aircraft, with its longitudinal axis oriented between 70 and 80 degrees to the right of the direction of travel of the aircraft, with the rear of the tractor in line with the No 2 engine.

The engine had initially grazed the right leg of the tractor (aft, looking forward), scoring the lower right side of the

Damage to No 2 engine caused on impact with tractor

cowls, before riding over the top of the left leg, which caused more extensive damage to the underside of the engine. A piece of the thrust reverser ‘C’-duct aluminium structure was found embedded in the reinforcing rib on the top of the left leg of the tractor.

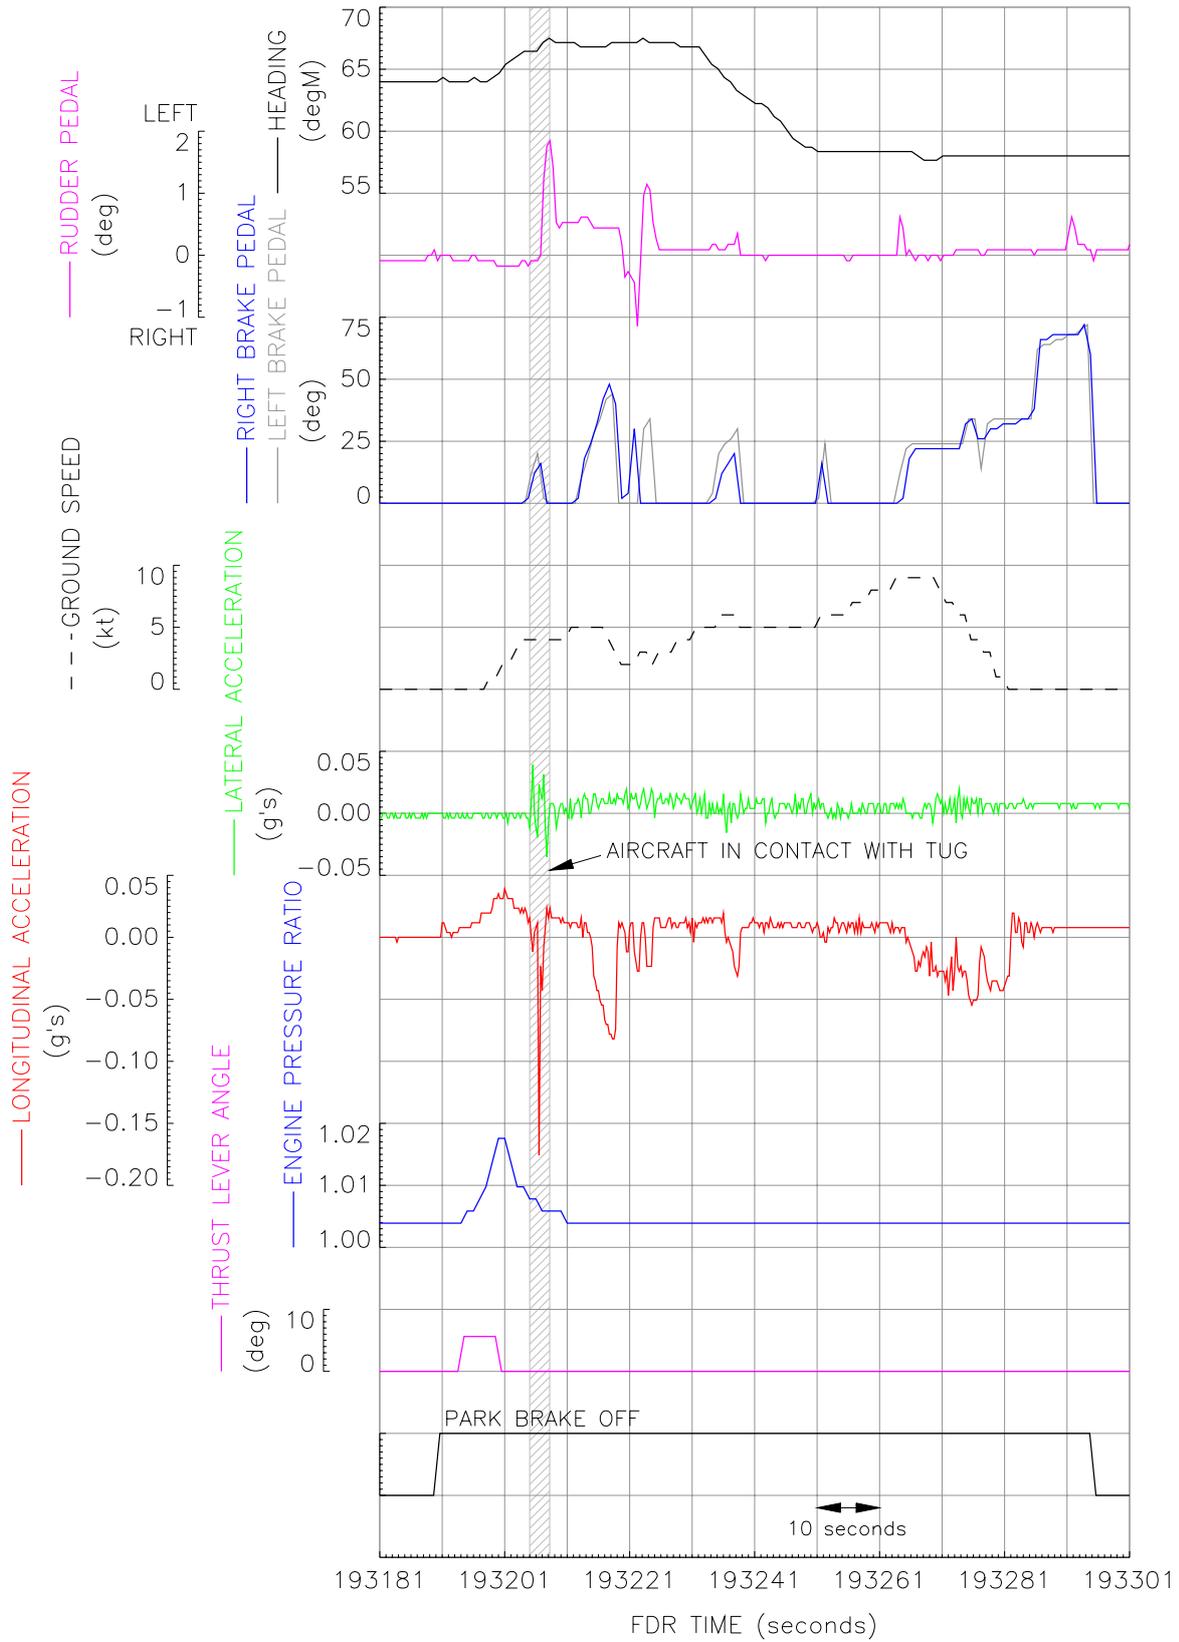
Figure 3
Salient FDR Parameters

A ‘time history’ plot of the relevant parameters is given at Figure 3. The data presented at Figure 3 starts after pushback, with the park brake set and starting checks complete, just over 10 seconds before G-EUUF started moving forward under its own power.

momentarily as the commander performed a brake check. During this check G-EUUF struck the tug - indicated by spikes in both lateral and longitudinal acceleration over a three second period (highlighted). This jolt was also noted by the crew. A small amount of left pedal was applied immediately after the collision, lining the aircraft up on a heading of 067°M, followed by braking which decelerated the aircraft to about two knots. The distance travelled before the collision was calculated to be 13 m.

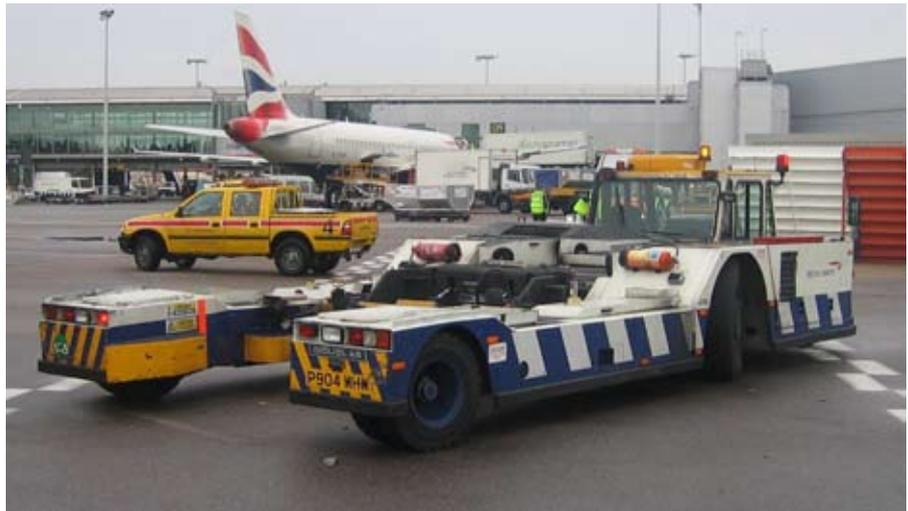
Figure 4

The damage to the tractor was largely confined to its left leg. The force of the No 2 engine bearing down on the leg had deformed the wheel spat which is manufactured from 10 mm steel plate, reinforced by a stiffening rib. Two of the mounting bolts attaching the wheel spat to the chassis leg had also sheared.

Post-accident photograph of Tractor AT0858
(Stand 139 in background)

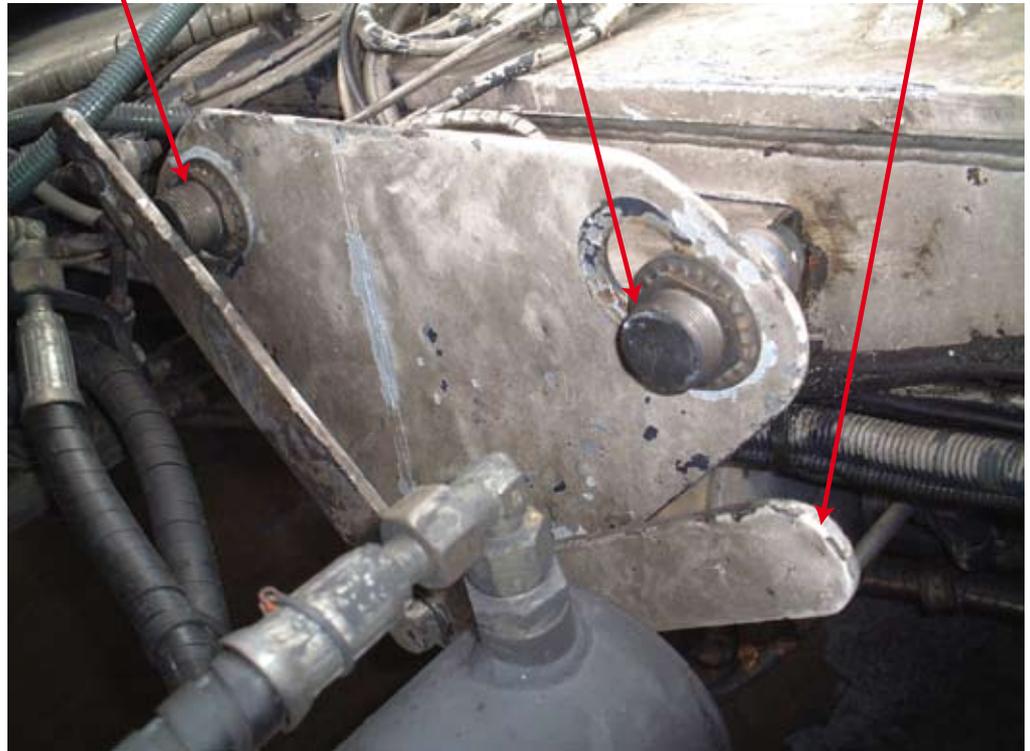
Figure 5

Cradle position sensor location showing ‘boomerang’ overtravel

On closer inspection, the target arm of the boomerang was found to have travelled past the ‘cradle up’ proximity sensor, to the extent that the boomerang operating arm was triggering the ‘cradle down’ sensor (Figure 5). During testing, it was found that the cradle overtravel could be reproduced occasionally if the tractor engine was ‘revved’ whilst raising the cradle. The defect was cured by adjusting the ‘cradle up’ and ‘cradle down’ proximity switch air gaps to the manufacturer’s specified gap of 4 mm and reducing the hydraulic fluid flow rate to the cradle rams to slow the cradle raise speed. Following these adjustments, it was no longer possible to reproduce the fault.
