ACCIDENT

Aircraft Type and Registration:	Airbus A321-211, G-DHJH
No & Type of Engines:	2 CFM56-5B3/P turbofan engines
Year of Manufacture:	2000
Date & Time (UTC):	18 July 2008 at 2010 hrs
Location:	Manchester Airport
Type of Flight:	Commercial Air Transport (Passenger)
Persons on Board:	Crew - 9 Passengers - 219
Injuries:	Crew - None Passengers - None
Nature of Damage:	Crack observed in wing gear rib lug.
Commander's Licence:	Airline Transport Pilot's Licence with Type Rating Instructor and Type Rating Examiner qualifications
Commander's Age:	51 years
Commander's Flying Experience:	12,200 hours Last 90 days - 124 hours Last 28 days - 56 hours
Information Source:	AAIB Field Investigation

Synopsis

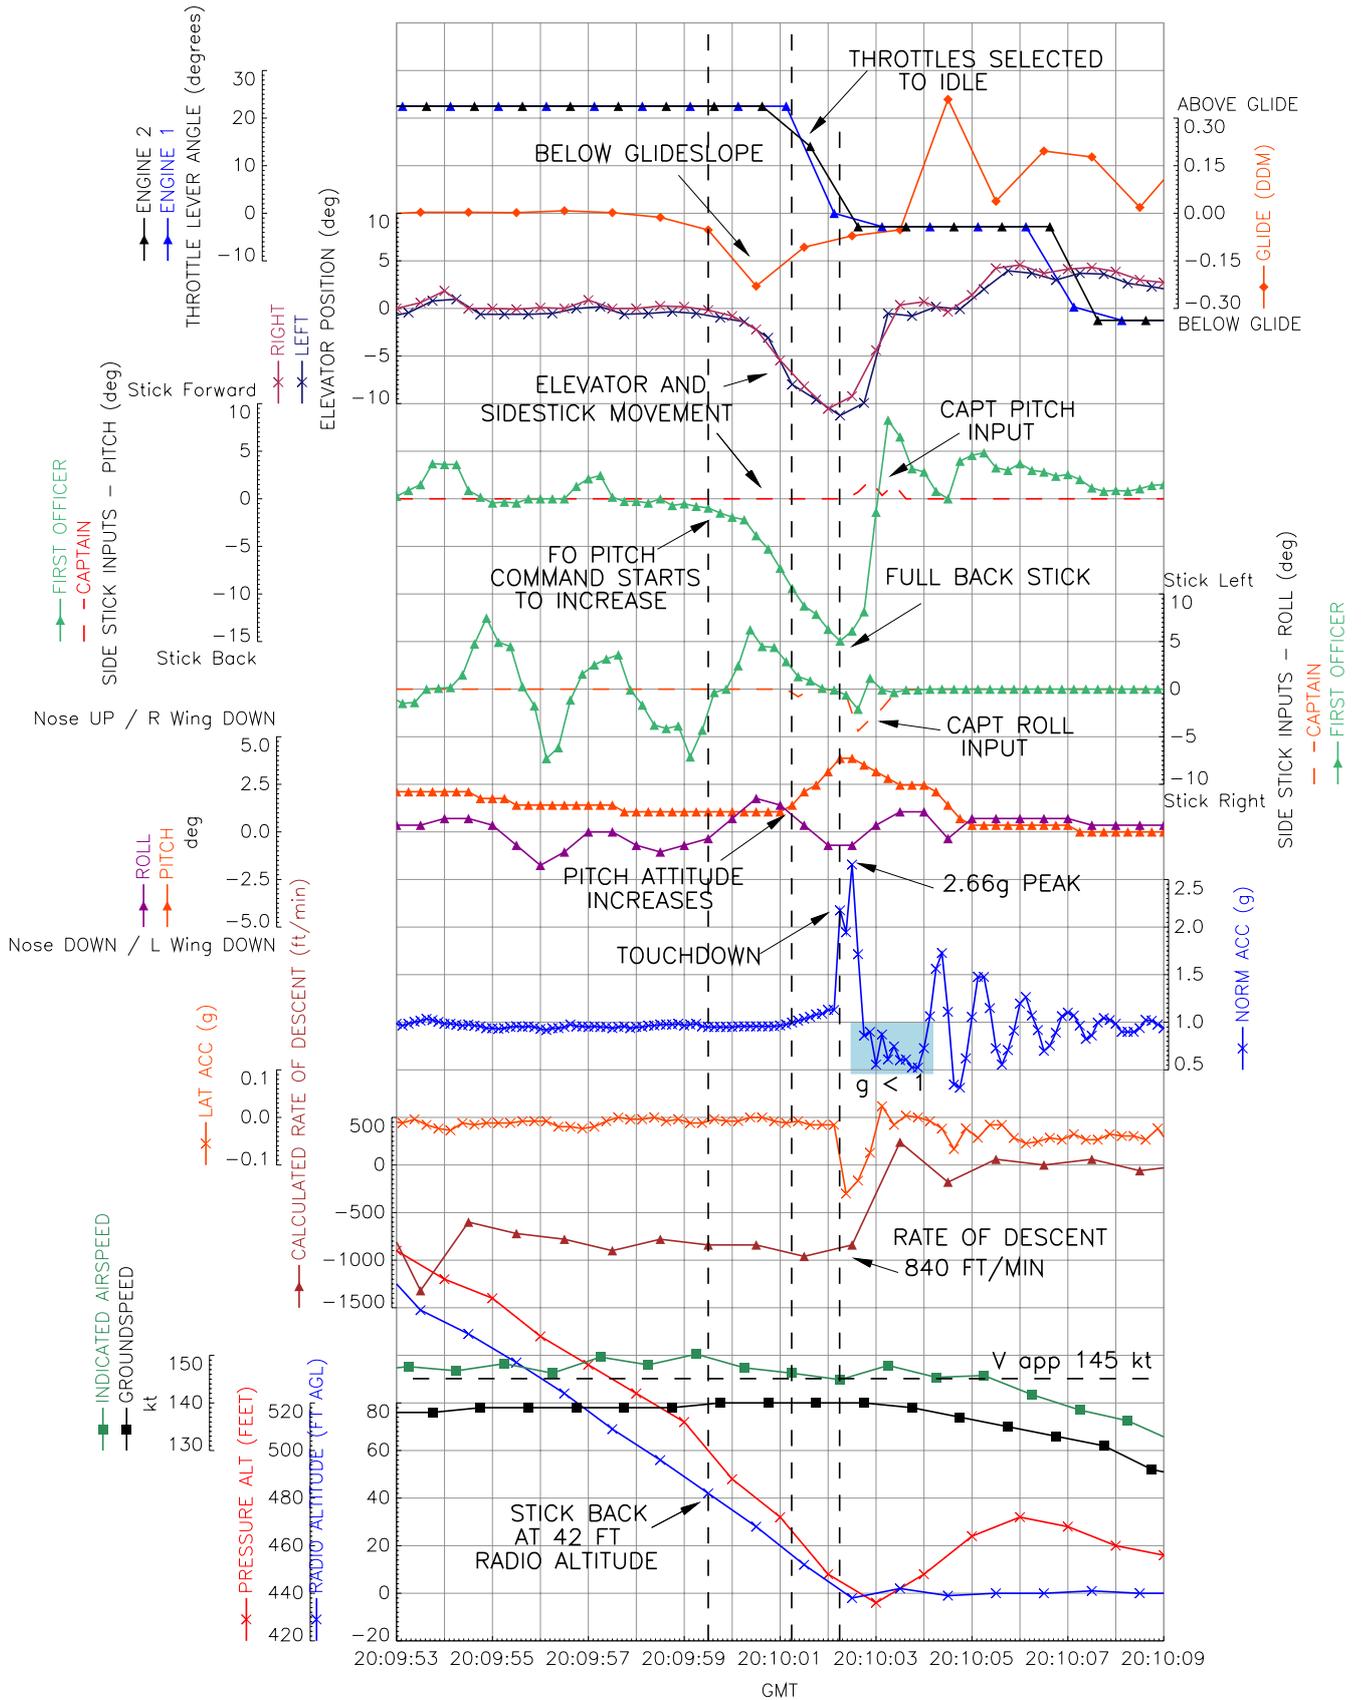
Figure 3

Relevant flight parameters during the final stages of the approach and landing at Manchester are shown in Figure 3. The data starts with G-DHJH approximately 2.2 nm from the Runway 23R threshold at a radio altitude of 584 ft, indicated airspeed of 147 kt and calculated rate of descent³ of approximately 750 feet per minute (ft/min). The airspeed, which had progressively decreased during the descent, was 2 kt above V_{APP} with a recorded wind speed of 218°/11 kt.

At a radio altitude of 42 ft, the co-pilot initiated a pitch-up demand on the sidestick. At the same time, the aircraft

Just less than one second later, the aircraft pitch began to increase from approximately 1° nose up, at a rate of approximately 2° per second. At the same time, the throttle levers were retarded to idle. One second from touchdown, the aircraft was at 15 ft radio altitude and a derived rate of descent of approximately 900 ft/min (15 ft per second (ft/s)).

The recorded position of the co-pilot's sidestick showed a continued stick-back command, to the maximum achievable position of 16°. This full back position was recorded at the same time as the initial spike in normal acceleration, signifying aircraft touchdown. Indicated airspeed was 145 kt, pitch attitude 3.9° and derived rate of descent was approximately 840 ft/min (14 ft/s). Rate of descent is approximate due to the one second sampling rate of the radio altitude.

After the initial spike in normal acceleration, the data shows a peak of 2.66g, a quarter of a second later. The initial spike prior to the maximum may have been due to one main landing gear touching down prior to the other (roll attitude was 0.7° left wing down). Both the left and right landing gear squat switches registered weight on wheels at the same time but these parameters are sampled every second so would not register a difference in touchdown time of the left and right gear of less than one second.

Just after touchdown, the commander applied 2° of forward and 4.3° of right sidestick. The normal acceleration then decreased to less than 1g which is indicative of a bounce but the MLG squat switches did not register weight off wheels. Pitch attitude reduced and three seconds after main gear the nose landing gear touched down.

G-DHJH landing in Manchester, 18 July 2008

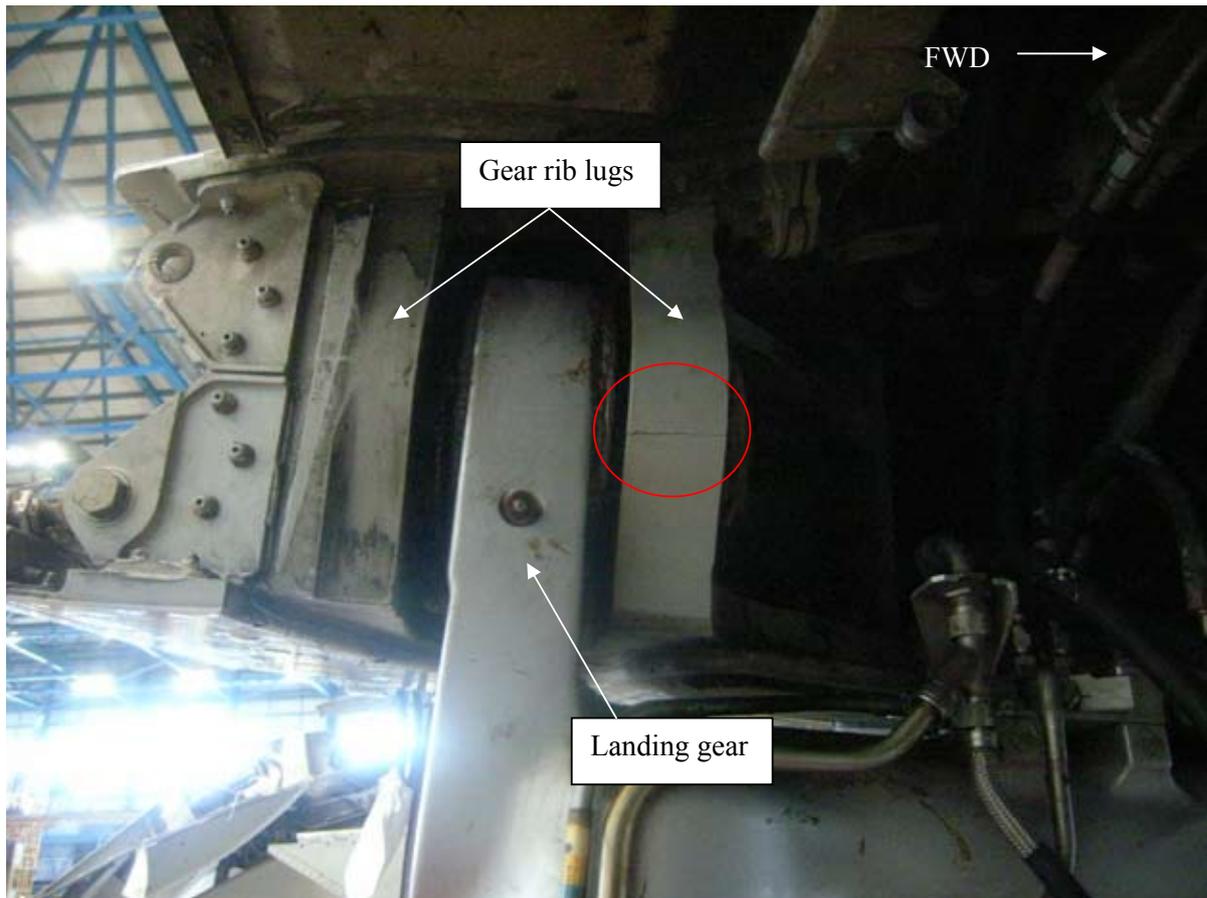
Figure 4

The mandatory inspection was a visual check for cracking on the main landing gear pintle support lugs which are part of wing rib 5. The inspection is mandated by EASA Airworthiness Directive (AD) 2007-0213 and is carried out in accordance with Airbus Service Bulletin A320-57-1138. When the inspection took place on 22 July 2008, it identified that the left pintle support rib had a crack extending through the entire section of the forward lug (Figure 4) and had to be replaced prior to further flight.

Landing gear support rib with cracked forward lug

The final overload phase of the lug failure in the gear support rib is likely to have been accelerated by the hard landing, though it was not possible to confirm this from the fracture surfaces. All other characteristics of the crack are consistent with the manufacturer's analysis of previous failures in this location. The mitigating actions already in place under EASA AD 2007-0213 are adequate to ensure the continued airworthiness of the aircraft. However, the effectiveness of the AD

Under the visual inspection regime, once a crack of any size has been identified, the rib must be replaced before further flight.

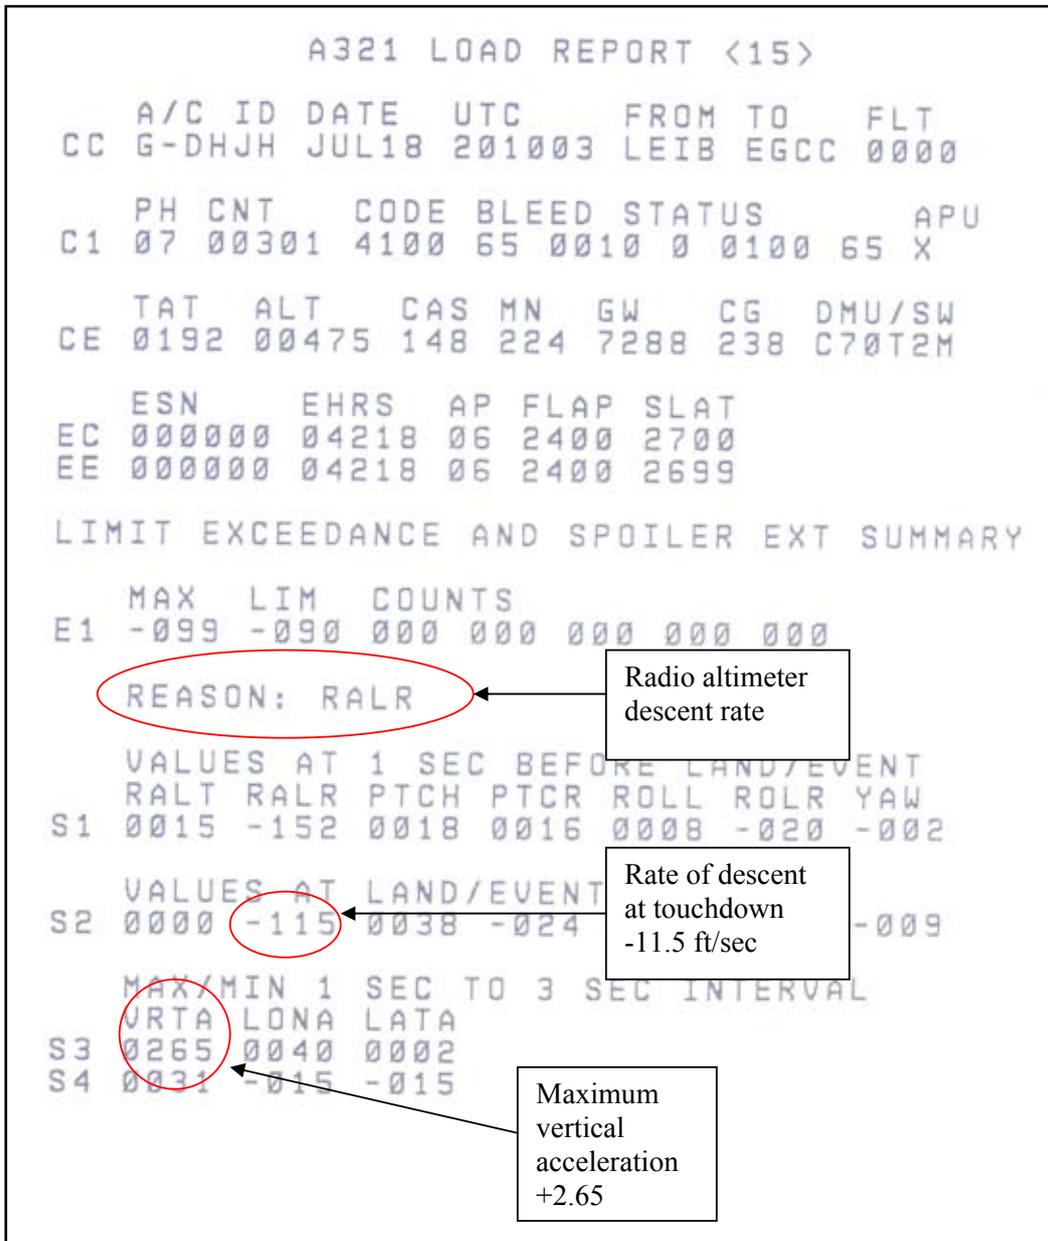
Figure 3
LOAD<15> Report

landing. Interrogation of the aircraft Data Management Unit (DMU) by engineers confirmed that a LOAD <15> report had been generated. This report recorded vertical acceleration and descent rate exceedences at touchdown during the landing at Manchester on 18 July 2008. The LOAD <15> report gave figures of 2.65g and -11.5 ft/s at touchdown which identified the landing as 'hard' based on maintenance manual limits. Analysis of flight data from that sector identified that the aircraft experienced a vertical acceleration of 2.66g and a rate of descent of 14 ft/s at touchdown. A rate of descent of 14 ft/s classified the landing as 'severe hard' and required the operator to carry out additional, more in-depth inspections of the aircraft. These should have been completed before further flight following the landing

as a LOAD <15> report (Figure 3) and is produced when any of the following landing conditions are met:

- 1) The radio altimeter descent rate (RALR) is less than (higher rate of descent) -9 ft/sec.
- 2) The vertical acceleration (VRTA) is more than +2.6G during +/- 0.5 seconds before and after landing.
- 3) The aircraft gross weight (GW) is more than the maximum landing gross weight (GWL) and the radio altimeter rate (RALR) is less than -6 ft/sec.
- 4) The aircraft gross weight (GW) is more than the maximum landing gross weight (GWL) and vertical acceleration is more than +1.7G.

- 5) For a bounced landing the vertical acceleration (VRTA) exceeds +2.6G for +/- 0.5 seconds of a detected bounced landing.

Since this event, the operator has configured all its Airbus aircraft to have the LOAD<15> auto-print facility enabled.

It is recommended that Airbus ensure that the generation of a LOAD<15> report by the DMU following a landing parameter exceedence, is indicated to the flight crew involved to enable them to record it in the aircraft's technical log.

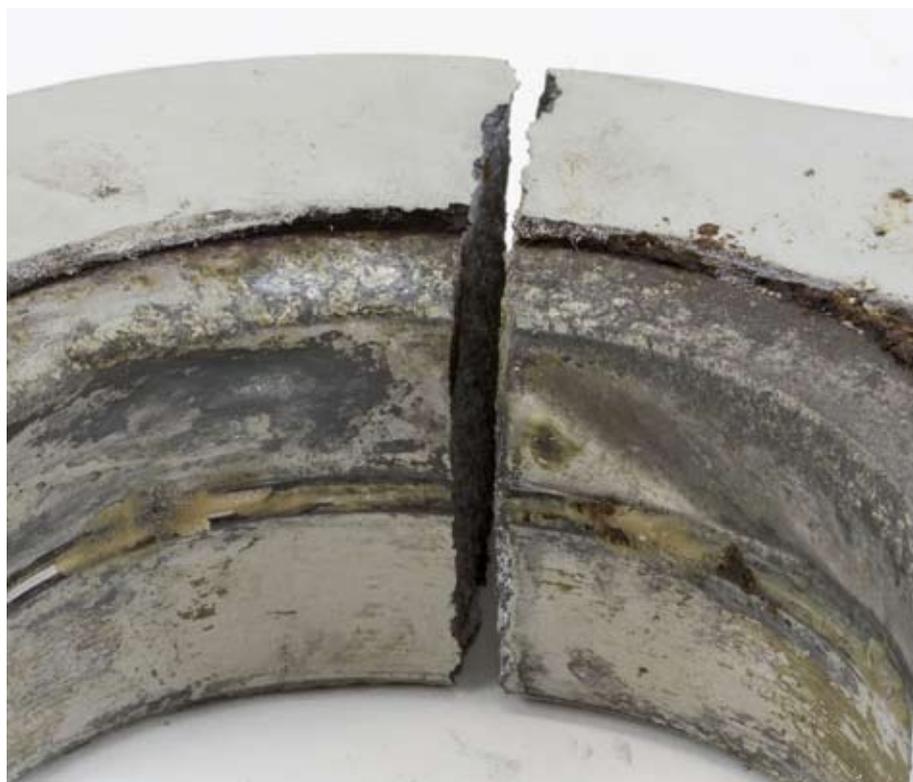
Figure 6

investigation and analysis. The cracked section of the lug was removed (Figure 6), the fracture faces cleaned and then inspected using a scanning electron microscope. This analysis determined that the crack was caused by fatigue growth initiating from surface corrosion pitting around the edge of the bore (Figure 7). From the staining on the surfaces and oxidation/corrosion damage on the fracture surface, it is likely that the fatigue growth had taken place over a considerable period of time before the final fracture occurred. It was not possible to find sufficient detail to determine exactly how long the fatigue crack had been present but the critical crack length was consistent with previous failures. There is no evidence to suggest that the material was in any way deficient as the microstructure, hardness and conductivity all appeared

to be as per specification. The crack was located in the one o'clock position of the lug looking forward. A crack in this location represents a failure of the primary load path for the lug. The secondary load path is via the opposite quadrant of the lug and no cracking was found in this location.

Cracked section of forward lug with the bush removed

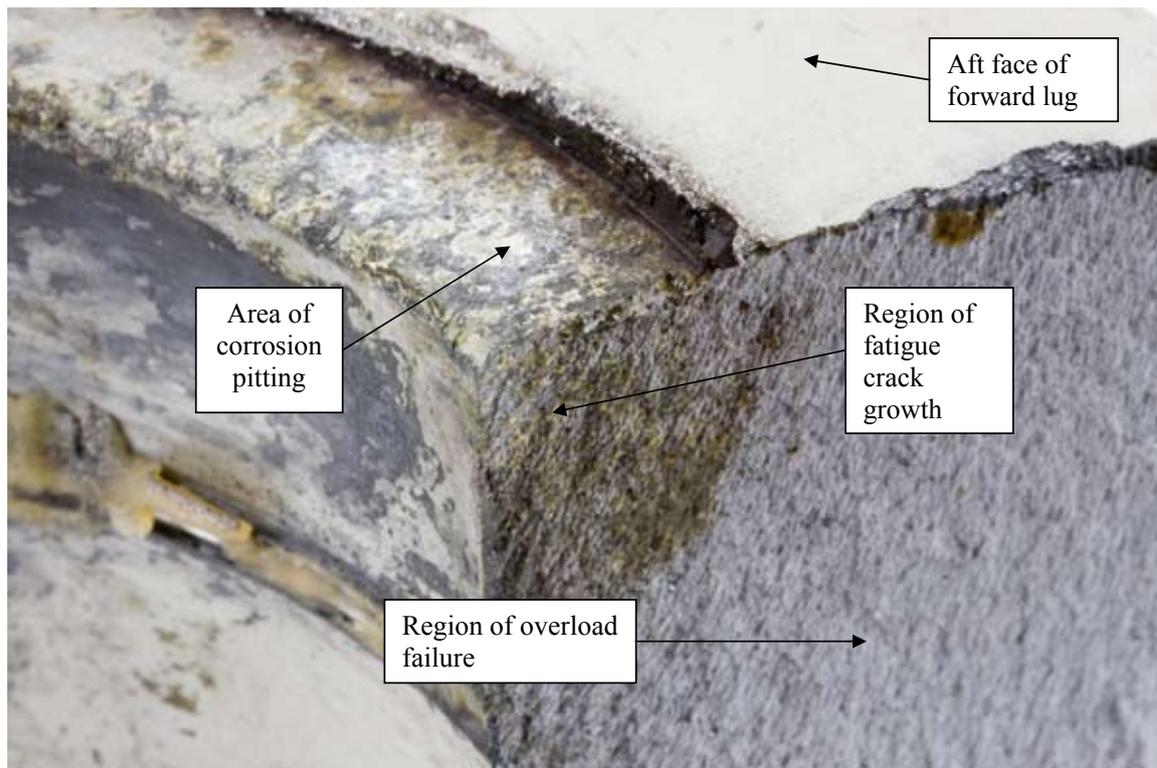
Figure 7

Detailed view of forward lug fracture surface
