DATA SUMMARY

Date and time	Monday, 11 February 2008; 18:29 local time¹
Site	Valencia Airport

Registration	PH-DMQ	EC-KLL
Type and model	De Havilland Canada DHC-8-315Q	Gulfstream G200
Operator	Air Nostrum	Executive Airlines

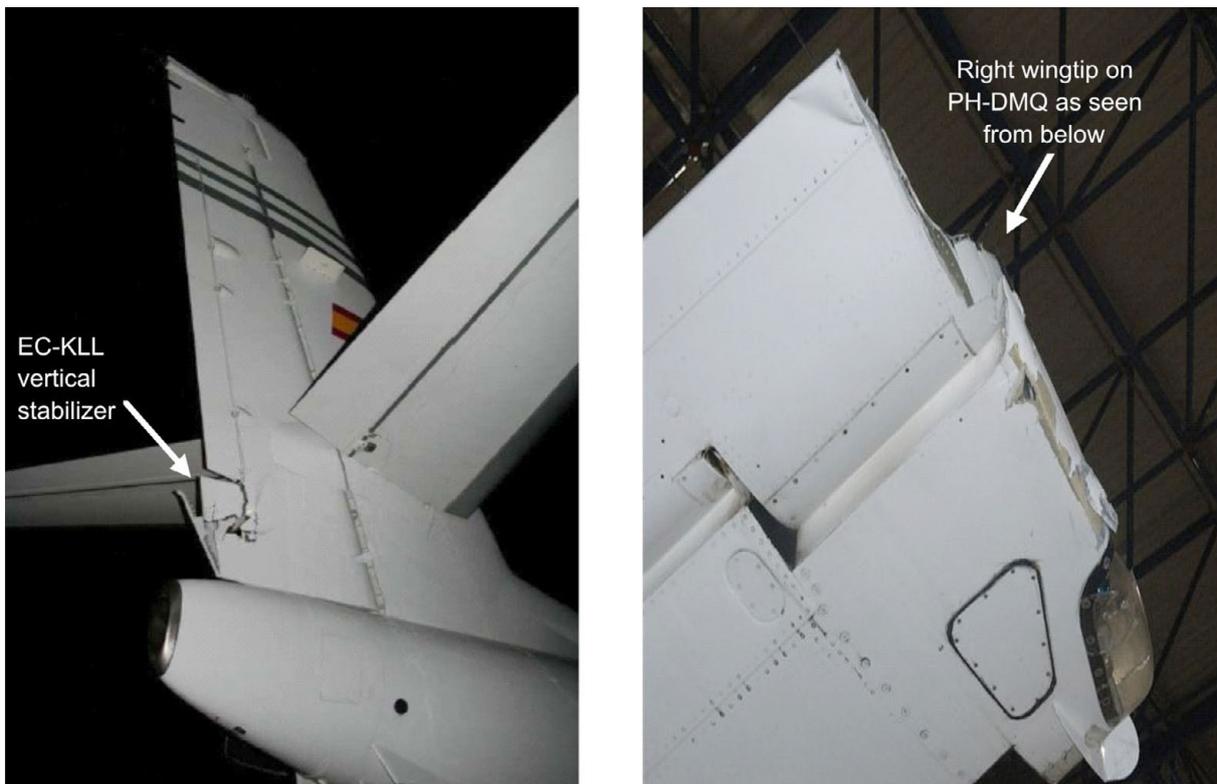
At 18:29, as aircraft PH-DMQ was transiting on taxiway N with aircraft EC-KLL stopped at H5, the right wingtip of the former struck the vertical stabilizer of the latter, resulting in minor damage to each (Figure 1). Aircraft PH-DMQ continued taxiing until it reached the signalman's car, which guided it to its parking stand on the north apron. Aircraft

Figure 1. Damage to aircraft EC-KLL and PH-DMQ

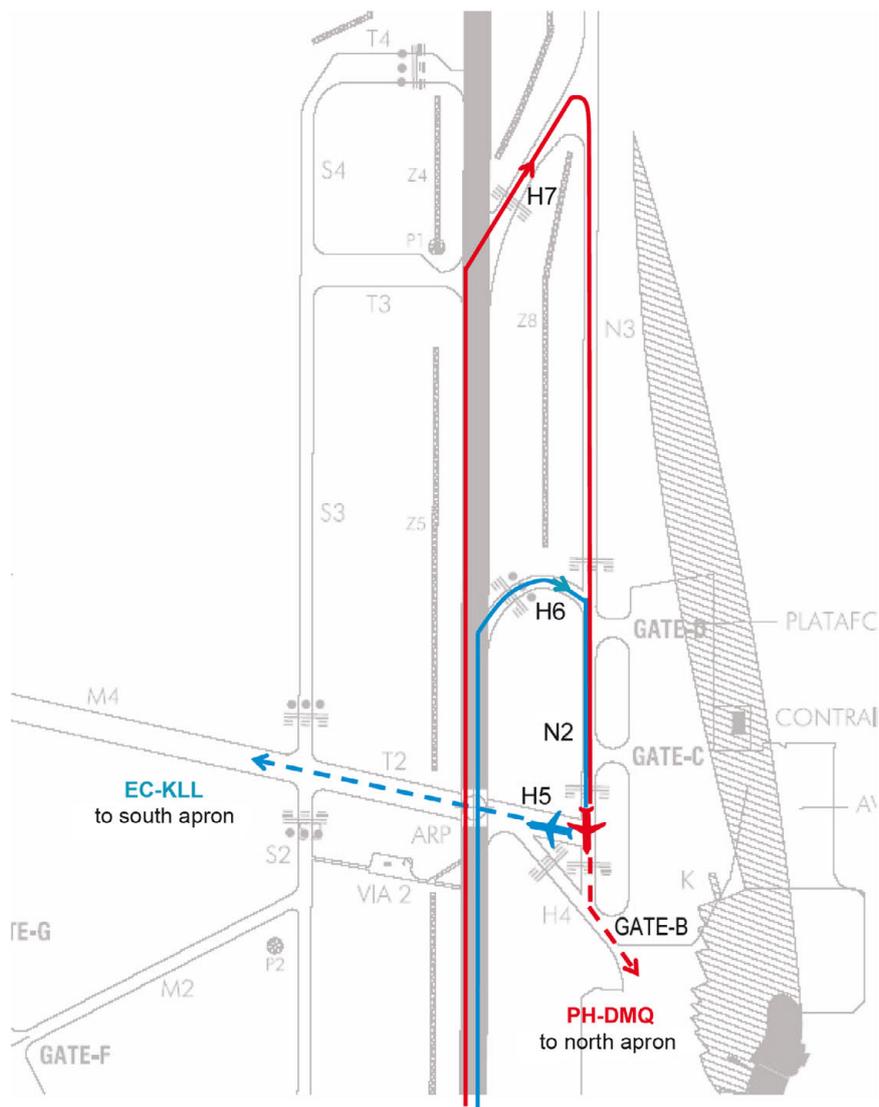
On Monday, 11 February 2008, aircraft EC-KLL, inbound from Torrejón airport, landed on runway 30 of Valencia airport at 18:24² with 6 persons onboard. It left the runway via taxiway H6 and was cleared to taxi to the H5 runway holding point, where it had to stop. A signalman was waiting for it there to guide it across the runway and on to the south apron (Figure 2).

Three minutes after aircraft EC-KLL landed, aircraft PH-DMQ, inbound from Seville airport, landed with a total of 32 people onboard. It left the runway via taxiway H7 and was cleared to taxi on taxiway N, perpendicular to H5, to gate B, where a signalman was waiting for it (Figure 2).

Figure 2. Taxi paths by aircraft EC-KLL and PH-DMQ

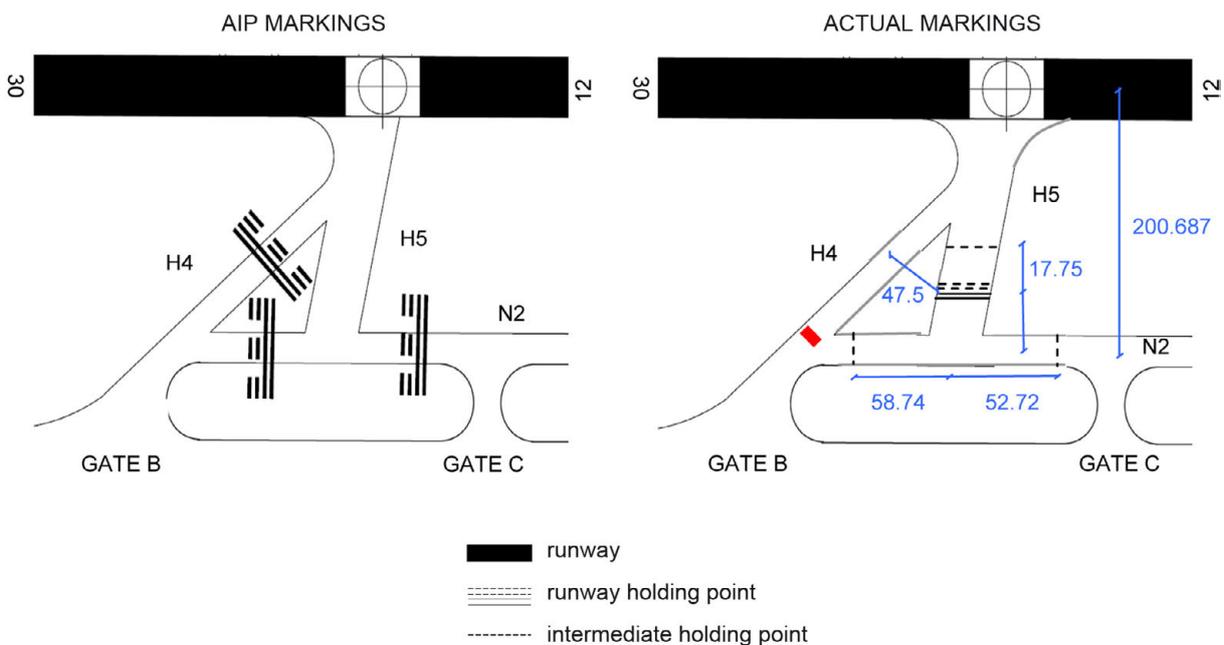
The published aerodrome map for ground movements in effect at the time of the incident showed the following configuration for the area where the impact occurred: two runway holding points on taxiway N2, one on taxiway H4 and none on H5 (Figure 3).

The actual airport configuration for the same area featured (Figure 3):

- A mandatory NO ENTRY marking at H4.
- A runway holding point and intermediate holding point at H5. The H5 runway holding point was equipped with stop bar lights and an inscription on the pavement with the characters H5 in yellow letters on a black background situated behind the dashed lines. There were no signs. The intermediate holding point had no lights.
- Two intermediate holding points at N2 (Figure 3), neither of which had lights.
- At the intersection of H5 with runway 12/30, a curved transition area had been built for the purpose of converting H4 into a rapid exit taxiway for runway 12.

Figure 3. Markings in the impact area (distances in meters)

Although it is irrelevant to the incident, some discrepancies were noted between the actual configuration in the area of the incident and that published in the AIP (aerodrome map for ground movements), with differences both in the location and type of holding points at N2 and H5 as well as in the direction of traffic on H4.

The H5 and N2 intermediate holding points did not have lights even though both taxiways are used in low-visibility conditions. In these cases, Annex 14 requires that the intermediate holding points be equipped with stop bars or intermediate holding point lights. This requirement is particularly important given that under low-visibility conditions, the markings are not visible from the cockpit and only the presence of lights can indicate the stopping point. Failing to stop at these points could allow aircraft to continue moving toward the intersection of taxiways H5 and N2, where there could be other taxiing aircraft.

Lastly, the H5 runway holding point did not have associated with it any runway designator marking as specified in Annex 14. These markings are usually accompanied by an information sign that, in the case of Valencia airport, had been replaced by a pavement marking.

- Adapt the contents of the aerodrome map for ground movements to reflect reality at the airport.
- Review the markings, signs and lights associated with the intermediate and runway holding points on H5 and N2.
- Analyze other possible solutions to the traffic direction and hold point problems present on H5 in relation with N2, or remind all affected parties of the traffic directions and requirements in said area.

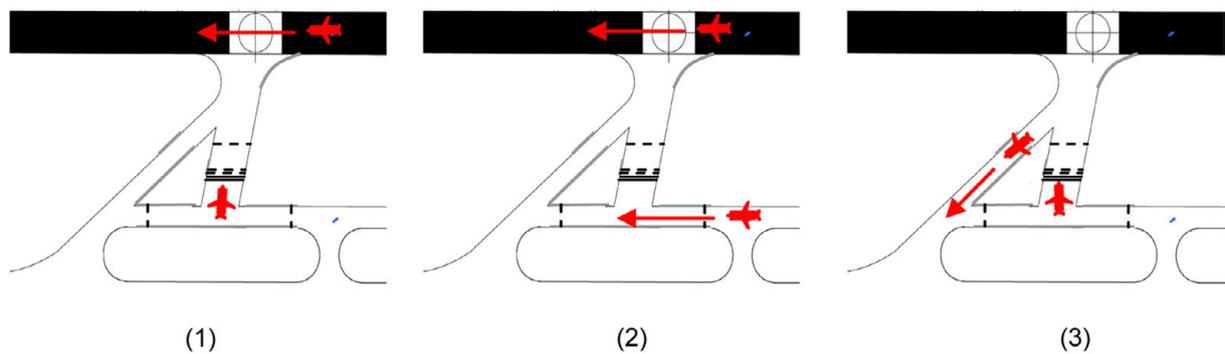
- (Figure 4A-1) To protect aircraft on the runway from any obstacle, an aircraft stopped at runway holding point H5 being such an obstacle. To achieve this, the separation between the two exceeds the 90 m specified in Annex 14.
- (Figure 4A-2) To protect aircraft taxiing on N2 from runway traffic with a separation of 200.6 m, in excess of the 182.5 m specified in Annex 14.
- (Figure 4A-3) To stop an aircraft at the H5 runway holding point so as to allow an aircraft to leave the runway via H4. To achieve this, the separation distance between H4 and an obstacle, in this case an aircraft stopped at runway holding point H5, complies with the 47.5 m specified in Annex 14.

Figure 4A. Traffic flow in area N2-H5

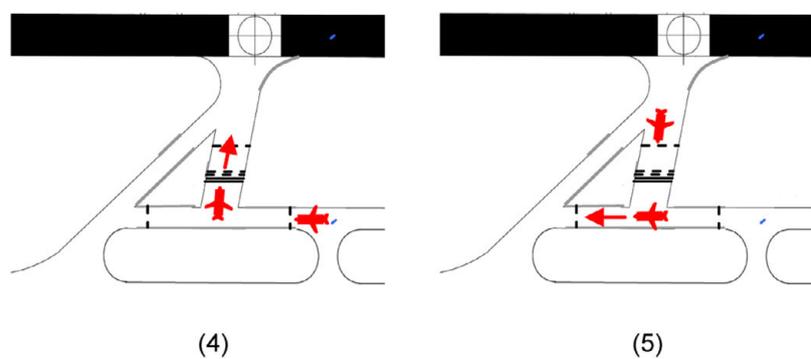
- (Figure 4B-4) To protect aircraft taxiing on H5 by having aircraft stop at the N2 intermediate holding points, maintaining a distance in excess of 47.5 m between the centerline of H5 taxiway and the nose of any airplane (considered an obstacle). This is essentially the situation that arose in the incident described in this report, in which aircraft EC-KLL should have been considered as taxiing on H5.
- (Figure 4B-5) To protect aircraft taxiing on N2 by stopping aircraft at the H5 intermediate holding point, maintaining a distance in excess of 47.5 m. The H5 holding point stops those aircraft proceeding from N2 from crossing the runway. This point does not impose any obligations on aircraft proceeding from the runway to N2, however, hence the location of the intermediate holding point on H5.

Figure 4B. Traffic flow in area N2-H5

As this last configuration explains, the H5 holding point closest to the runway is not marked as a runway holding point, but rather as an intermediate holding point whose sole purpose is to protect the intersection of H5 and N2 for traffic moving toward N2. This configuration requires a stoppage of operations on the runway since a critical aircraft (of maximum dimensions) stopped at intermediate holding point H5 would violate the 90-m clearance for category I, II and III operations. The existence of an intermediate holding point closer to the runway than the runway holding point could create confusion, since it is not typical for the second to be closer to the runway than the first. This scenario is the object of a safety recommendation aimed at studying other possible solutions for taxiing on H5 and N2, or to issue an explanatory note on the traffic flows in this area.
