Lauda Air B767 Accident Report

AIRCRAFT ACCIDENT INVESTIGATION COMMITTEE MINISTRY OF TRANSPORT AND COMMUNICATIONS THAILAND

**LAUDA AIR LUFTFAHRT AKTIENGESELLSCHAFT
BOEING 767-300ER
REGISTRATION OE-LAV
DAN CHANG DISTRICT
SUPHAN BURI PROVINCE
THAILAND
26 MAY B.E. 2534 (A.D. 1991)**

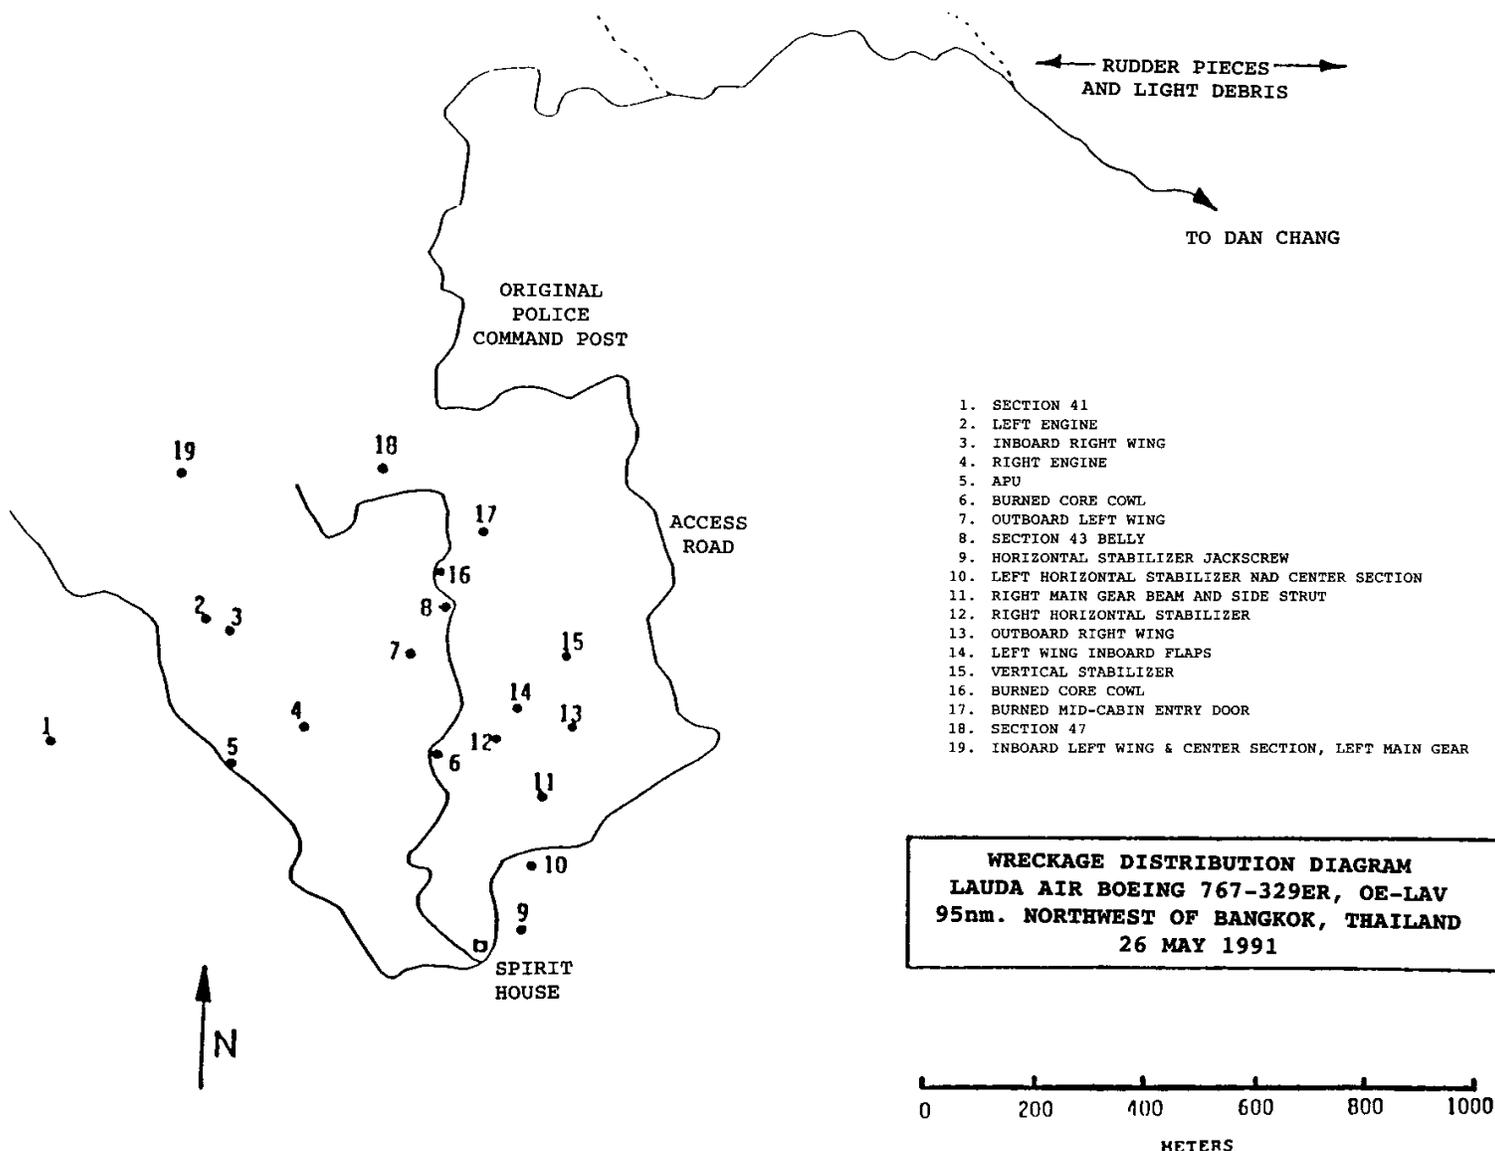
FIGURE 1

Most of the wreckage was found in a one square kilometer area, but some lighter weight components were found up to 2,000 metres from the initial impact point. The horizontal stabilizer was the first major component found in the debris pattern, which was along a generally northwest/southeast track. Thrust reverser actuators from the left engine (both sleeves) were found in the fully deployed position. A diagram
