## **AVIATION INVESTIGATION REPORT**

**A00Q0094**

### **RUNWAY EXCURSION**

**BOEING 747-200 CN-RME**

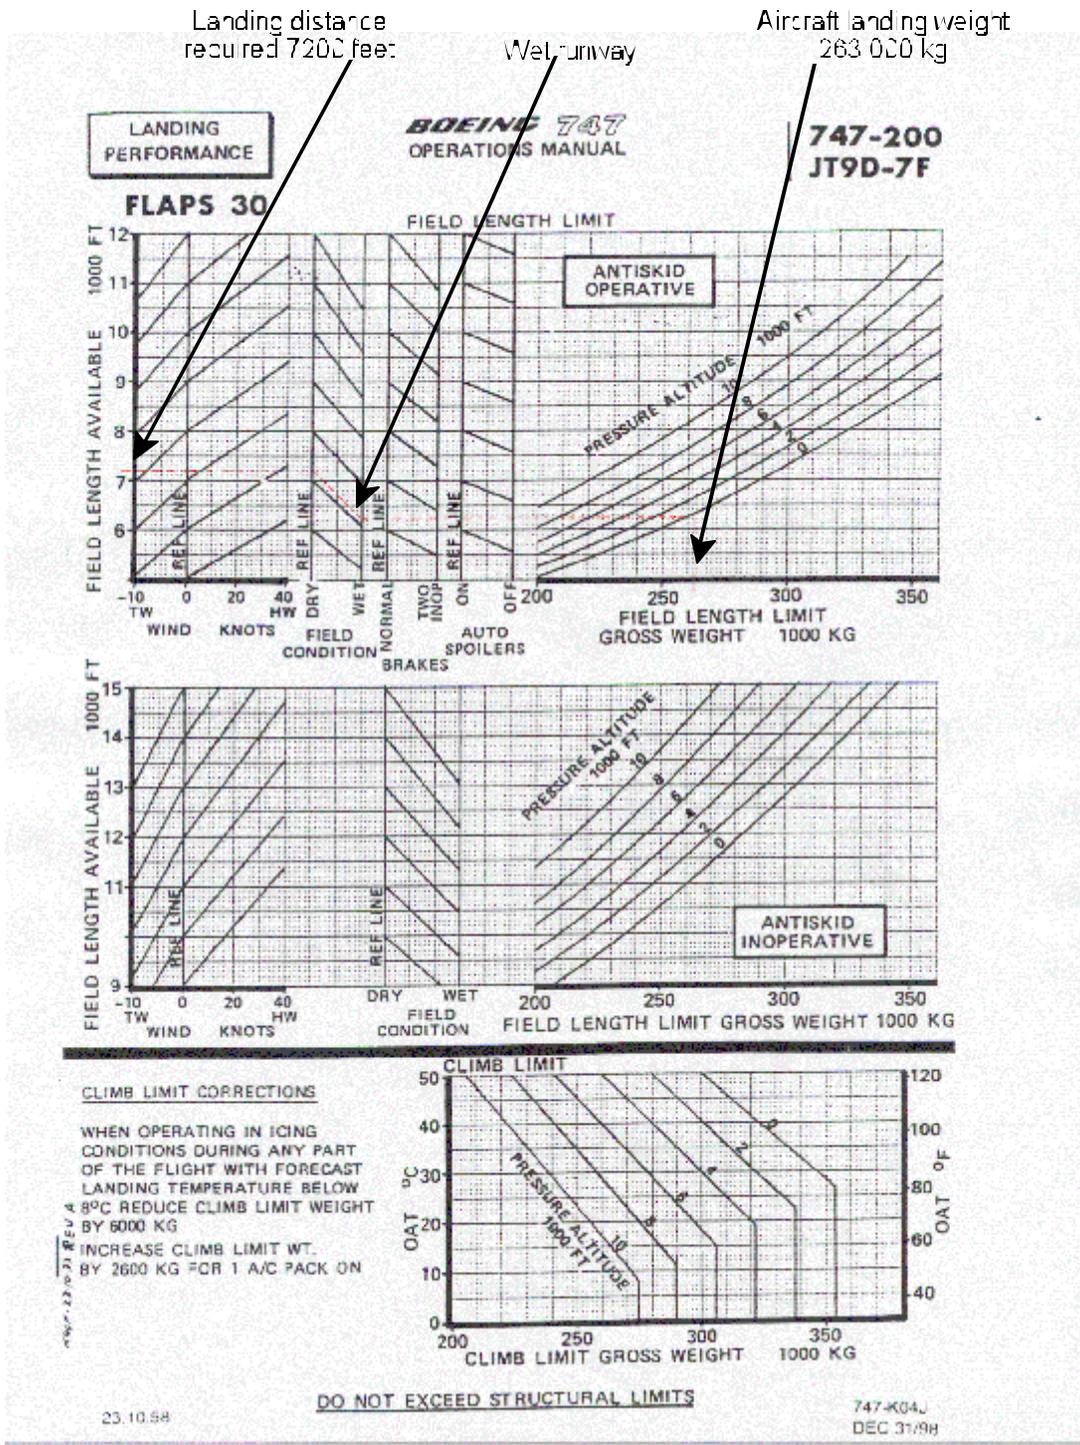
# Appendix A—Landing Performance Diagram

The landing performance diagrams in the Boeing 747 operations manual can be used to determine the runway length required based on various factors that can affect landing roll distance, such as aircraft weight, flap setting, airport altitude above sea level, and surface wind. The diagrams can also be used to make corrections to the runway length required, in the event of a wet runway, defective automatic ground spoilers, two disabled brakes, or all three factors combined. The diagrams include the 40 per cent safety margin required under the certification standards for this aircraft type. There was no indication that the flight crew referred to these diagrams before the landing. Instead, the crew relied on their experience and their knowledge of the aircraft performance to determine whether or not the runway length was sufficient. The aircraft landing weight was calculated to be 263 000 kilograms. According to the landing performance diagram, with calm wind, the aircraft could land on a wet runway 7200 feet long without contravening the certification rules.

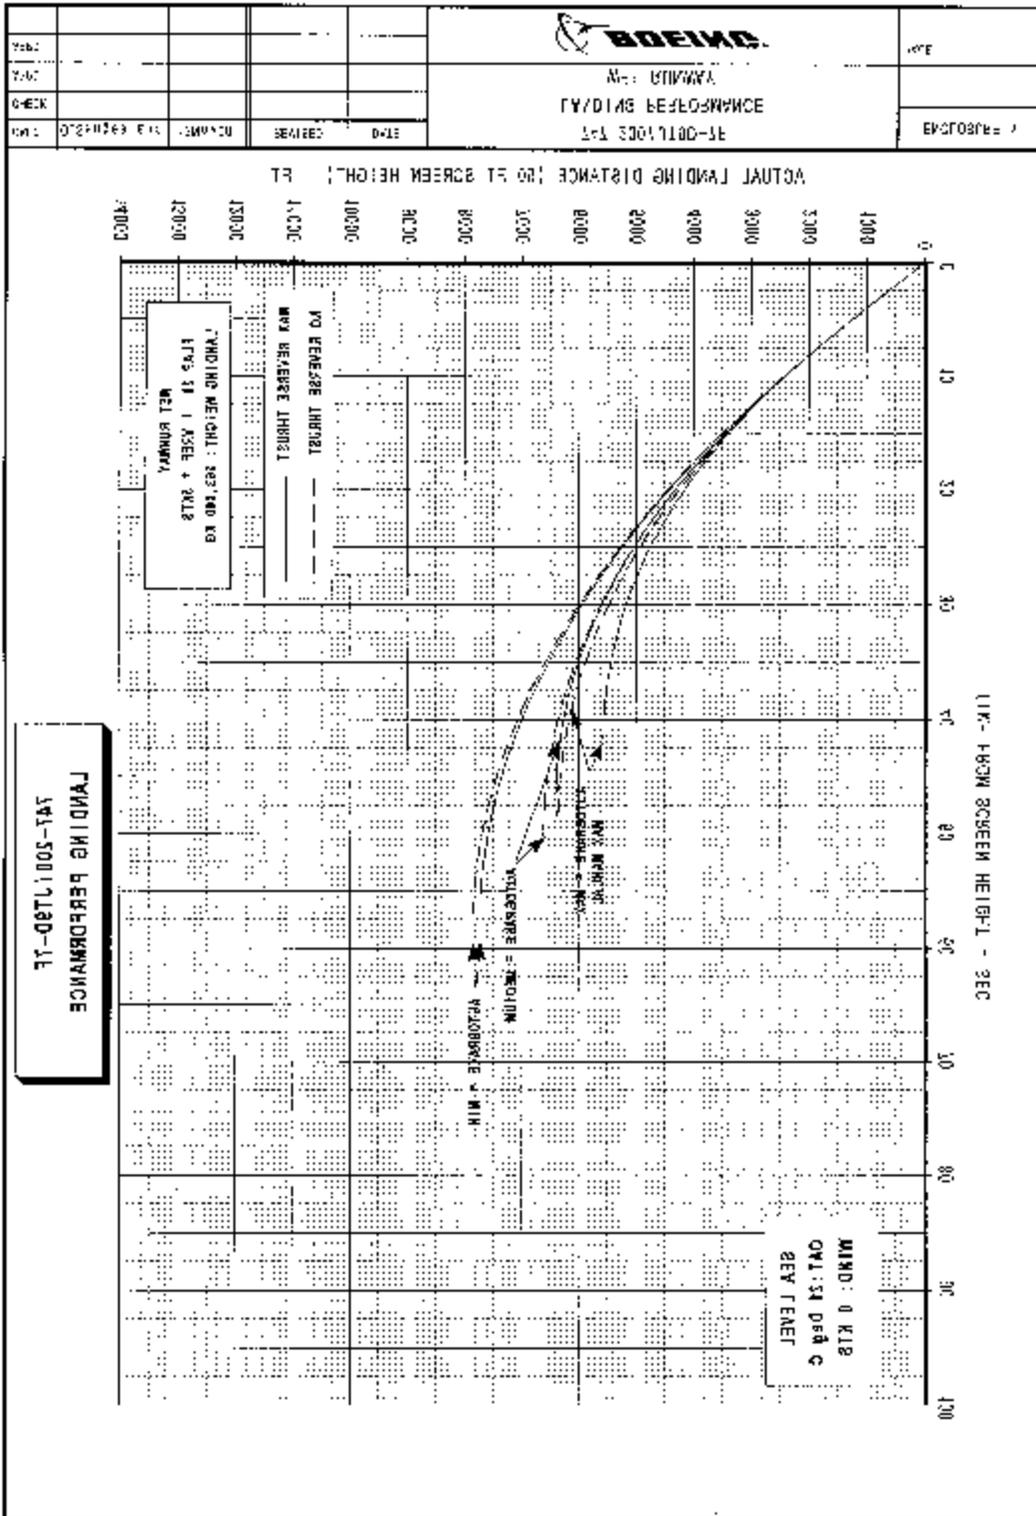
# Appendix B—Landing Distances on Wet Runway: Calm Wind

During the approach, the PNF occasionally glances at the data from the inertial navigation system (INS), such as wind direction and speed. This allows the PNF to recognize the possibility of wind shear and take corrective action as required. It was reported that no signs of wind shear were observed from the INS data during the approach. However, the surface wind changed just before touchdown, causing a variable tailwind component of about 15 knots on landing. A 15-knot tailwind component when the runway is wet increases the landing roll distance by 1000 to 1400 feet, depending on the braking method used. (See Appendices B and C.)
