**Report C 1998:03e**  
**Accident involving aircraft SE-DMX,**  
**9 March 1997,**  
**Kiruna airport, BD county, Sweden**

**L-16/97**

**Report C 1998:03E**

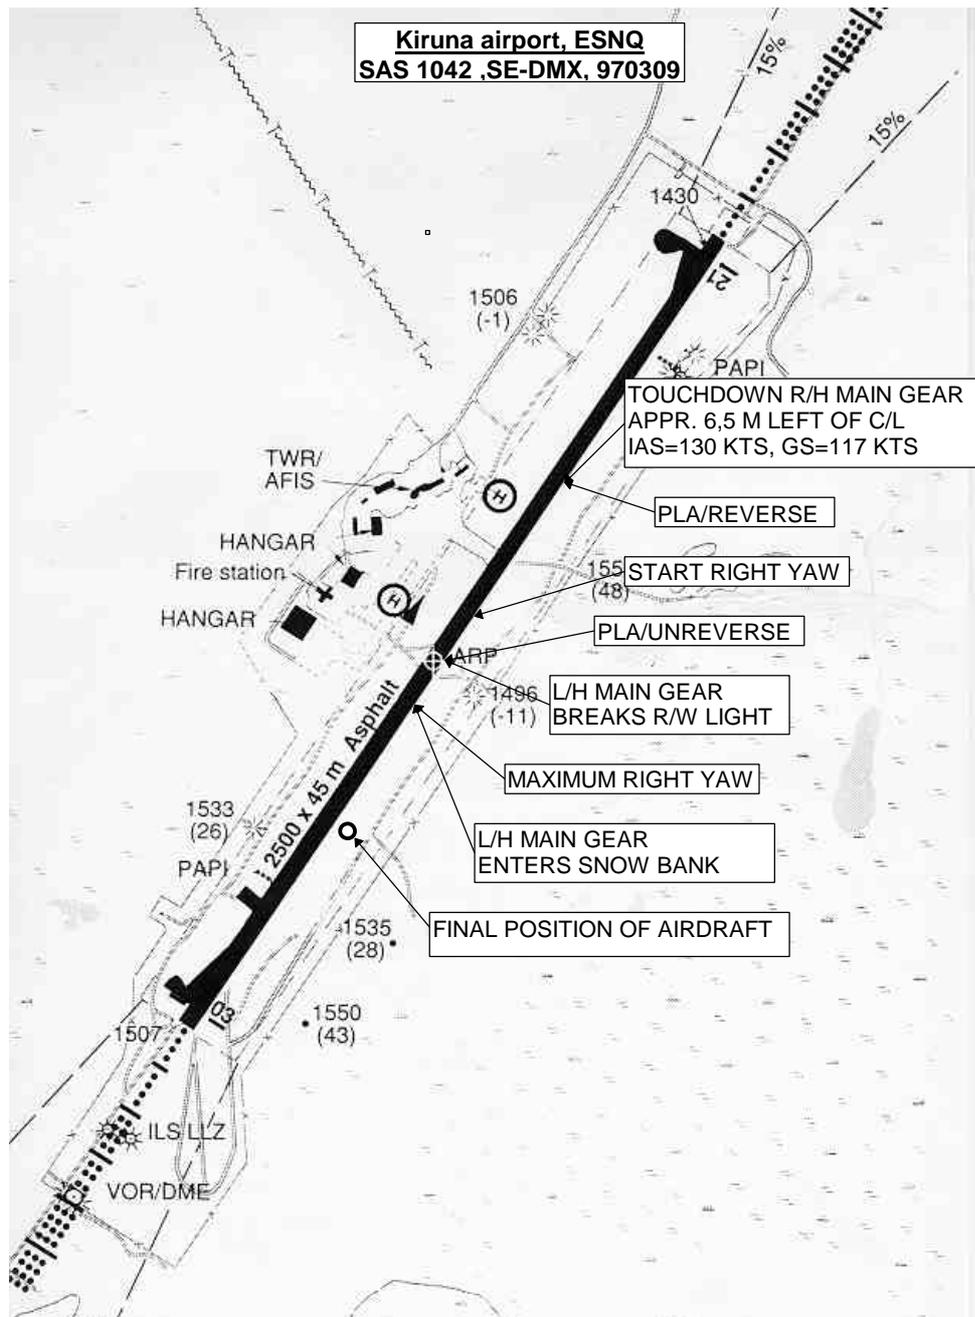
The lateral excursion (the aircraft's position with respect to the centerline) and the heading along the runway is graphically presented in appendix 4.

The measurements of the runway and the essential positions and occurrences along it are depicted on the airport map below.

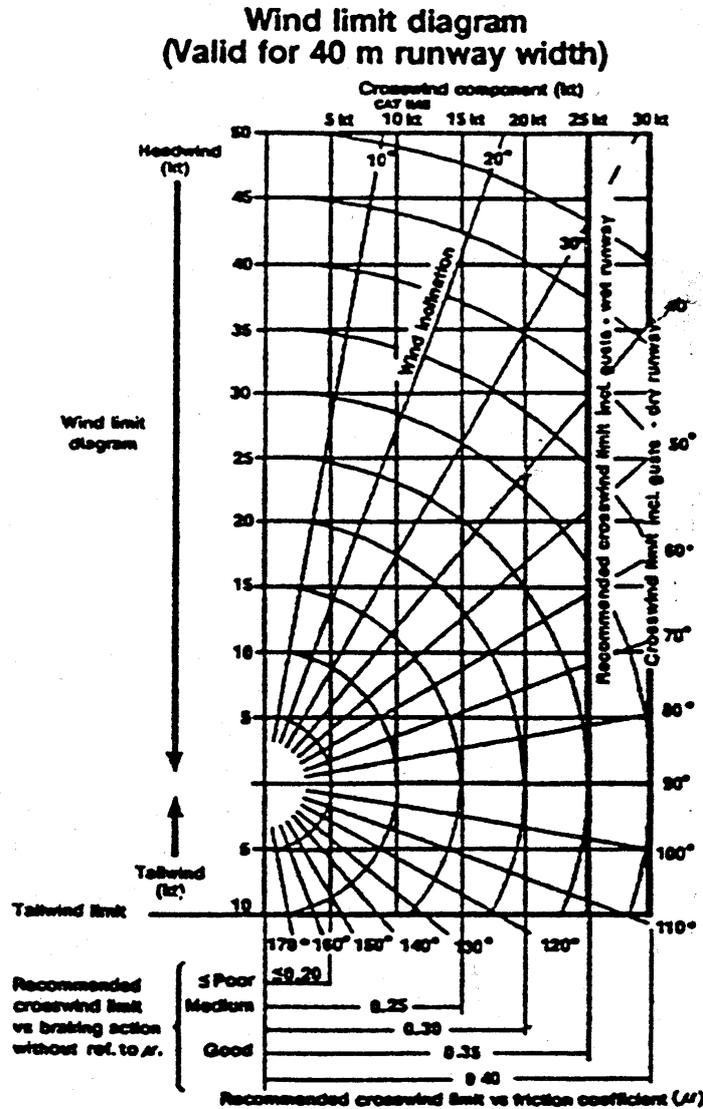
Wind limit diagram (actual size 33 x 66 mm)

From the diagram, the maximum allowed crosswind component<sup>10</sup> can be found for landing on a runway with a reported friction coefficient of 0.32. It is 22 knots, which on runway 21 at Kiruna corresponds to an actual wind of 250°/42 knots or 270°/25 knots.

If the pilots had understood the change in the wind direction and had had the possibility of checking the new direction on the wind limit diagram, they would have found that the crosswind component now exceeded the recommended value for landing with the prevailing runway braking coefficient. But even if the pilots had perceived the message, it would hardly have been possible for them to accomplish that check at this late phase of the landing. With the thought in mind that the pilots were aware that the landing conditions were difficult, they should have requested
