## **AVIATION INVESTIGATION REPORT**

**A0000199**

### **FAN COWL SEPARATION**

**AIRBUS A320-232 C-GTDC**

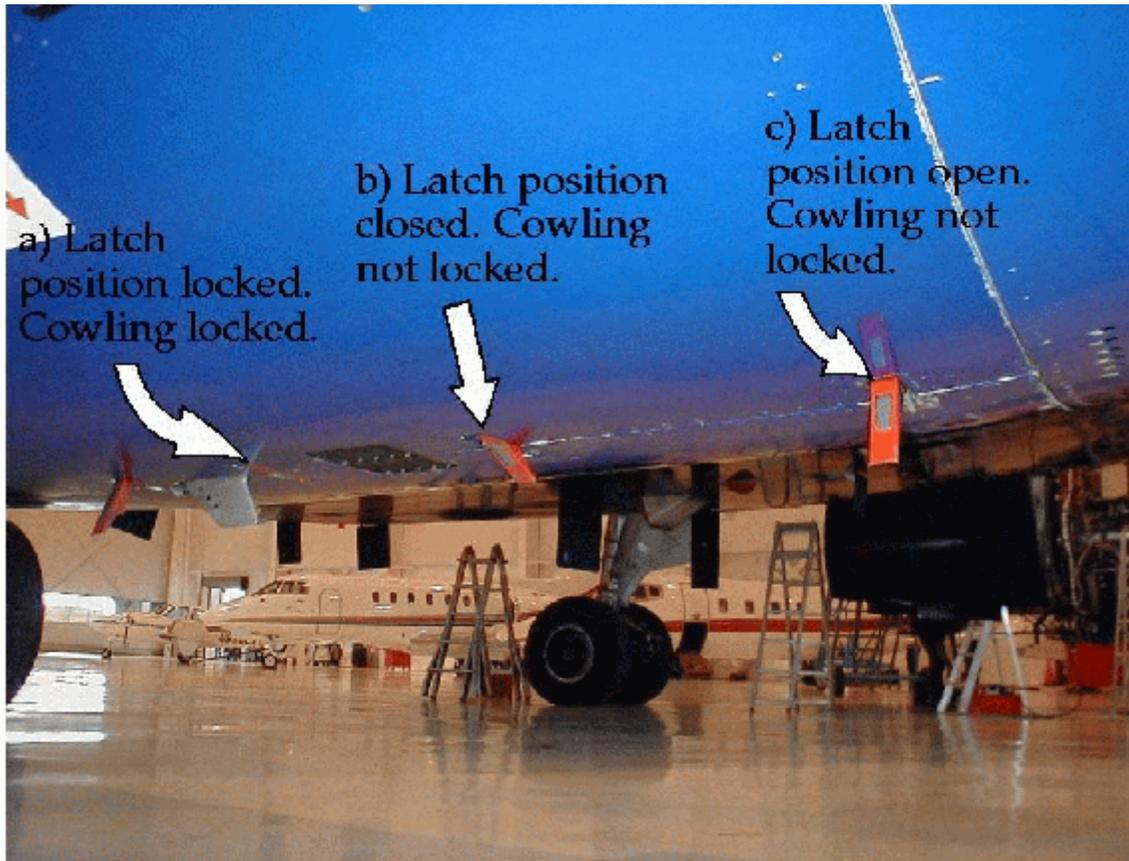
## Appendix A - Latch Position

The fan cowling has four latches that connect at the bottom of the engine. The fan cowling doors are heavy and designed such that, when hanging unsupported, they fair flush, giving the appearance of being locked, even if they are not latched. Normally, the latches can be in three possible conditions (see Appendix A):

- a) latches fully locked and will appear flush with the cowling;
- b) latches closed, but cowling not locked. In this condition, they will protrude about one inch underneath the cowling. This is the normal condition of the latches after maintenance opens the cowling, until the latches are re-locked; and
- c) latches fully open and cowling unlocked. This is considered a temporary condition after unlocking the cowls. According to industry standard, the latches are immediately closed because the fully unlocked latch presents a personal injury risk to maintenance engineers. Fully unlocked latches protrude down about four inches from the bottom of the cowling.

Because of the circumference of the engines and their proximity to the ground, a proper visual inspection of the latches requires an individual to get on hands and knees, go underneath the nacelle, and look up at the latches. The latches are out of view to a person standing within about 10 feet of the engine, and difficult to see from a greater distance because they are relatively small and inconspicuous.

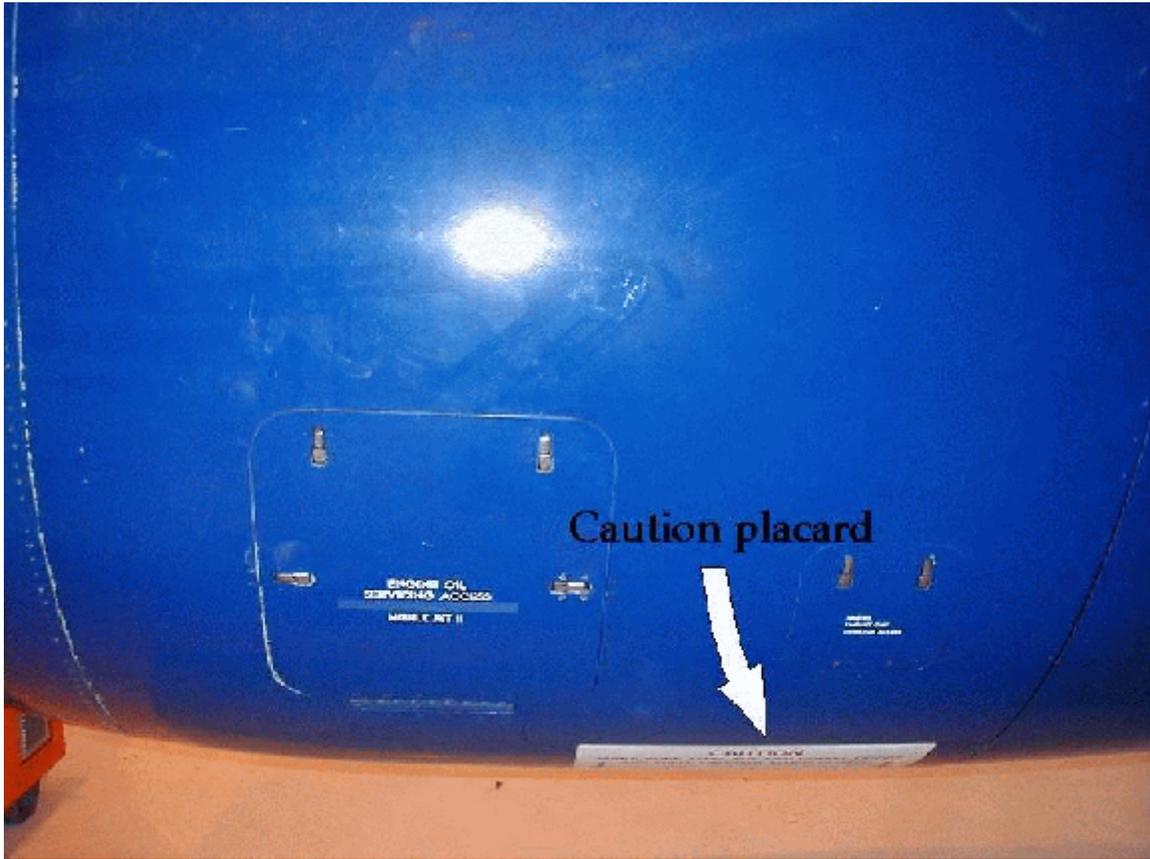
*Appendix B - Caution Placard*

The aircraft modification issued by the engine manufacturer to apply instructions to the fan cowl doors: "Caution Make Sure That The Fan Cowl Doors Are Fully Latched When Closed," was ineffective. The service bulletin requires the placard to be placed low, on both sides of the fan cowling. This increases the visibility of the placard when the fan cowlings are open and supported. However, when the fan cowlings are closed, the low placement of the instructions and the wide circumference of the fan cowlings decrease the visibility of the instructions, reducing the likelihood of drawing attention to the latches (see Appendix B). Additionally, none of the personnel associated with the aircraft before departure could identify either the number or locations of these placards.
