**SOUTH AFRICAN CIVIL AVIATION AUTHORITY
(SACAA)**

SERIOUS INCIDENT INVESTIGATION REPORT

FINAL REPORT

**Boeing B747-400
G-BYGA
Group 'A' L/E Flaps retracted on Takeoff
from O.R. Tambo Airport,
SOUTH AFRICA.
11 May 2009**

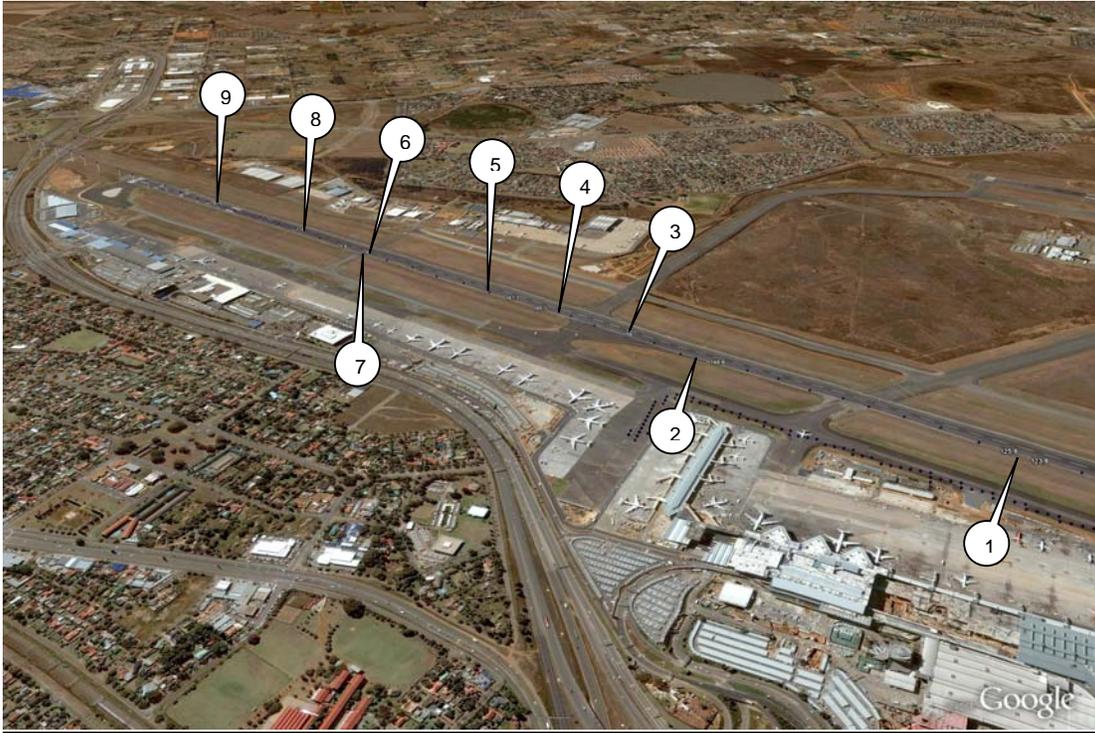
- 1.1.3 The aircraft rotated at approximately 173kt with 20 units of flaps selected and became airborne at approximately 176kt. See Photo 1 for the take-off path of the aircraft. The stick shaker subsequently activated at 176kt intermittently for 8 seconds within a period of 15 seconds and significant aircraft buffeting was experienced. In order to counteract the stall warning and buffeting, the PF (who also had aerobatic flying experience and being familiar with aircraft buffeting) continued to fly the aircraft with the PIC calling out the aircraft heights AGL. The undercarriage was selected up at a CAS of 177kt and the Group 'A' LE flaps immediately extended automatically. The stick shaker stopped at a CAS of approximately 186kt. The Group 'A' LE flaps had been in the retracted position for approximately 23 seconds during the occurrence. After the auto re-extension of the Group 'A' leading edge flaps the aircraft's performance returned to normal.

PHOTO 1: GOOGLE EARTH VIEW OF THE TAKE-OFF PATH FROM RUNWAY 03L AT FAJS

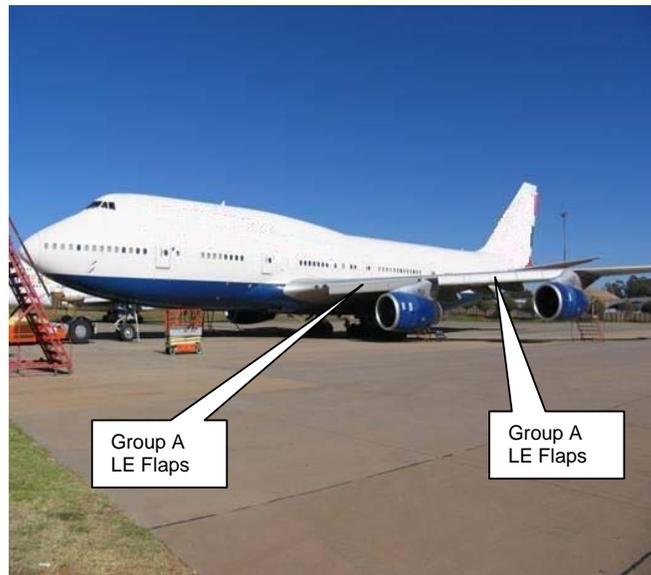
Photo 2: VIEW OF THE B747-400 G-BYGA WITH GROUP 'A' LEADING EDGE FLAPS EXTENDED ON THE LEFT HAND WING (RIGHT HAND WING LE FLAP CONFIGURATION IS SIMILAR).

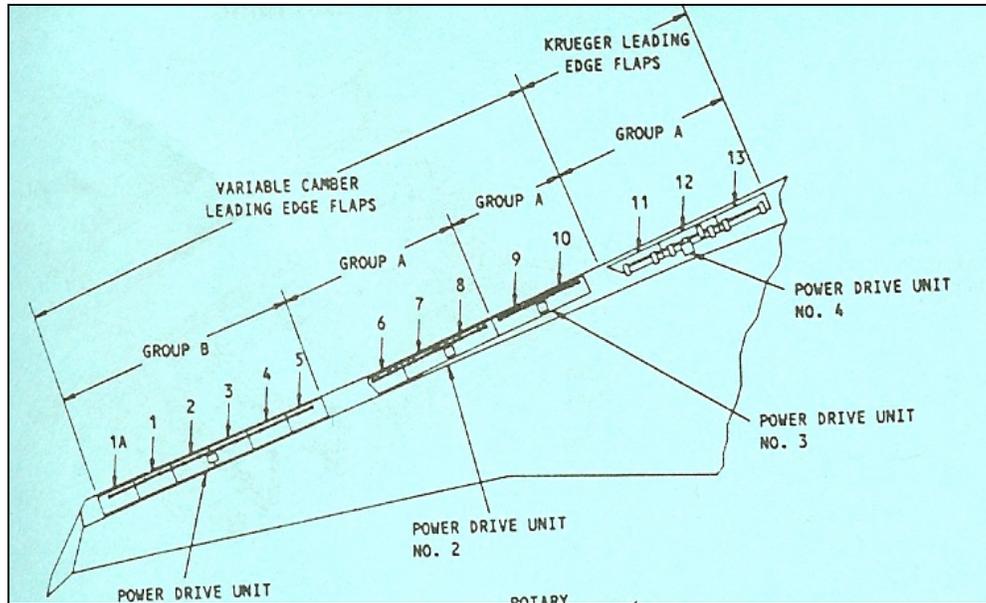
Group A: Variable Camber LE Flaps – 6 to 10 (Inboard of No. 1 Engine) and Krueger LE Flaps 11 to 13 (Inboard of No. 2 Engine)

Group B: Variable Camber LE Flaps – 1A to 5 (Outboard of No. 1 Engine)

FIGURE 2: THE LE FLAPS ON THE LEFT-HAND WING

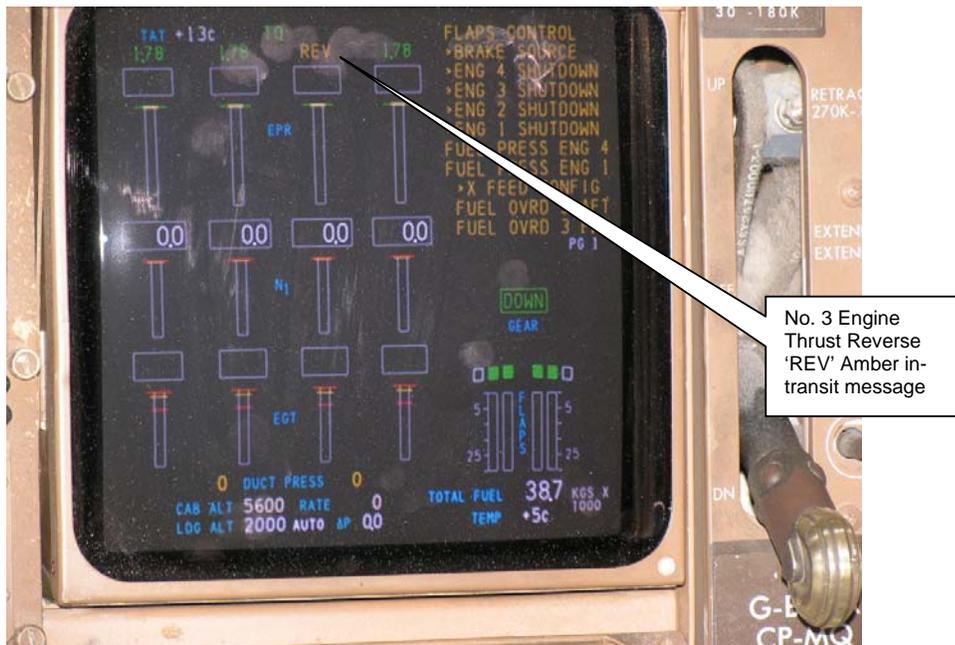
- a) During the takeoff roll the No. 3 'REV' amber EICAS message displayed on the P2 – Pilots Center Instrument Panel. Some seconds later, a No. 2 engine 'REV' amber EICAS message displayed on the P2 – Center Instrument Panel.
- b) The 'REV' amber EICAS message indicated to the flight deck crew that the specific thrust reverser was out of the stowed and locked position and in transit [Note that in this case both engines #2 and #3 had one TR gearbox unlock, however the other locking gearbox and the air motor brake remained engaged and neither reverser deployed].
- c) The aircraft air/ground logic then signaled the Group 'A' LE flaps to re-deploy (extend) and this occurred automatically.

PHOTO 4: VIEW OF P2- CENTER INSTRUMENT PANEL & 'REV' AMBER EICAS MESSAGE
 [Photo taken during simulation]

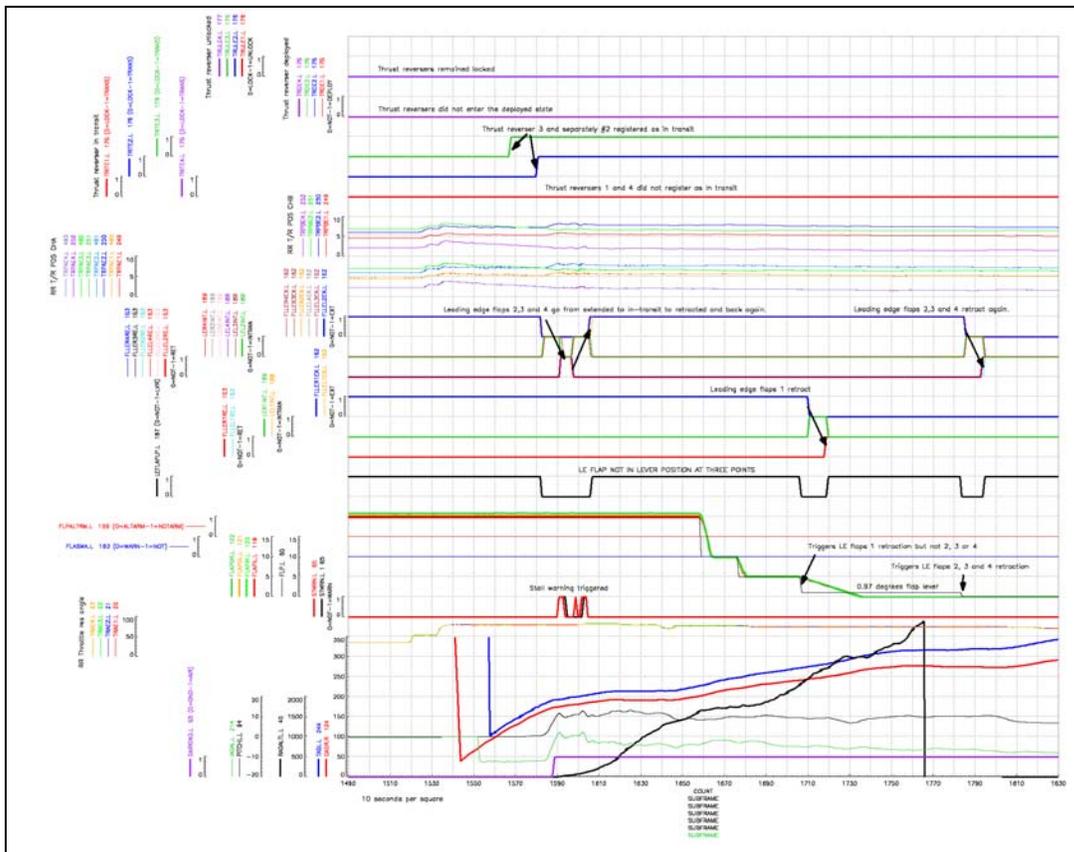
- The thin black line shows the pitch attitude decreasing (nose down attitude) as the aircraft became airborne from Runway 03L.
- On the upper section of the graph, the green line (Thrust Reverser No. 3) and blue line (Thrust Reverser No. 2) shows the thrust reversers in transit, 12secs and 8secs respectively prior to rotation.

- The purple and magenta lines illustrates No. 2, 3 and 4 leading edge flaps retracting, in transit and then extending again in approximately 20 to 25 seconds just before and just after the aircraft rotated.

GRAPH 1: QUICK ACCESS RECORDER (QAR) GRAPHS

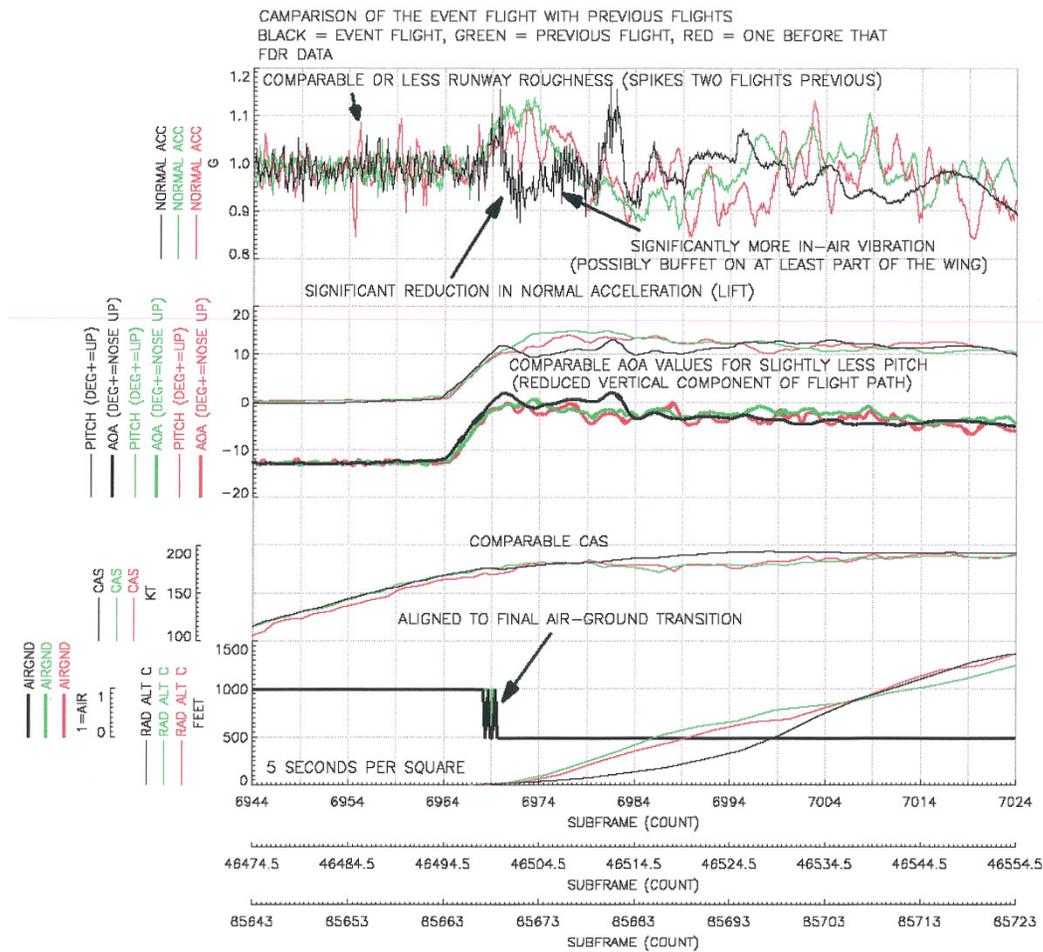
GRAPH 2: QUICK ACCESS RECORDER (QAR) GRAPHS

1.12.2 Graph 3 shows the portion of the flight profile for a normal takeoff (green line) and the event takeoff (black line). The altered flight profile for the event takeoff is due to the reduction of lift capability caused by the retraction of the Group 'A' LE flaps. A normal climb profile was re-established once the Group 'A' LE flaps extended back out. Refer graph 2 above.

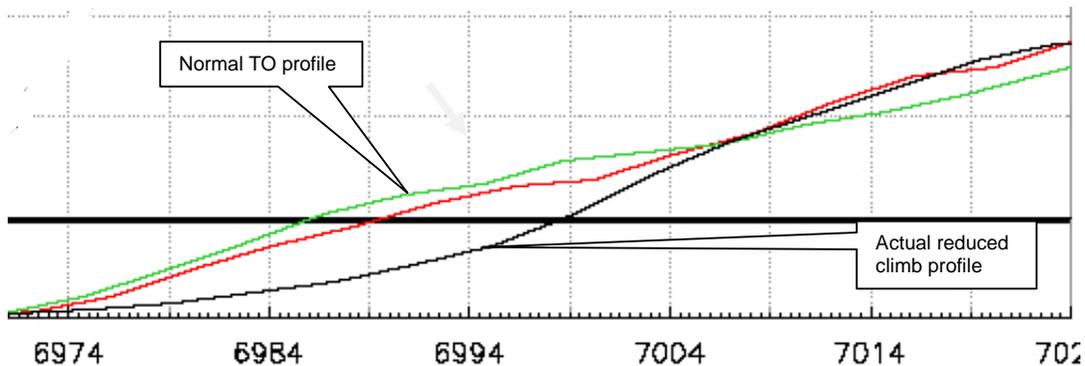
GRAPH 3: The normal TO profile versus the actual reduced climb profile

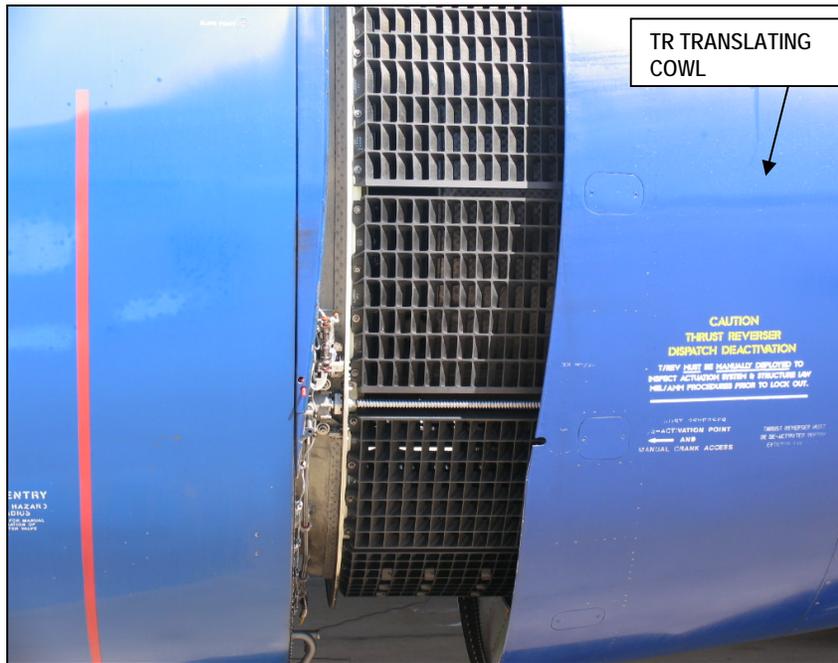
During the initial investigation, the Thrust Reverser Cowl Positioning (TRCP) reading for the engines were noted which showed No. 3 Engine TRCP during the take-off roll as 8.25% and No. 2 Engine TRCP when the aircraft became airborne also as 8.25%. According to the Aircraft Maintenance Manual for the RB211 Series Engines, the TRCP is normally between 3% to 5%. If the TRCP is between 5% and 8%, with the reverse thrust levers in the forward thrust position, the TRCP must be adjusted to give the correct indication as mentioned above.

The Thrust Reverser Cowl Position (TRCP) also referred to as the translating cowl, is monitored by an independent resolver, driven by the thrust reverser system gearbox in the No. 4 position on each engine and has independent output signals. A proximity switch which monitors movement of the thrust reverser cowl, triggers the 'REV' amber indication on the P2 Pilot Center Instrument Panel.

PHOTO 6: SHOWS THE TRANSLATING COWL IN THE EXTENDED POSITION

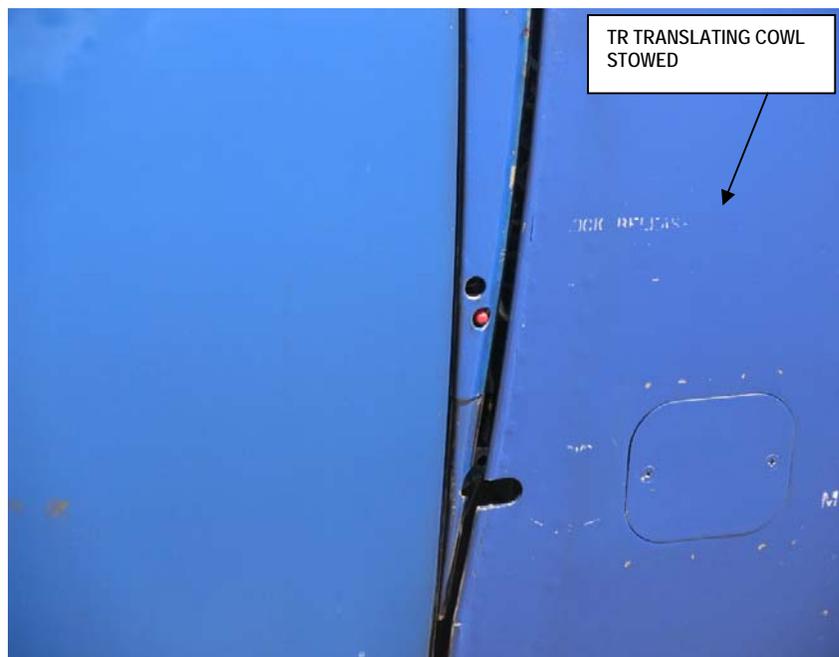
PHOTO 7: SHOWS THE TRANSLATING COWL IN THE FWD STOWED POSITION.

- *The increase in TRCP readings with increasing engine power appear to be typical for this fleet, but no physical movement of the thrust reverser cowl was found.*
