INCIDENT

Aircraft Type and Registration:	Boeing 777-200ER, AP-BGL	
No & Type of Engines:	2 GE 90 turbofan engines	
Category:	1.1	
Year of Manufacture:	2004	
Date & Time (UTC):	1 March 2005 at 0910 hrs	
Location:	Manchester Airport, Manchester	
Type of Flight:	Public Transport (Passenger)	
Persons on Board:	Crew - 12	Passengers - 332
Injuries:	Crew - 0	Passengers - 31 (Minor)
Nature of Damage:	Slight damage to fuselage skin adjacent to door 3R, heat damage to the No 10 tyre and hydraulic hoses on the left main landing gear	
Commander's Licence:	Airline Transport Pilot's Licence	
Commander's Age:	54 years	
Commander's Flying Experience:	13,000 hours (of which 600 were on type) Last 90 days - 176 hours Last 28 days - 36 hours	
Information Source:	AAIB Field Investigation

Synopsis

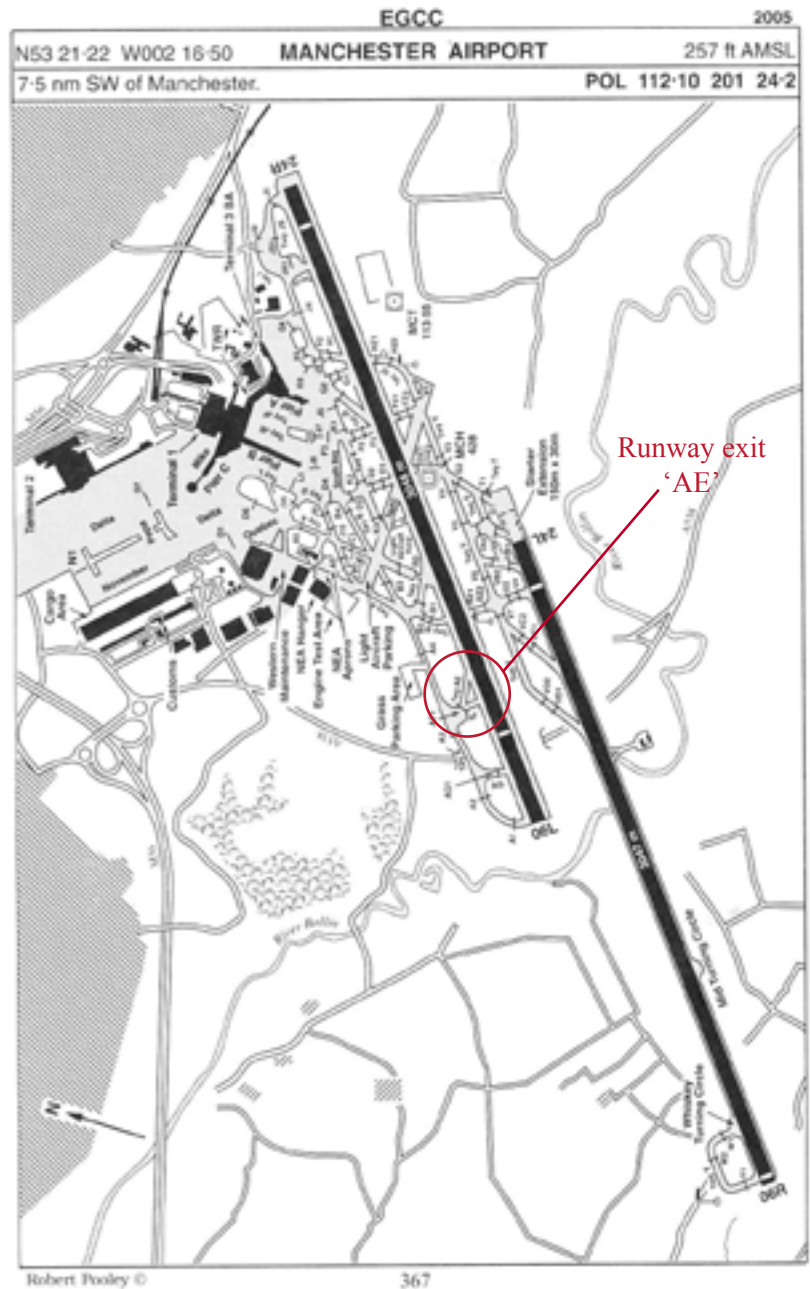
Figure 1

A short time later, as the aircraft was still taxiing, an aircraft on an adjacent taxiway transmitted on the GMC frequency “AND GROUND ERR (CALLSIGN) THE PIA IN FRONT HAS FIRE IN HIS LEFT - ON HIS LEFT MAIN UNDERCARRIAGE”. The GMC Controller replied “ROGER”. Initially, the crew of the Boeing 777 did not realise that this transmission about fire related to their aircraft. There was a brief exchange of communications on the GMC frequency with other aircraft, and then the GMC controller transmitted “PAKISTAN SEVEN EIGHT NINE ERR JUST GETTING THE FIRE SERVICE OUT TO CHECK YOUR UNDERCARRIAGE CAN YOU HOLD POSITION”, to which the co-pilot responded “ERR HOLDING PAKISTAN SEVEN EIGHT NINER”. The commander brought the aircraft to a halt and set the Parking Brake. The aircraft was now parked on Taxiway J9, adjacent to the north side Airport Fire Station.

The GMC controller observed the aircraft through binoculars and saw yellow and white flames coming from the left MLG. He activated the Crash Alarm, contacted the RFFS, declared an Aircraft Ground Incident (AGI) and passed the appropriate details.

The Watch Commander had stopped his vehicle in front of the aircraft, from where he had an unrestricted view of the front of the left MLG bogie. He saw that a wheel hub appeared fully alight and observed what he described as

“intense, very bright orange flames” from the rear set of wheels. Firefighters deployed two hose lines, one to the front of the left MLG and one to the rear, and began applying water in a spray pattern on to the wheels and brakes. The ATC Supervisor observed the aircraft from the Visual Control Room (VCR) and saw an intense white fire on the landing gear, which he described as “like a gas mantle” and “like white hot metal”. He did not see significant smoke and stated that the fire did not appear similar to hot Boeing 777 brakes that he had seen on previous occasions. As water was applied, significant and increasing amounts of what appeared to be ‘smoke’ emanated from the landing gear assembly.

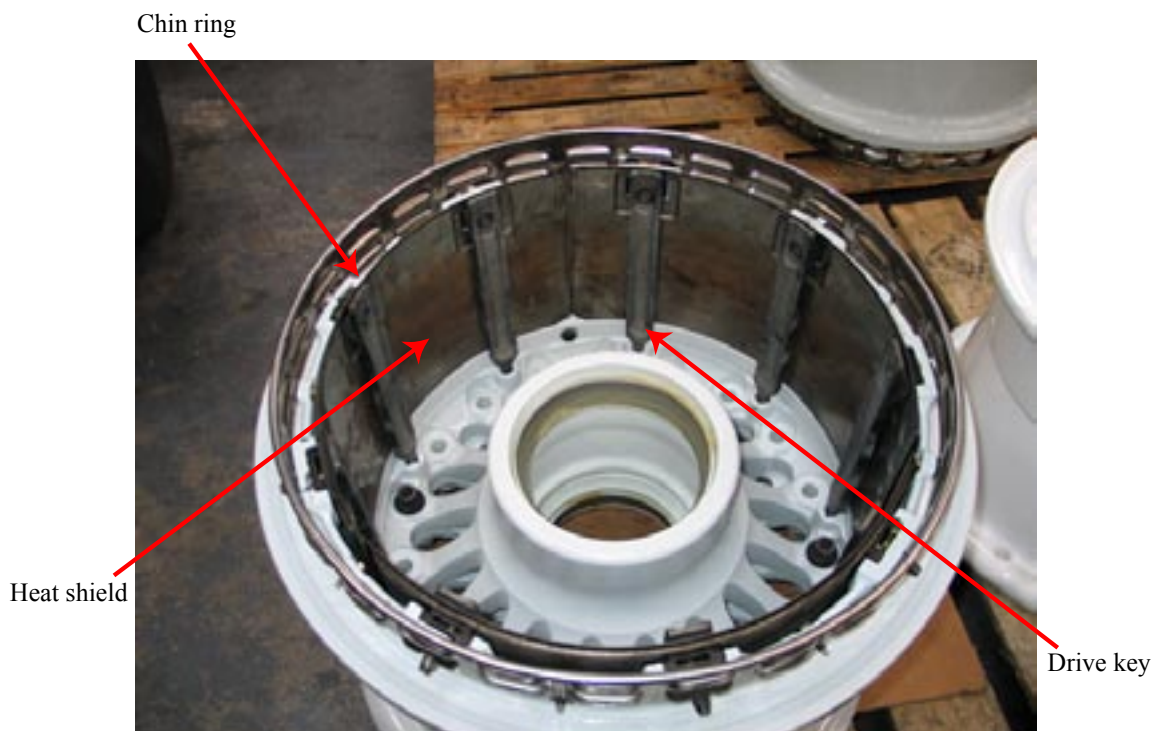
Figure 4
Construction of main wheel

aluminium hub from the high temperatures generated by the carbon brake pack. The heat shields are constructed from two thin sheets of stainless steel, spot welded around their edges, and which contain an absorbent ceramic insulation material. They have a hole on the outer edge to allow the brake pack drive keys to be secured to the hub, and rubber bumpers fitted along the outside surface to prevent fretting against the wheel hub.

All three of the heat shields from this wheel were coated in black soot-like deposits, which was considered to have been wear dust from the carbon brakes. One of the heat shields displayed blue and straw coloured interference patterns on its outside surface, a typical signature of heat on the shield material. This emanated from the edge closest to the axle, indicating that the shield section had been subject to abnormal heating, concentrated on the outer edge of the heat shield. Whilst there was slight discolouration on the inner surface, it was less intense and widespread. This was unusual in that the inner surface of the heat shield is normally exposed to the high temperatures from the brake pack, whilst the outer surface is close to the significantly cooler hub. The rubber bumpers showed no evidence of heat damage. The normal weight of a wheel heat shield is 900 g. The measured weights of the three heat shield sections removed from this hub were 1.013 kg, 1.008 kg and 1.009 kg.

Two of the heat shields from wheel No 10 were sent to an independent laboratory for further analysis. Upon dissection, it was noted that there was considerable charring of the internal ceramic insulating material, particularly at the edges and around the rubber inserts. The material felt damp to the touch and there was a strong smell of a hydrocarbon substance. Two samples of the material weighing 0.9 g and 0.8 g were heated to 50°C and a weight loss of approximately 31% was recorded after one hour and 43% after 12 hours. Further analysis determined that the material contained a number of volatile organic components, similar to products used

A review of the incidences of wheel fires on the operator's Boeing 777 aircraft indicated that all the affected wheels had been fitted to the aircraft at Karachi, with the fires all occurring on the 'second' landing at Manchester. It is likely that, in these incidents, solvent escaping from the heated heat shields was ignited and briefly burnt and/or that any excessive grease either on the axle or thrown onto the brake pack during the first landing, could have been ignited when the aircraft landed at Manchester. Either way, the most likely explanation for the majority of the fires occurring at Manchester is that it is here the aircraft normally undertakes its first landing with a full payload following a wheel change at Karachi. Hence the brake packs would likely be hotter than on landing at Lahore, with the result that the heat shields became sufficiently hot for the entrapped solvent to escape as a vapour and ignite, probably, on contact with the hot brakes.

remove the possibility of such fires completely, it would be preferable for the heat shields to be cleaned with a water based detergent. However, if the recommended solvent is used, it is essential that operators follow the manufacturers instructions and take sufficient measures to prevent contamination of the absorbent ceramic filler.

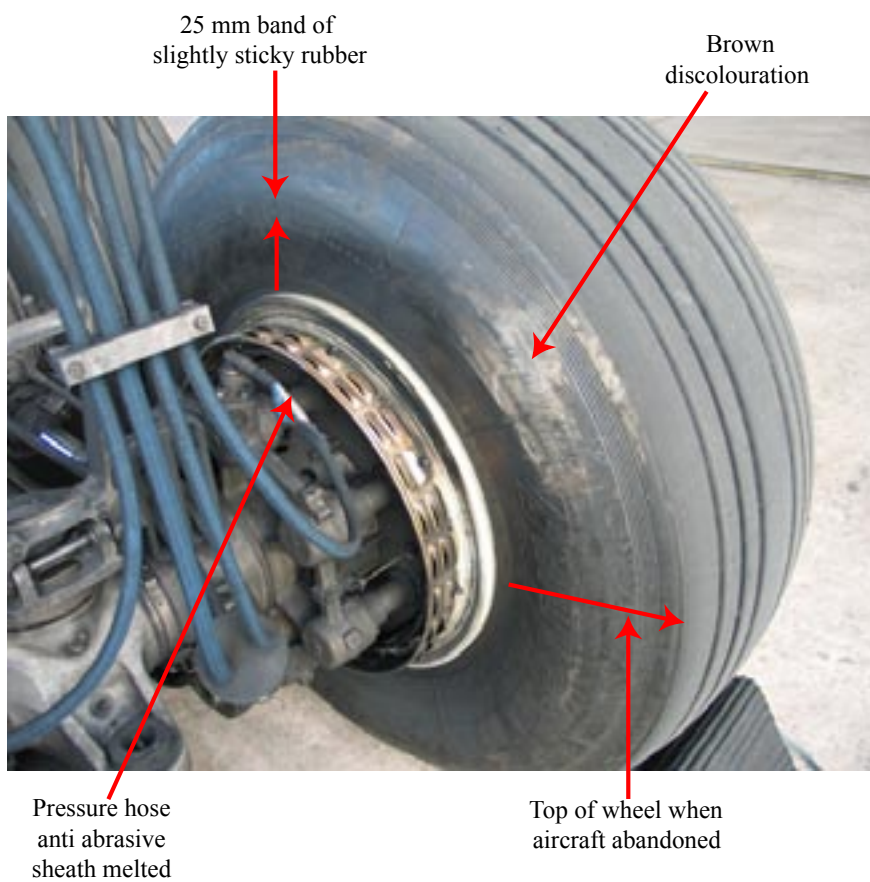
Figure 5

The damage on each pipe was approximately 16 cm long and was on the side of the pipes facing the wheel. There was also slight damage to the inside of the No 10 tyre, consisting of a small brown area of discoloration at the 12 o'clock position, and two areas where the rubber had just started to turn sticky, indicating that these areas had been exposed to temperatures between 100°C and 150°C. Apart from this slight damage, the tyre appeared to be in good condition, Figure 5.
