**Statens haverikommission**  
Swedish Accident Investigation Board

## ***Report RL 2007:23e***

**Aircraft accident to YK-AHB at Stockholm/  
Arlanda airport, AB county, Sweden, on  
11 December 2006**

Case L-30/06

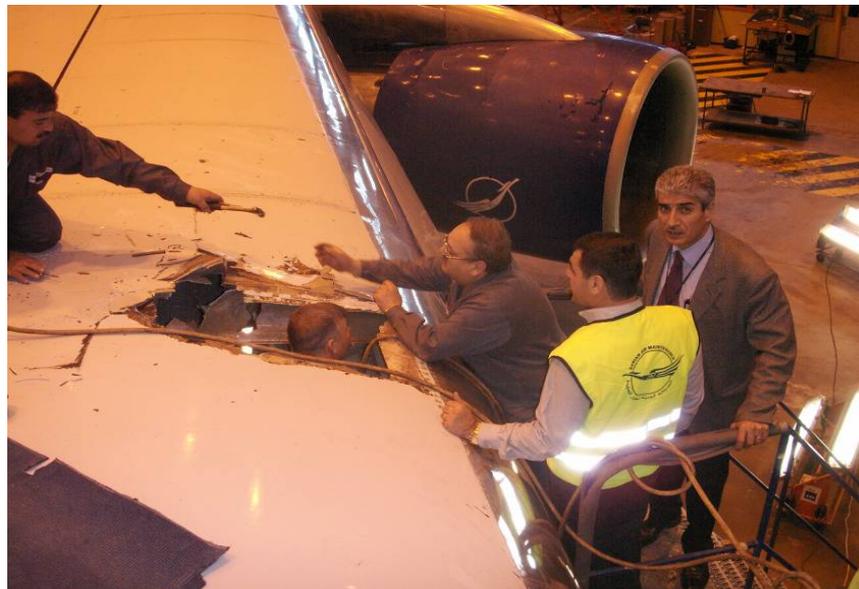
When the aircraft was taxiing in towards the gate the display indicated the type version B 747, according to the computer log in the system. During the interview the Commander stated that he earlier had experienced that docking systems had displayed B 747, and yet had been correct for a B 747 SP. The operator supervised the intaxiing and when she realized that the aircraft came alarmingly close to the airbridge housing, she activated the emergency stop button. This was however already activated by the ground staff at the ramp. The top of the left wing struck the under side of the airbridge at the same time as the display indicated “STOP” and a large hole was torn up at the upper side of the wing.

Fig. 2. The aircraft being repaired after the accident

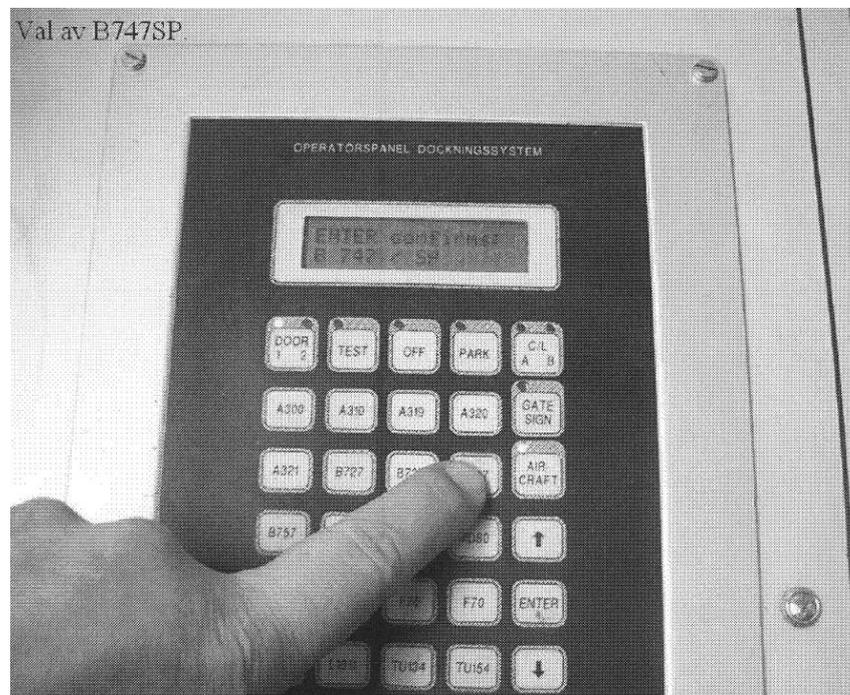
*Fig. 4. Operator's panel on the airbridge. (Selection of B747SP)*

In the configuration that was applicable at the time of the accident, the system's laser scanner could not distinguish between different versions of the same aircraft type, because it could only detect the frontal contour of the aircraft, without taking varying fuselage lengths into account. At certain gates at Arlanda there is an updated version of Safedock, where the system can distinguish between different versions.

- Work for that all docking terminals at Arlanda airport are designed in a way that information regarding aircraft types and type versions not can be misinterpreted. (*RL 2007:23e R4*).

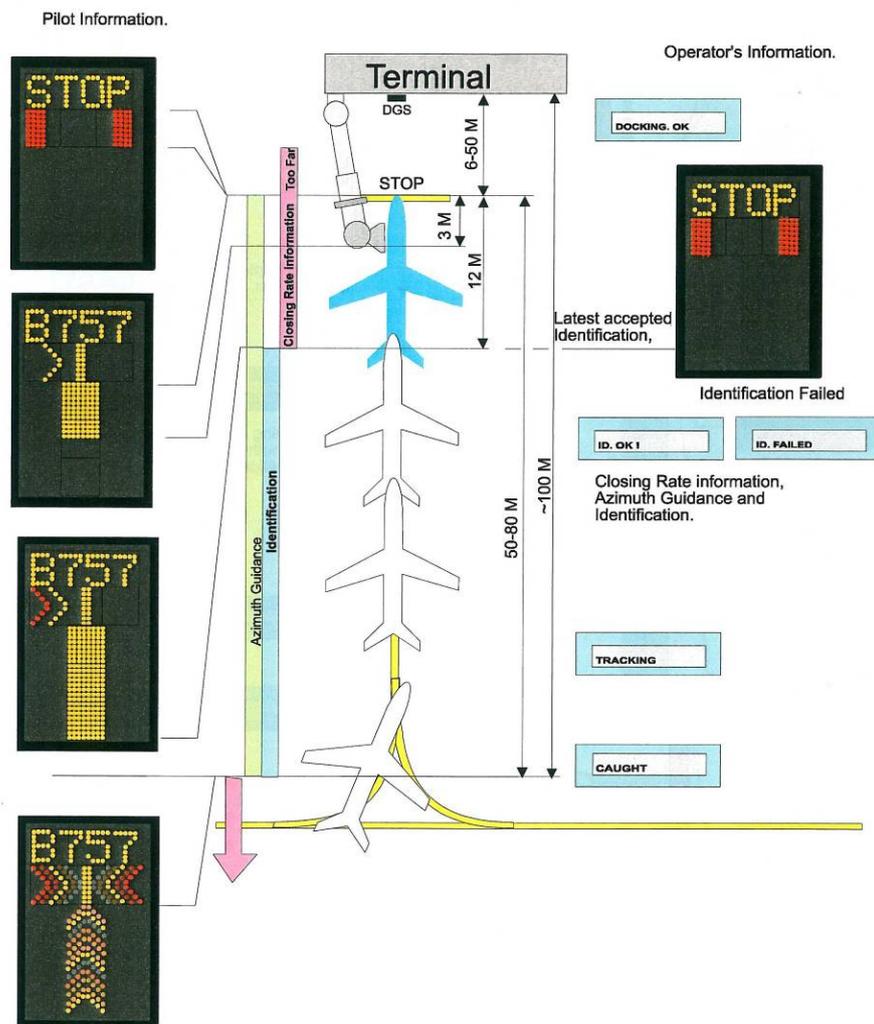
Fig. 5. Docking procedure

Once the aircraft type has been selected, the system's laser scanning unit is activated and goes over to an active mode to search for an approaching aircraft. If visibility is very poor, the text "DOWNGRADE" appears, and the floating arrows are switched off. This is also a message to tell the pilots to taxi in with extra care. The graphical distance meter LEDs light up when the aircraft is caught by the laser, usually about 30 metres from the stop position, and the arrows showing lateral deviation from the centreline and distance indication are activated. This is indicated on the operator's panel by the message "TRACKING" being shown on the display. When the system has identified the approaching aircraft and verified that it is the selected type, "IDENTIFIED" is shown on the operator's display. If verification of the correct aircraft type has not been achieved before there is 12 metres remaining to the stop position, the LED display shows "WAIT", and if a second attempt at verification fails, the message "STOP" is shown. The laser scanning system at gate 18 at Arlanda cannot detect the difference between a B 747 and a B 747 SP.
