Midair Collision Over Hudson River
Piper PA-32R-300, N71MC
and Eurocopter AS350BA, N401LH
Near Hoboken, New Jersey
August 8, 2009

Aircraft Accident Summary Report

NTSB/AAR-10/05
PB2010-910405

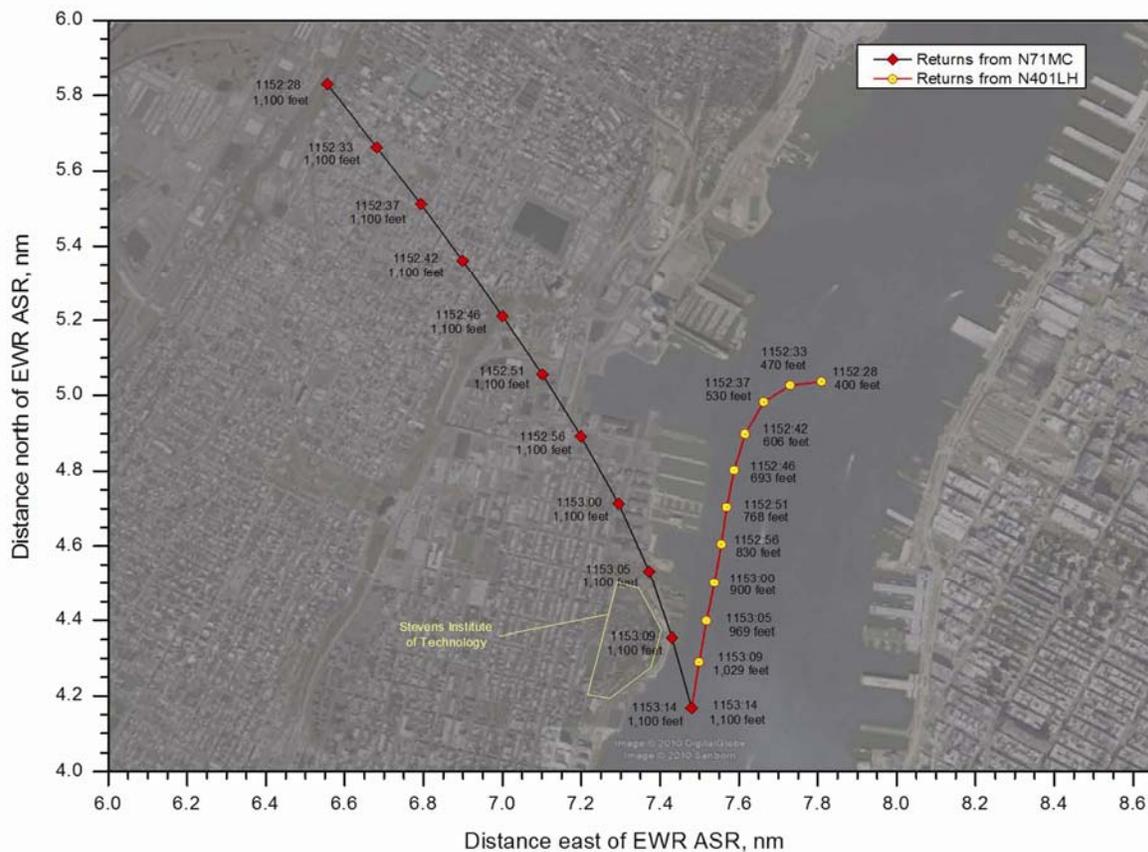
calculate the position and orientation of each aircraft in the minutes preceding the accident.²² Figure 1 shows the ground tracks of the accident aircraft and the collision location over a Google Earth™ image of the Hudson River Class B exclusion area along with each aircraft's mode C-reported altitudes at each data point. This information was used to estimate the approximate location of each aircraft during the same time as viewed from the other aircraft's windscreen and the traffic information that could have been presented on the navigation display in each aircraft, as discussed in section 2.2. Figure 2 shows the Class B exclusion area in relation to the surrounding Class B airspace. The accident aircraft ground tracks just before the collision are also depicted.

Figure 1. Accident aircraft ground tracks.

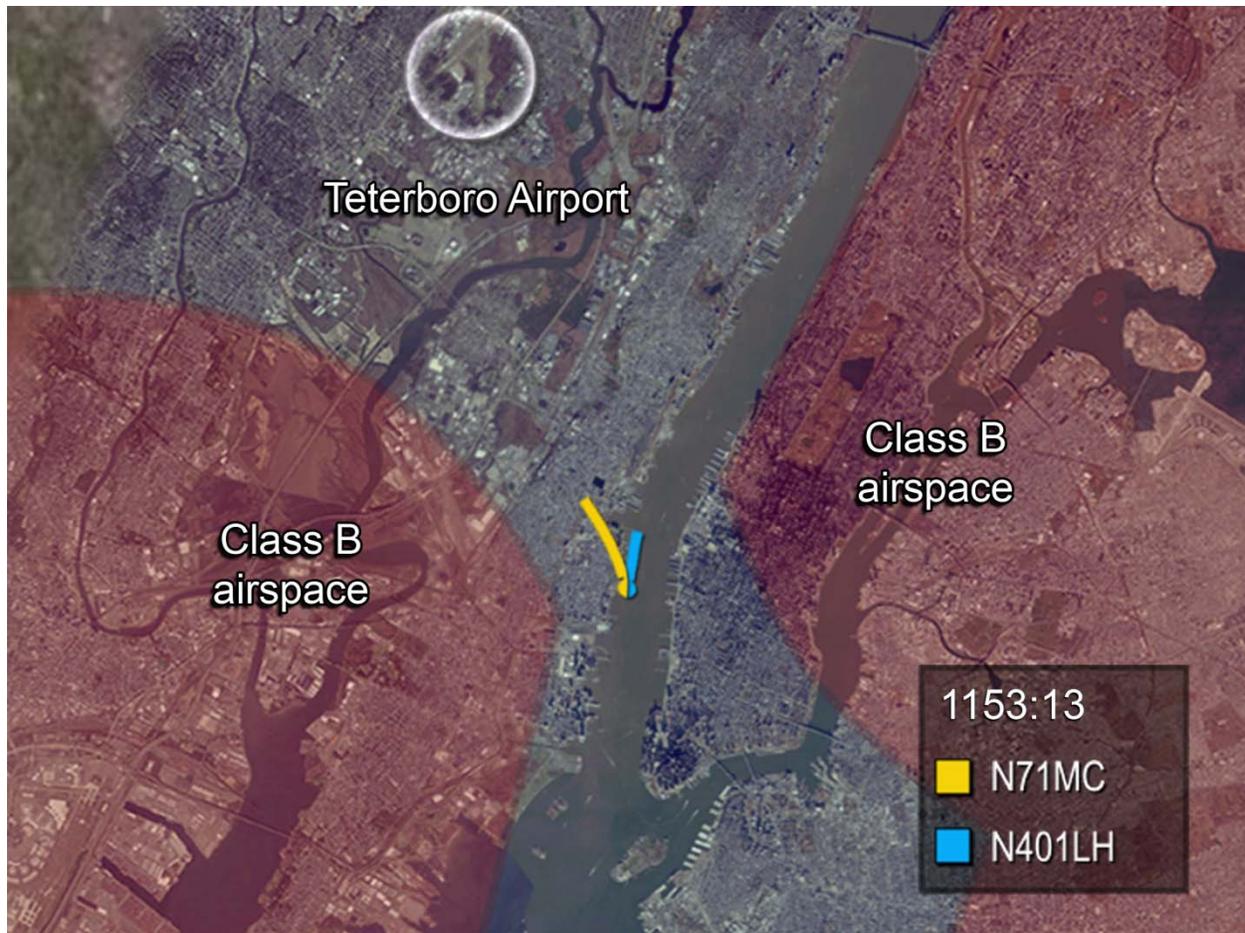
Note: The Class B airspace over EWR, shown on the left, extends from 500 to 7,000 feet. The Class B airspace over LaGuardia Airport, shown on the right, extends from the surface to 7,000 feet.

Figure 2. Hudson River Class B exclusion area.

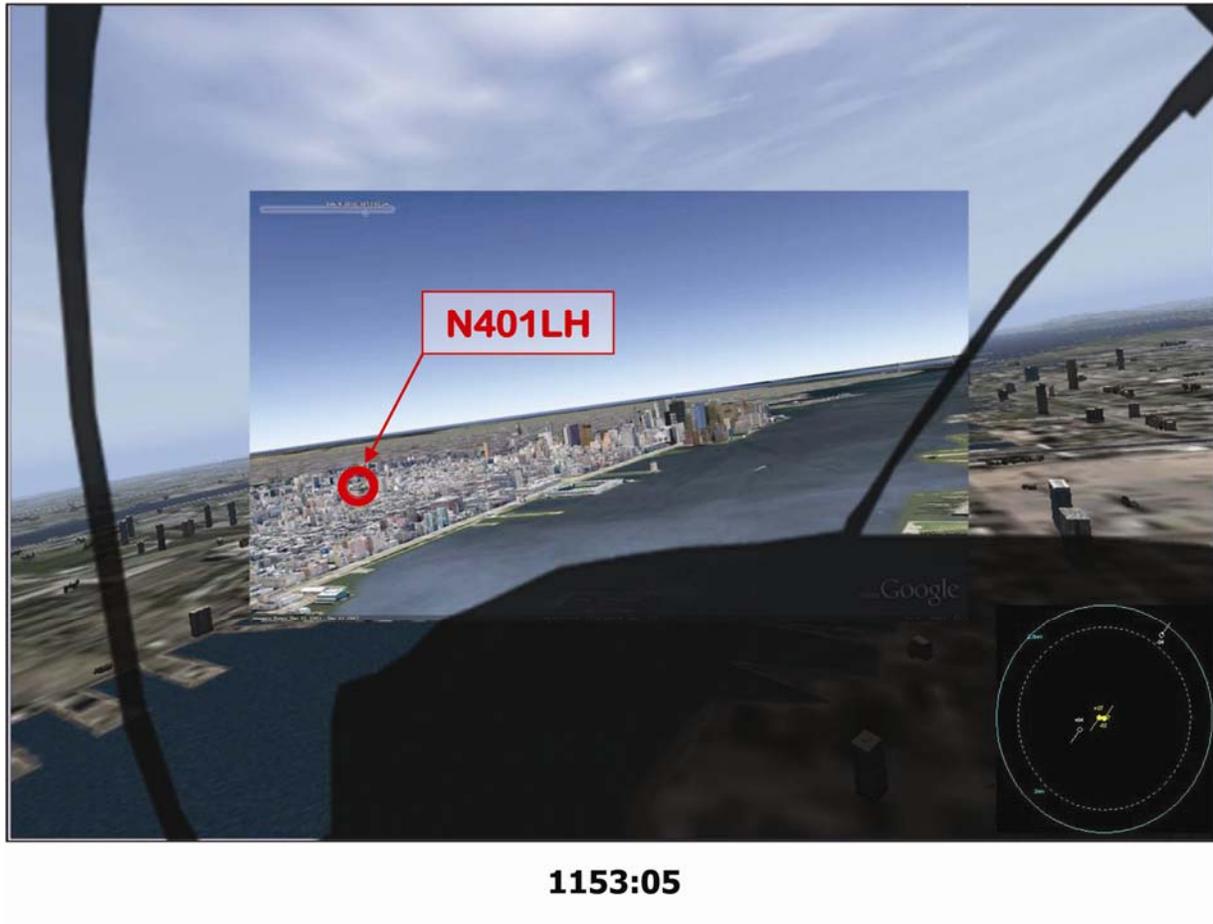
Figure 3. View of helicopter from airplane cockpit about 9 seconds before collision.

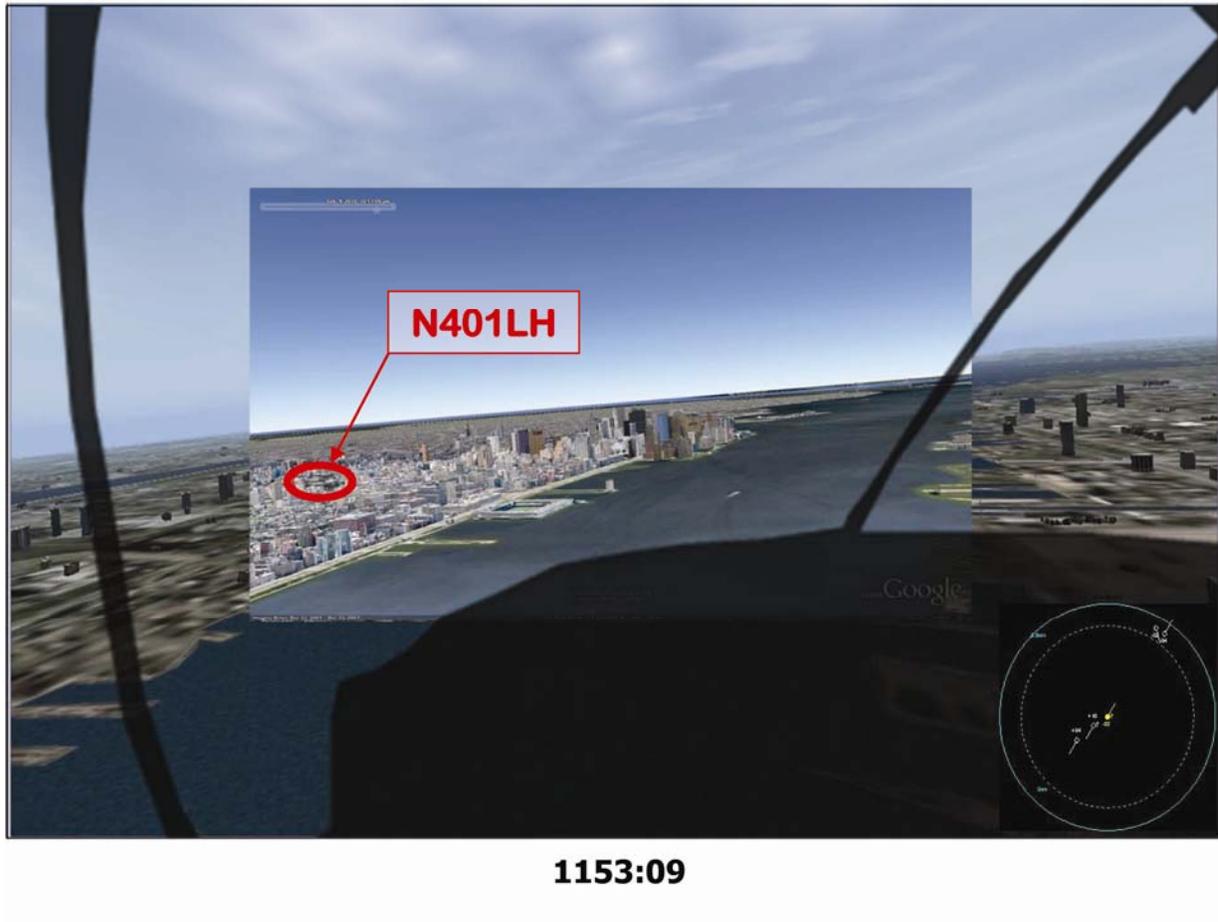
Figure 4. View of helicopter from airplane cockpit about 5 seconds before collision.

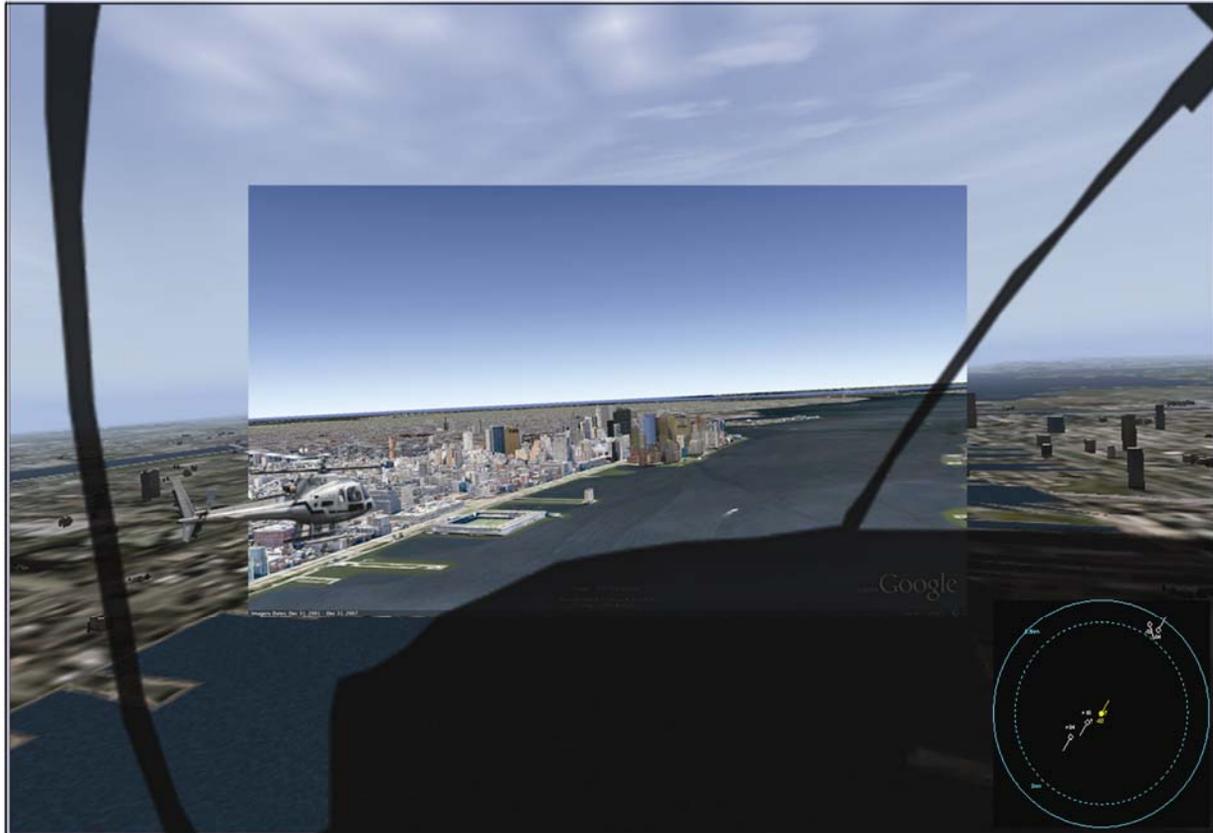
1153:13

Figure 5. View of helicopter from airplane cockpit about 1 second before collision.

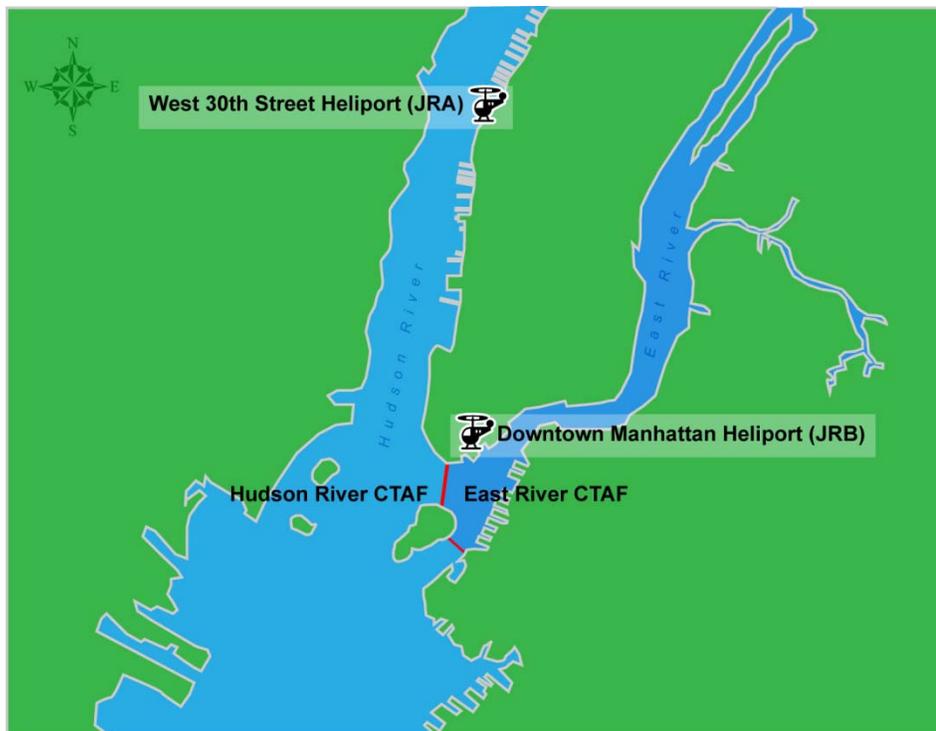
Figure 6. Location of West 30th Street and Downtown Manhattan Heliports and Boundary Between Hudson River and East River common traffic advisory frequencies.

The NTSB concludes that pilots operating air tour helicopters to and from JRB may not be fully aware of other aircraft operating over the Hudson River because the CTAF used for such flights is for the adjacent East River area. Therefore, the NTSB recommends that the FAA redefine the boundaries of the East River CTAF so that JRB will be located in the area that uses the Hudson River CTAF.
