GENERAL INFORMATION

Identification number:	2007044
Classification:	Serious incident
Date, time ¹ of occurrence:	18 May 2007, 20.53 hours
Location of occurrence:	Groningen Airport Eelde (EHGG)
Aircraft registration:	OO-VLI
Aircraft model:	Fokker F27 MK50 (Fokker 50)
Type of aircraft:	Passenger Aircraft
Type of flight:	Scheduled passenger transport
Phase of operation:	Landing
Damage to aircraft:	Minor
Cockpit crew:	Two
Cabin crew:	One
Passengers:	Eleven
Injuries:	None
Other damage:	One runway edge light and a runway end light destroyed
Light conditions:	Daylight (sunset at 21.32 hours)

SUMMARY

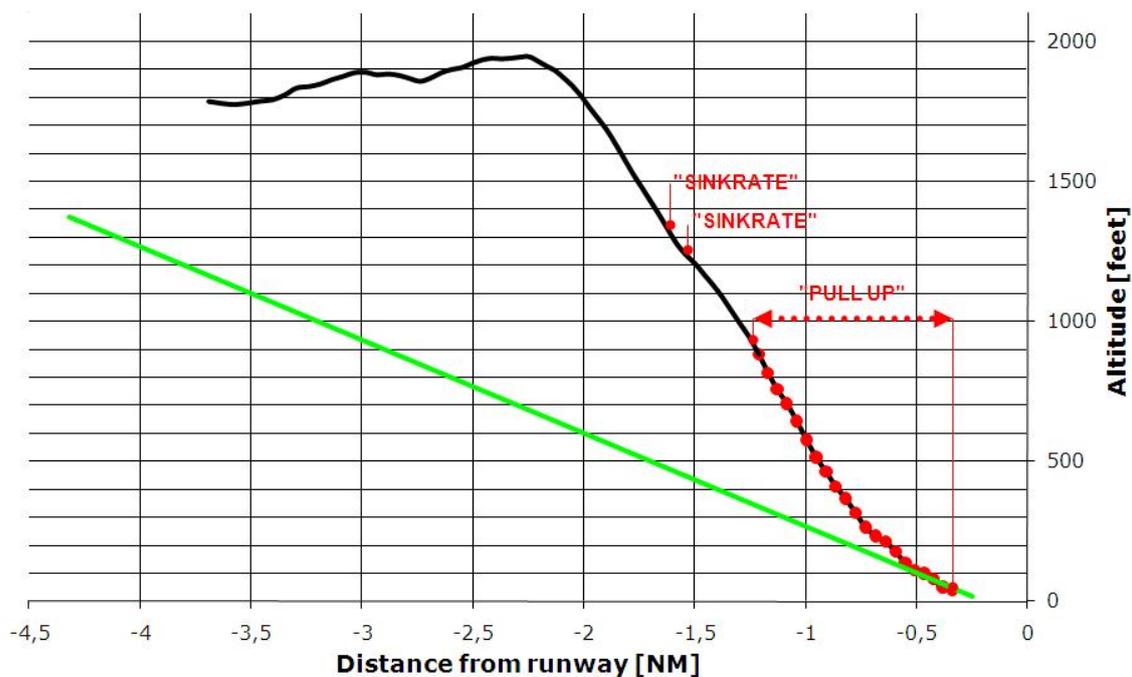
Illustration 1: side view of descent profiles

two 'sink rate' warnings followed by a series of 'pull up' warnings; see illustration 1. At 800 feet above ground the sink rate had increased to 4000 feet per minute. The PF positively identified both warnings, ordered to disregard them and continued the approach. During the final approach the pitch angle⁵ varied between -2 and -20 degrees.

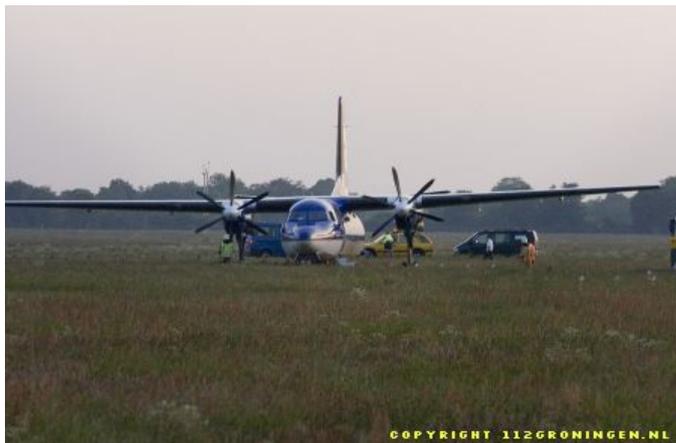
Illustration 2: OO-VLI after the incident

There was no fire and the crew and passengers sustained no injuries. The aircraft sustained minor damage. A runway edge and a runway end light were destroyed.

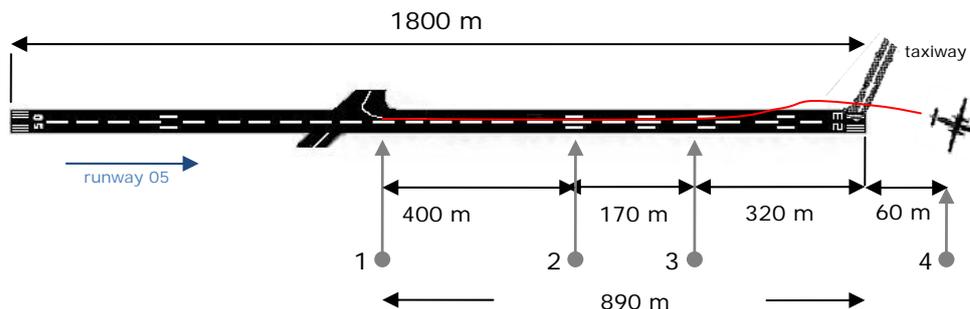
Illustration 3: runway 05/23 at EHGG (not to scale)

The aircraft left several skid marks on the runway. Initially a 22 meter skid mark from the left main landing gear was found starting 490 metres before the departure end of runway 05. Left and right main landing gear tyre tracks started approximately 320 metres before the runway end and both tracks veered off to the left of the runway. The left main landing gear tyre track went off the left hand edge of the runway, destroyed a runway edge light, and ran through the grass for a short distance before it reappeared on the concrete surface of the taxiway (illustration 3). It proceeded onto the intersecting taxiway, just one metre outside the westerly edge of the runway. With the right main landing gear destroying a runway end light, the aircraft left the runway end and came to a halt in the grass after approximately 60 metres near a row of approach lights and with the right hand main landing gear just in front of embedded heavy concrete constructions.

- 1 : Nose wheel touchdown
- 2 : First skid mark left main landing gear
- 3 : Skid marks left and right main landing gear
- 4 : Aircraft position after the incident
- : Aircraft ground track

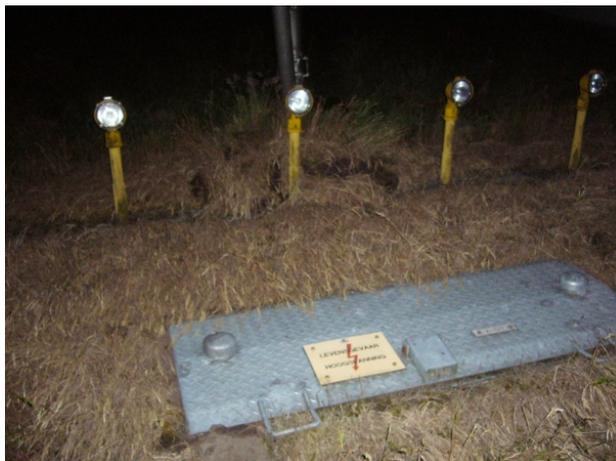
Illustration 5: embedded construction in front of Fokker 50

The area beyond the end of the runway, i.e. the 'overrun area', contained underground concrete structures, containing electrical transformers, in soft soil. It is likely that such a combination (*underground* structures and soft soil) entails a substantial fire hazard for the aircraft and its occupants in the event of a collision (the aircraft fuel, the risk of ignition of sparks and the temperature of the engines).

This finding was also mentioned in report number 2003071 of the Dutch Safety Board regarding an aircraft accident on 17 June 2003 involving an MD-88 that overran the runway at Groningen Airport Eelde during a take-off abort. In 2006 it was recommended to the Dutch Minister of Transport, Public Works and Water Management to investigate to which extent the requirements concerning

the underground infrastructure in the direct vicinity of start and landing runways have to be stepped up to prevent serious damage to aircraft that overrun the runway. In November 2007, six months after the Fokker 50 incident, the Minister stated it will add the survey of underground infrastructure in close proximity to runways to its inspection program.

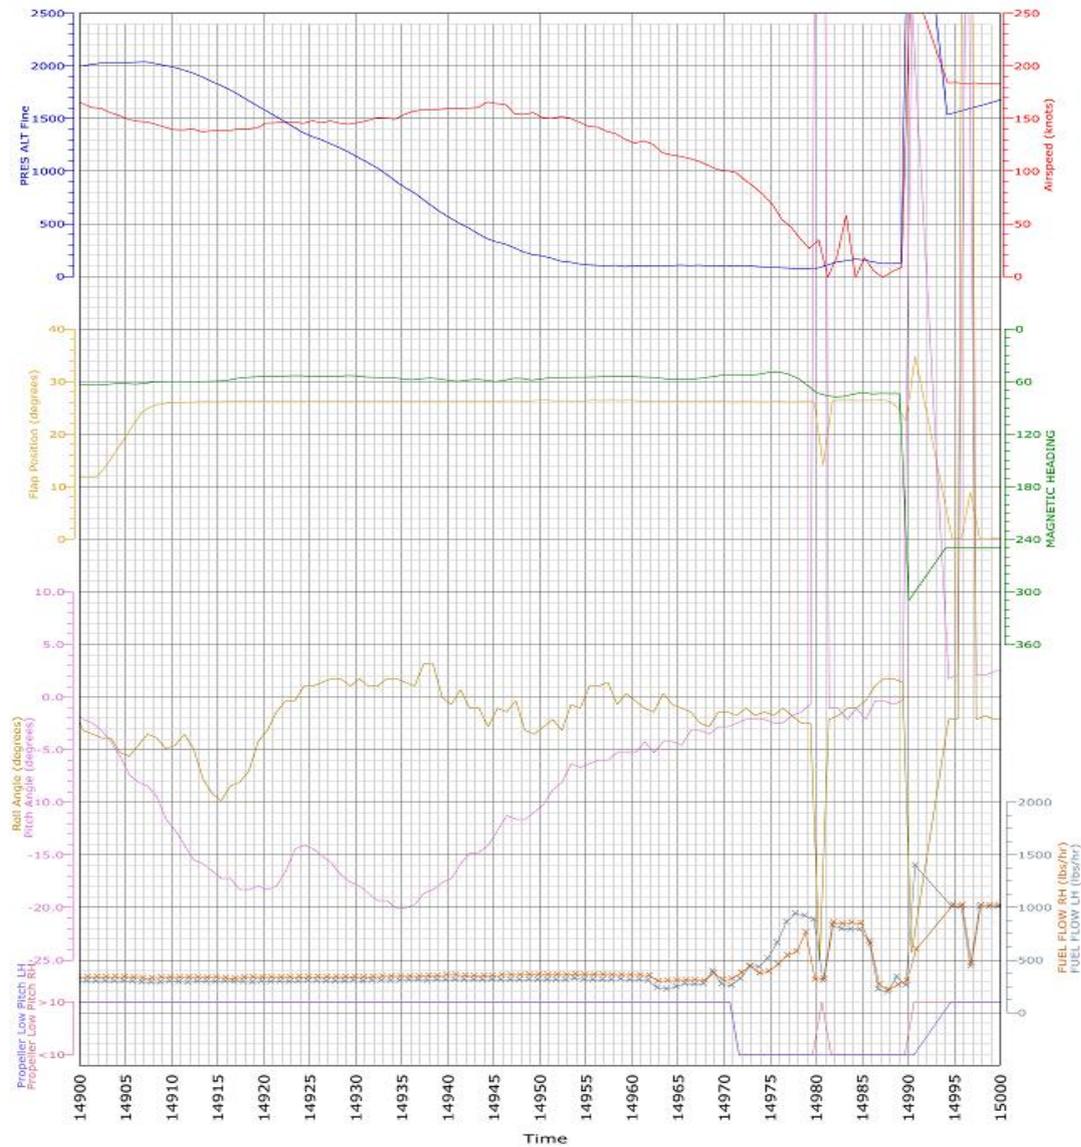
Illustration 7: flight data presentation starting approximately two minutes prior to landing at EHGG

The figure represents the final approach and landing phase and starts at 14900 (= 20.51:38 hours) and ends one minute and forty seconds later at 15000 (= 20.53:18 hours); interval on the time axis is five seconds.
