**Australian Transport Safety Bureau**

**ATSB TRANSPORT SAFETY REPORT**  
Aviation Occurrence Investigation  
AO-2009-012  
Final

**Tailstrike and runway overrun  
Melbourne Airport, Victoria  
20 March 2009  
A6-ERG  
Airbus A340-541**

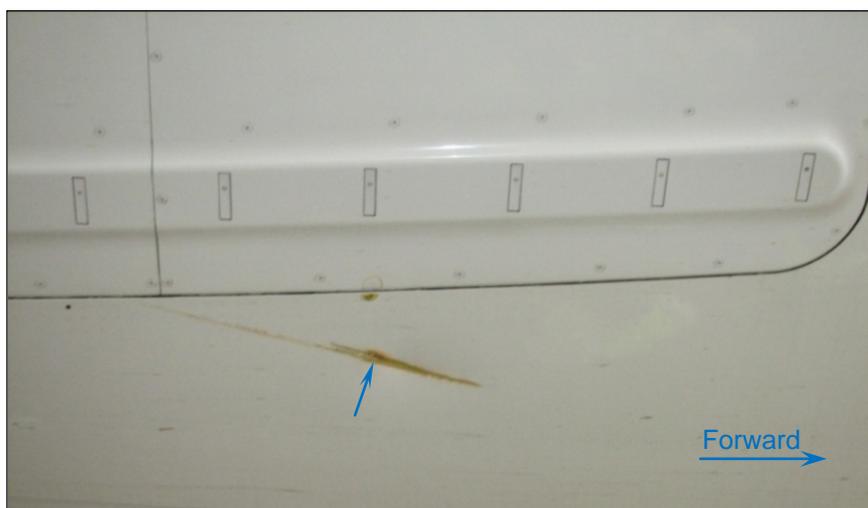
The right side rear fuselage contained several contact marks. One contact mark, forward of the abraded area and immediately below the rear cargo door (Figure 4), was orange in colour consistent with the orange paint on the localiser near-field monitor antenna. Another contact mark was located adjacent to the skin abrasion and consisted of several fine, divergent marks running rearwards and slightly upwards (Figure 5).

**Figure 4: Contact mark below rear cargo door**

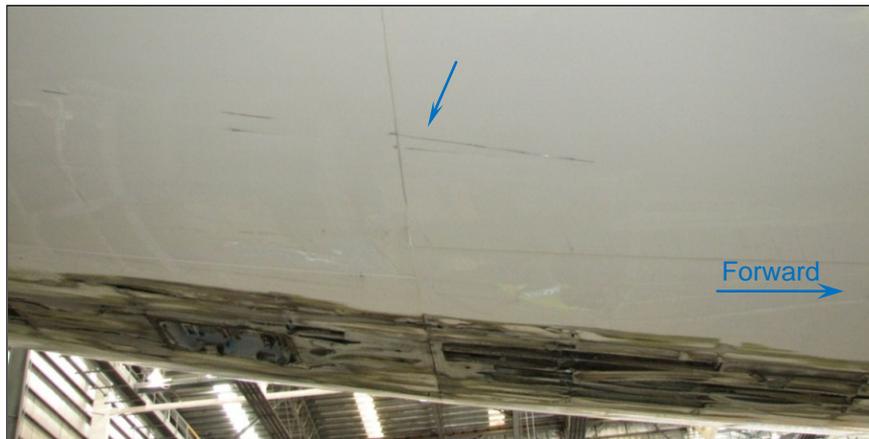
**Figure 5: Contact marks adjacent to the skin abrasion**

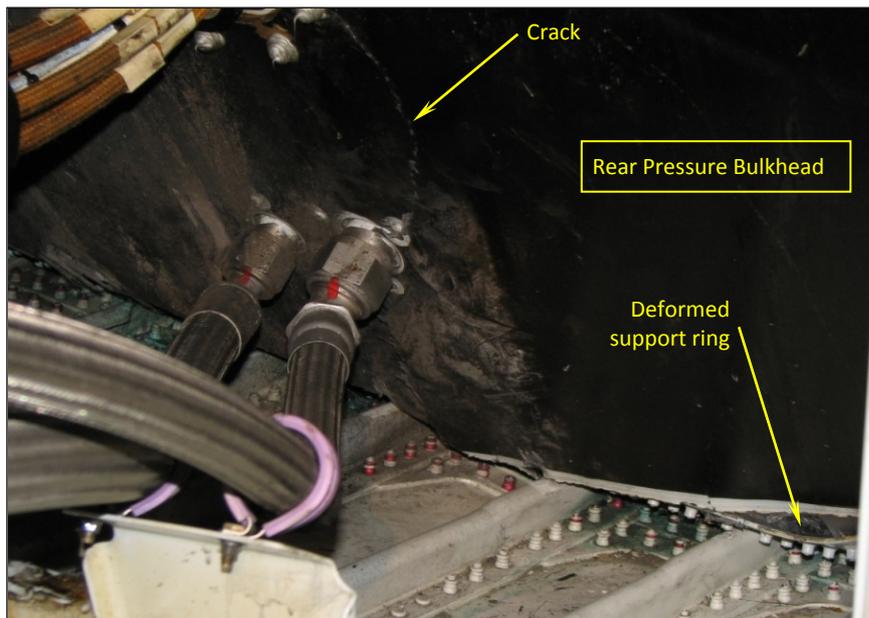
Numerous fuselage frames and stringers in the rear fuselage area were damaged by the abrasion and contact forces during the tailstrike. The damaged frames were deformed and several were cracked. The composite rear pressure bulkhead<sup>12</sup> had cracked, and the bulkhead diaphragm support ring was deformed (Figure 6).

**Figure 6: Example of rear pressure bulkhead damage**

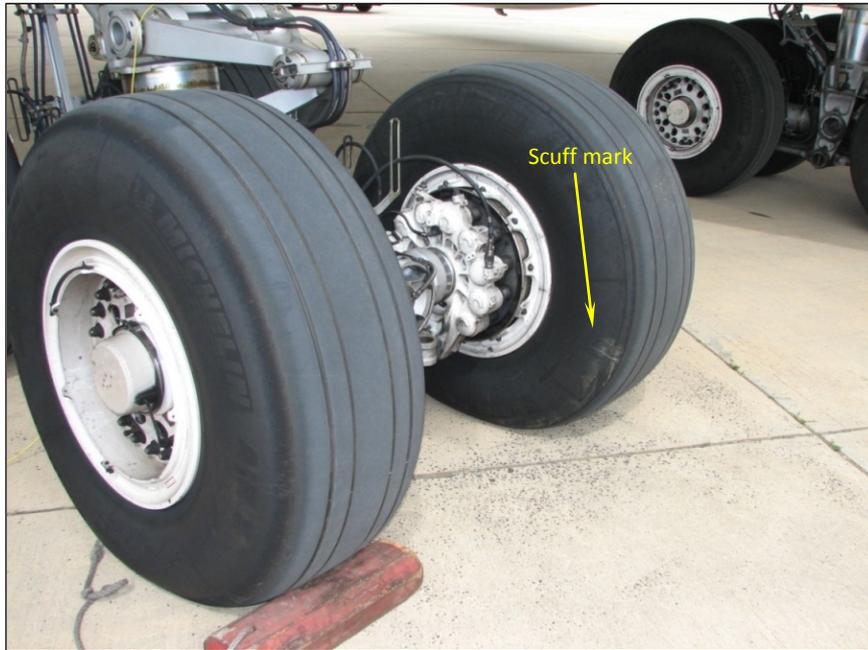
The inboard rear tyre on the left main landing gear had a scuff mark on its sidewall (Figure 7). The mark contained transferred material that was the same orange colour as the localiser antenna system.

**Figure 7: Contact mark on the left main landing gear, inboard rear tyre**

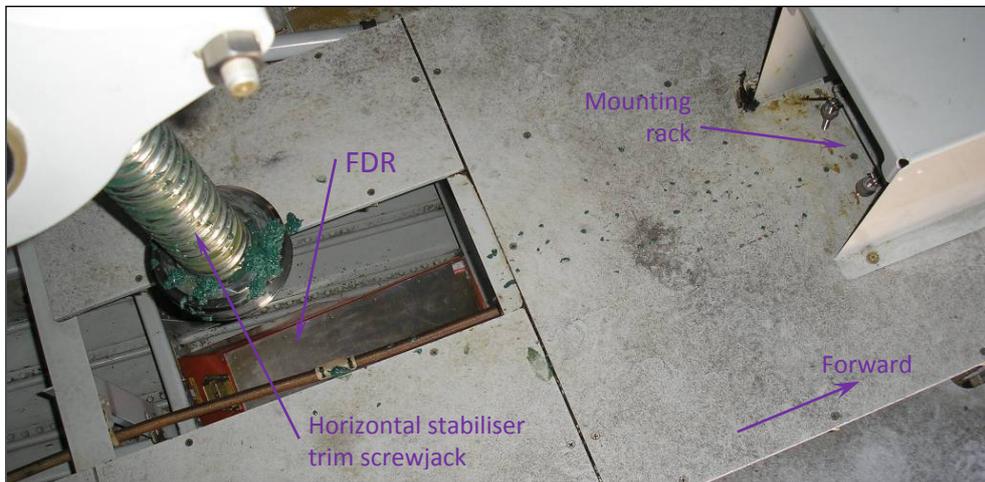
The flight data recorder (FDR) was dislodged from its mounting rack immediately behind the rear pressure bulkhead and was found lying on the lower fuselage skin below and slightly to the rear of the mounting rack (Figure 8). The FDR was undamaged and contained recorded data from the commencement of the take-off roll until the dislodgement at 2232:05. The results of an examination of the FDR rack are at Appendix A.

**Figure 8: Location of the dislodged FDR and its mounting rack**

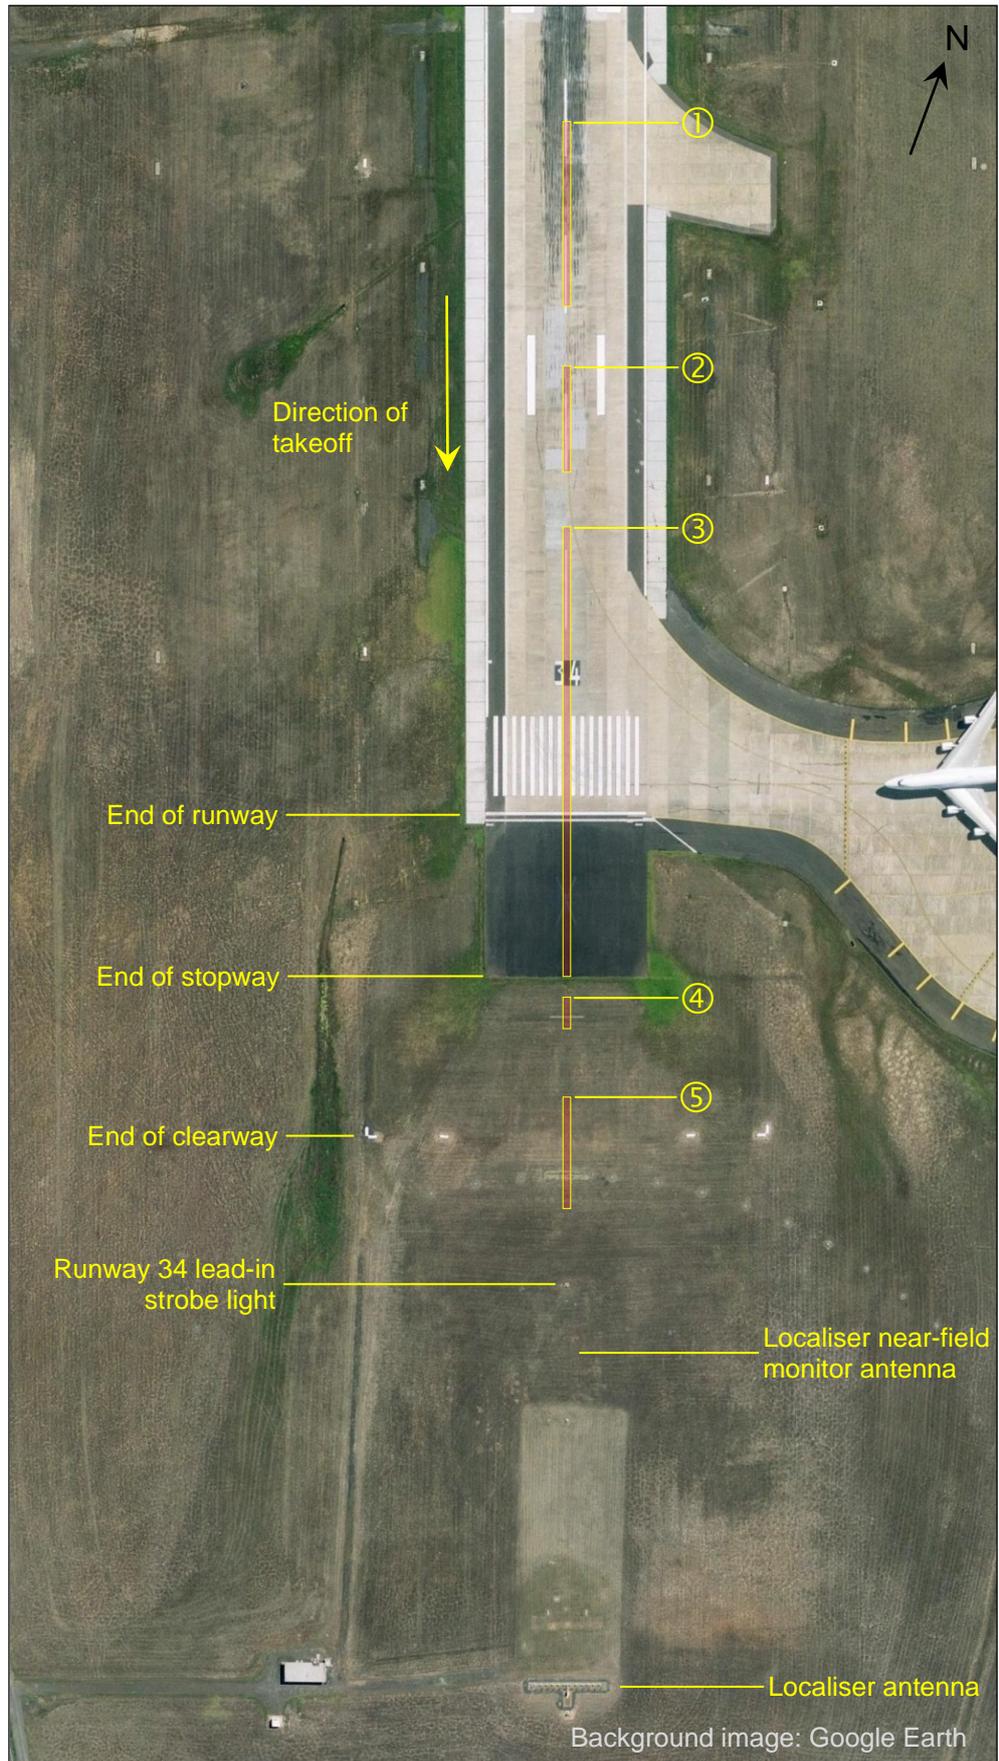
Figure 9: Ground contact marks

An inspection of the runway, stopway, clearway, and overrun areas identified multiple contact marks, consistent with the tailstrike and overrun (Figure 9). The aircraft's tail contacted the runway at three locations, starting at 265 m, 173 m, and 110 m from the end of the runway, respectively (indicated by ①, ②, and ③ in

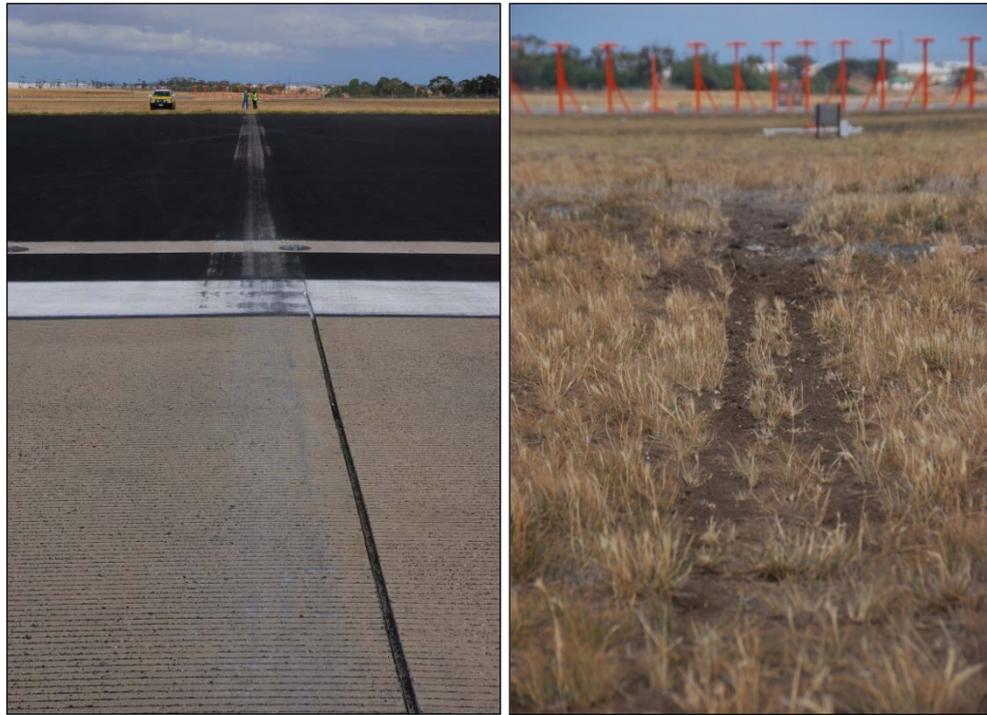
**Figure 10: Typical contact marks on runway, stopway and grassed areas**

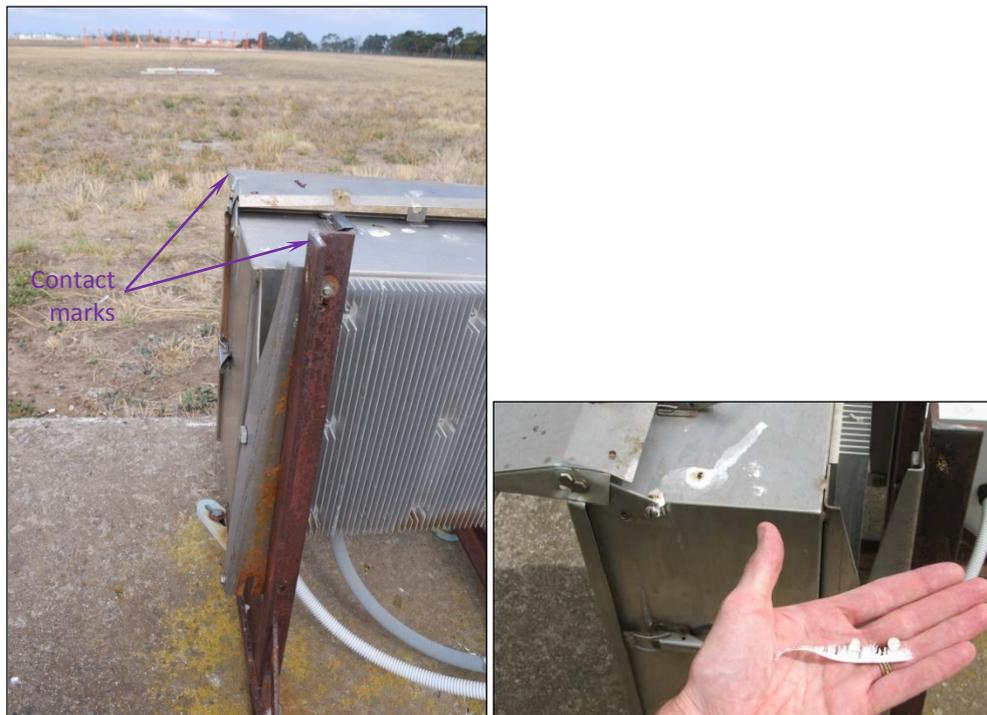
**Figure 11: Lead-in strobe light**

To the south of the last ground contact mark, the fuselage contacted the runway 34 lead-in strobe light that was closest to the runway 16 end (Figure 11). That contact was slight and resulted in scrape marks on the support post and slight deformation of the lens shield. A small strip of white paint was located adjacent to the strobe light (Figure 11).

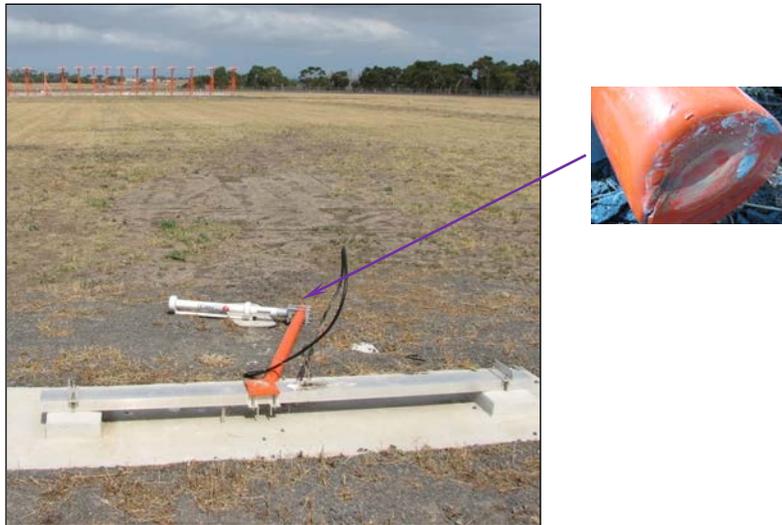
**Figure 12: Localiser near-field monitor antenna**

The aircraft struck the runway 16 localiser near-field monitor antenna and the main localiser antenna array. The localiser near-field monitor antenna support post was fractured at the base and fell in the approximate direction of takeoff (Figure 12). The antenna was damaged and the top of the support post was indented and exhibited white paint transfer.

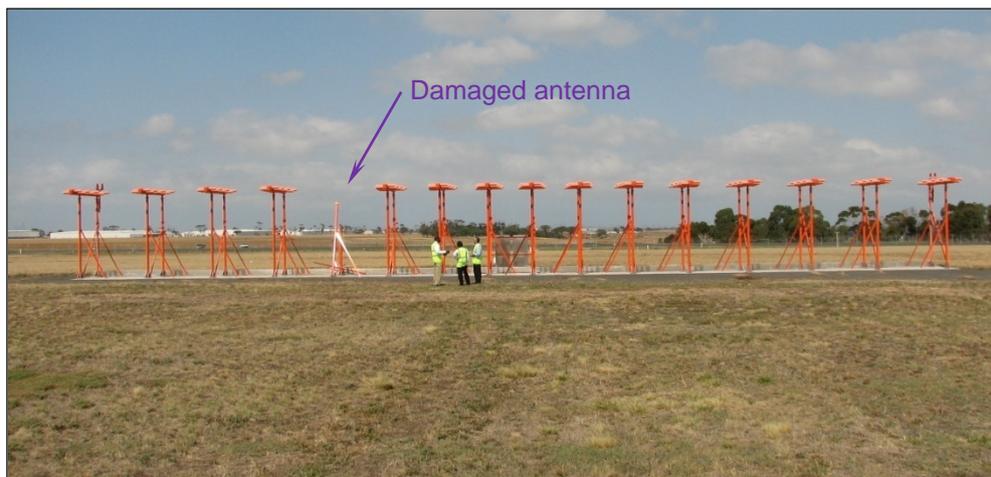
**Figure 13: Localiser antenna array**

Damage to the localiser antenna array was limited to one of the 16 antennae (Figure 13). The forward (runway) end of the damaged antenna was deformed and the composite cover was severely disrupted. The top of the forward end of the antenna had a black, rubber-like marking and the deformation of the antenna was consistent with an impact (Figure 14).

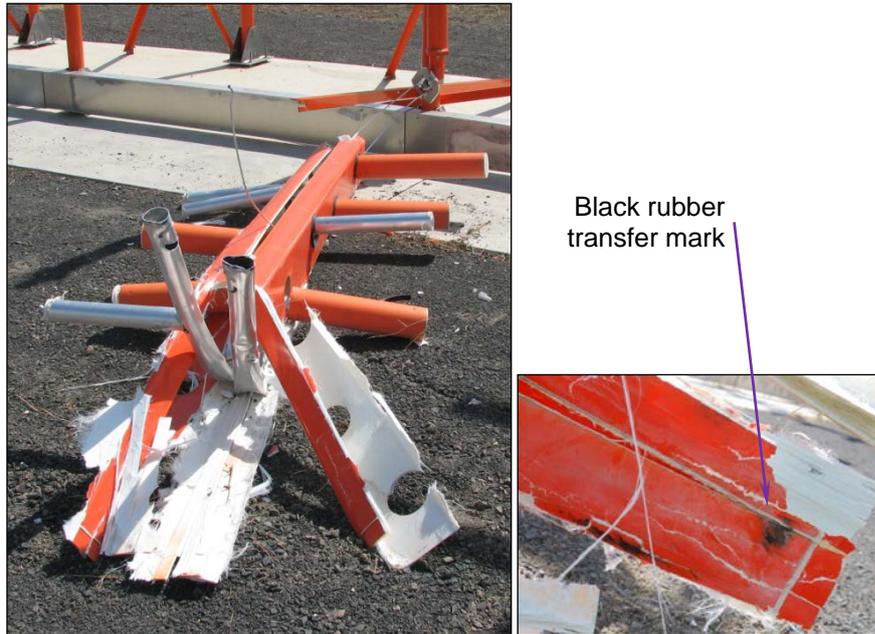
**Figure 14: Damaged localiser antennae**

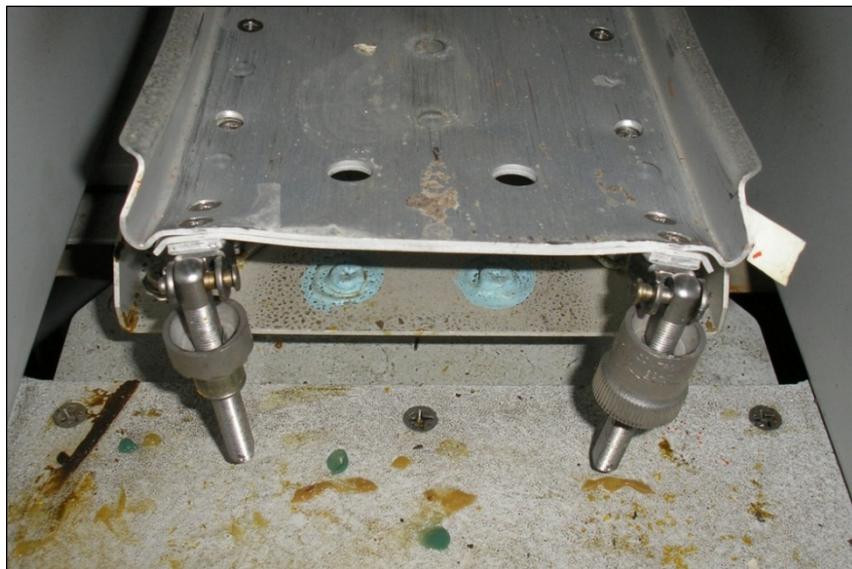
**Figure A3: On-site photograph showing the original position of the threaded fasteners following the occurrence**

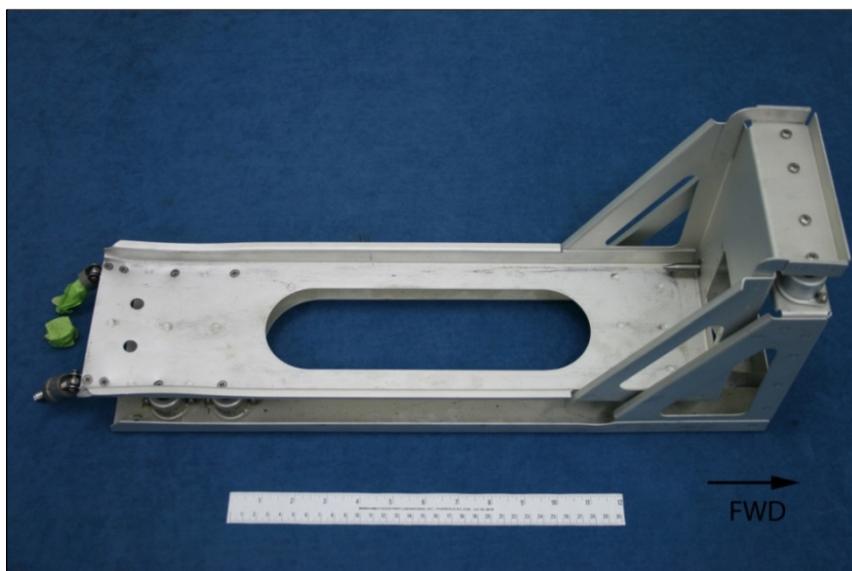
**Figure A4: FDR rack as received**

Examination of the FDR rack revealed moderate plastic deformation towards the front end of the rack, that is the end facing the rear of the aircraft (Figure A4).

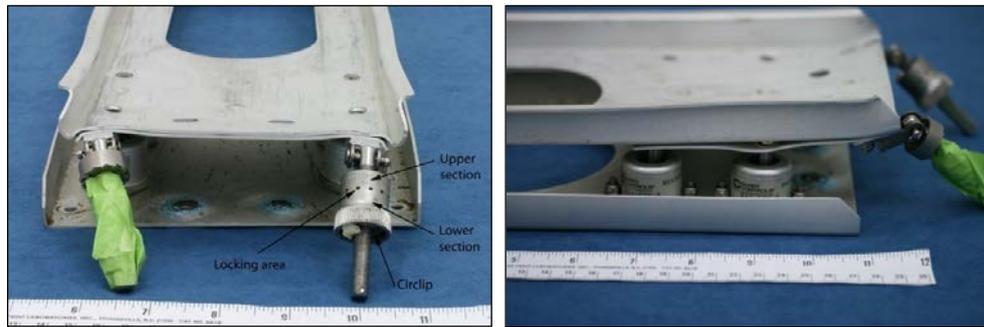
The upper shelf of the rack had deformed upwards, and some distortion across the width of the rack was also observed (Figure A5). The heads of the screws holding the upper tray in position had been pulled through their recesses.

**Figure A5: Magnified views of the damaged end of the FDR rack**

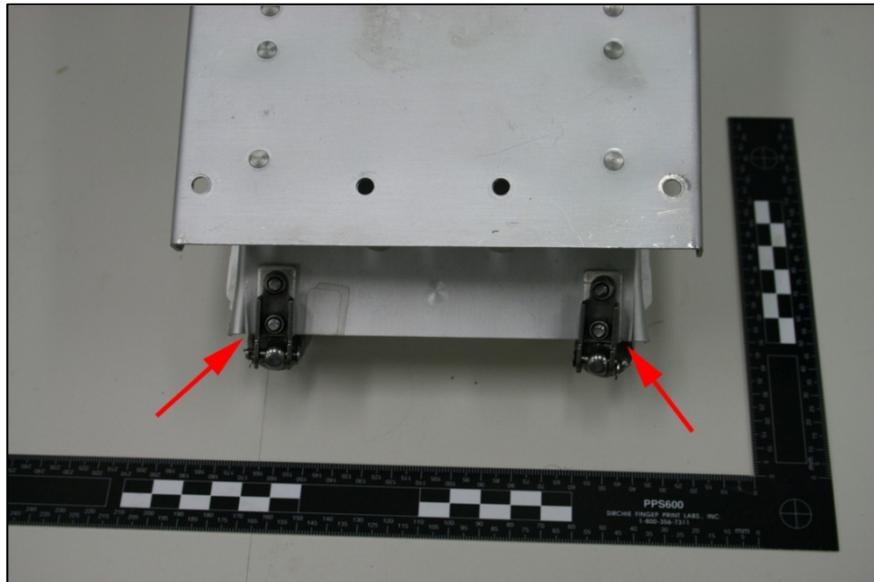
Plastic deformation was also observed on the underside of the upper tray in the areas adjacent to the fasteners (Figure A6). Note the plastic deformation appeared to have affected the upper tray of the rack only, displacing it upwards and outwards. No contact marks were evident on the underside of the rack or fasteners.

**Figure A6: Underside of rack showing deformation in the region adjacent to the fasteners**
