**ATSB TRANSPORT SAFETY REPORT**  
Aviation Occurrence Investigation  
AO-2010-081  
Final

**Stickshaker activation**  
**Kalgoorlie Airport, Western Australia**  
**13 October 2010**  
**VH-NXD, Boeing 717-200**

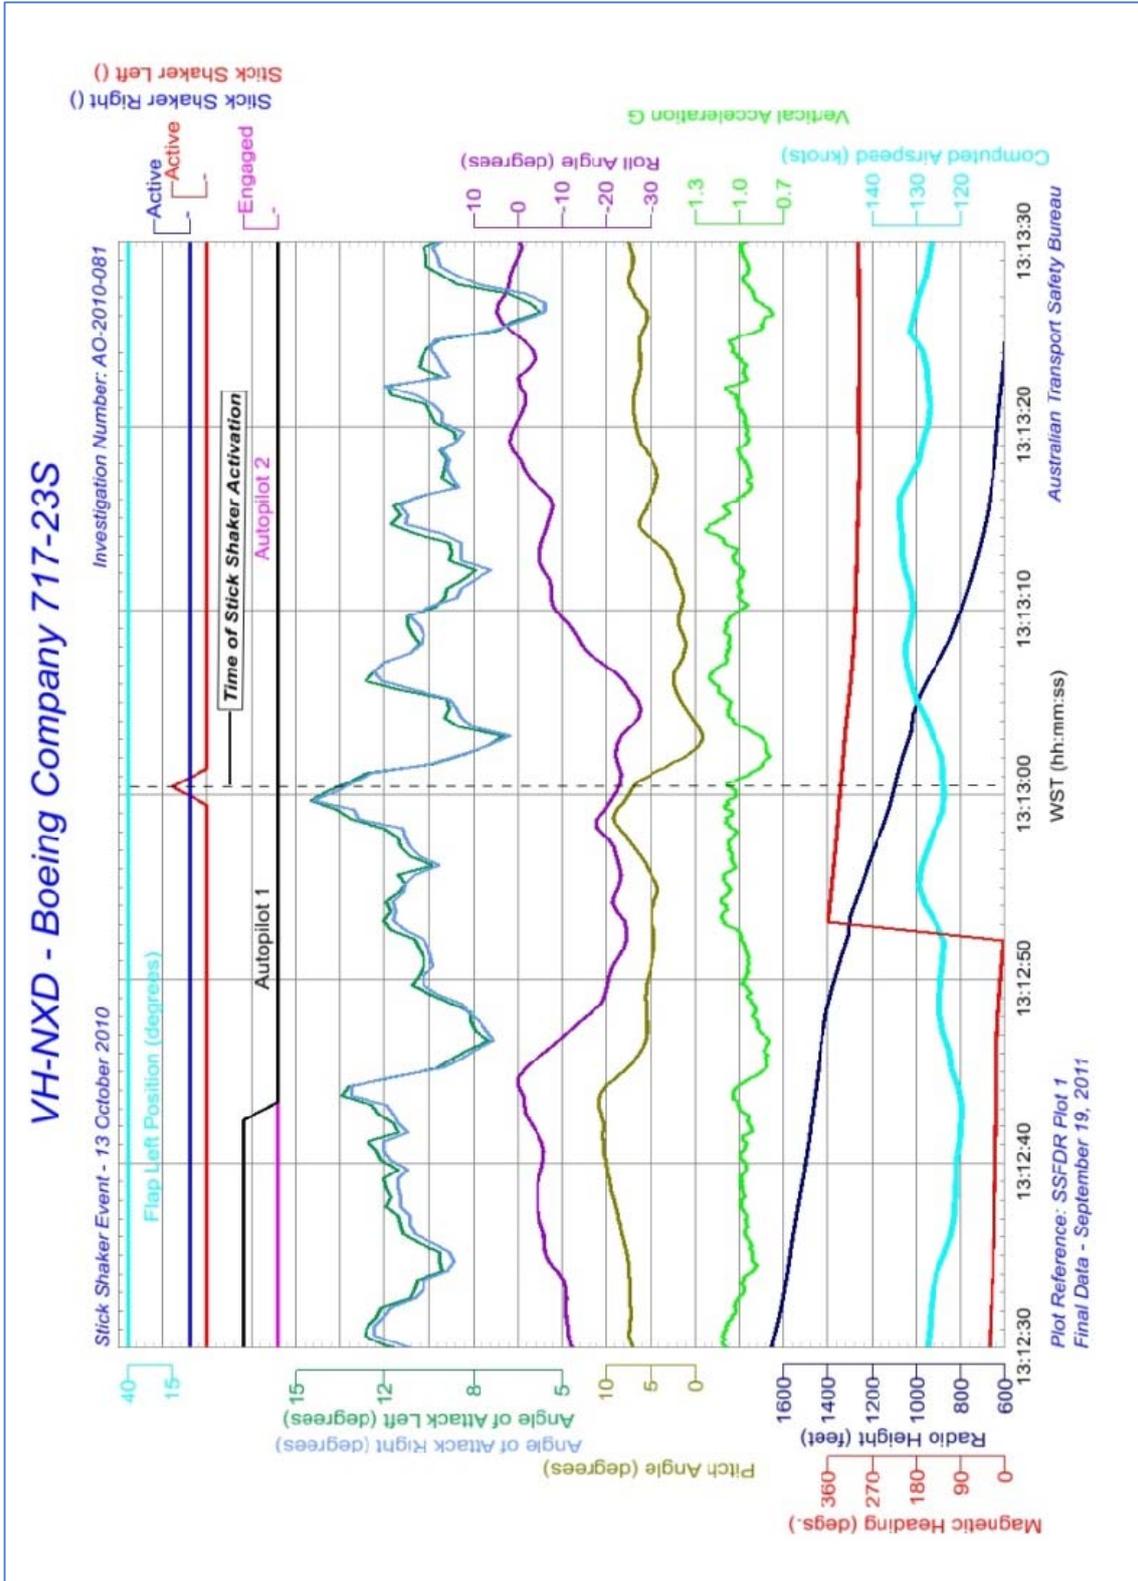
# APPENDIX A: DATA PLOT - 1<sup>st</sup> STICKSHAKER EVENT

During the turn onto final approach, the aircraft's stickshaker<sup>7</sup> activated momentarily. The copilot responded by reducing the aircraft's pitch attitude while continuing the turn and the approach. The copilot reported that he had considered conducting an immediate go-around but continued the approach on advice from the PIC. About a minute later, the flight crew conducted a go-around as the approach no longer met the stabilised approach criteria.

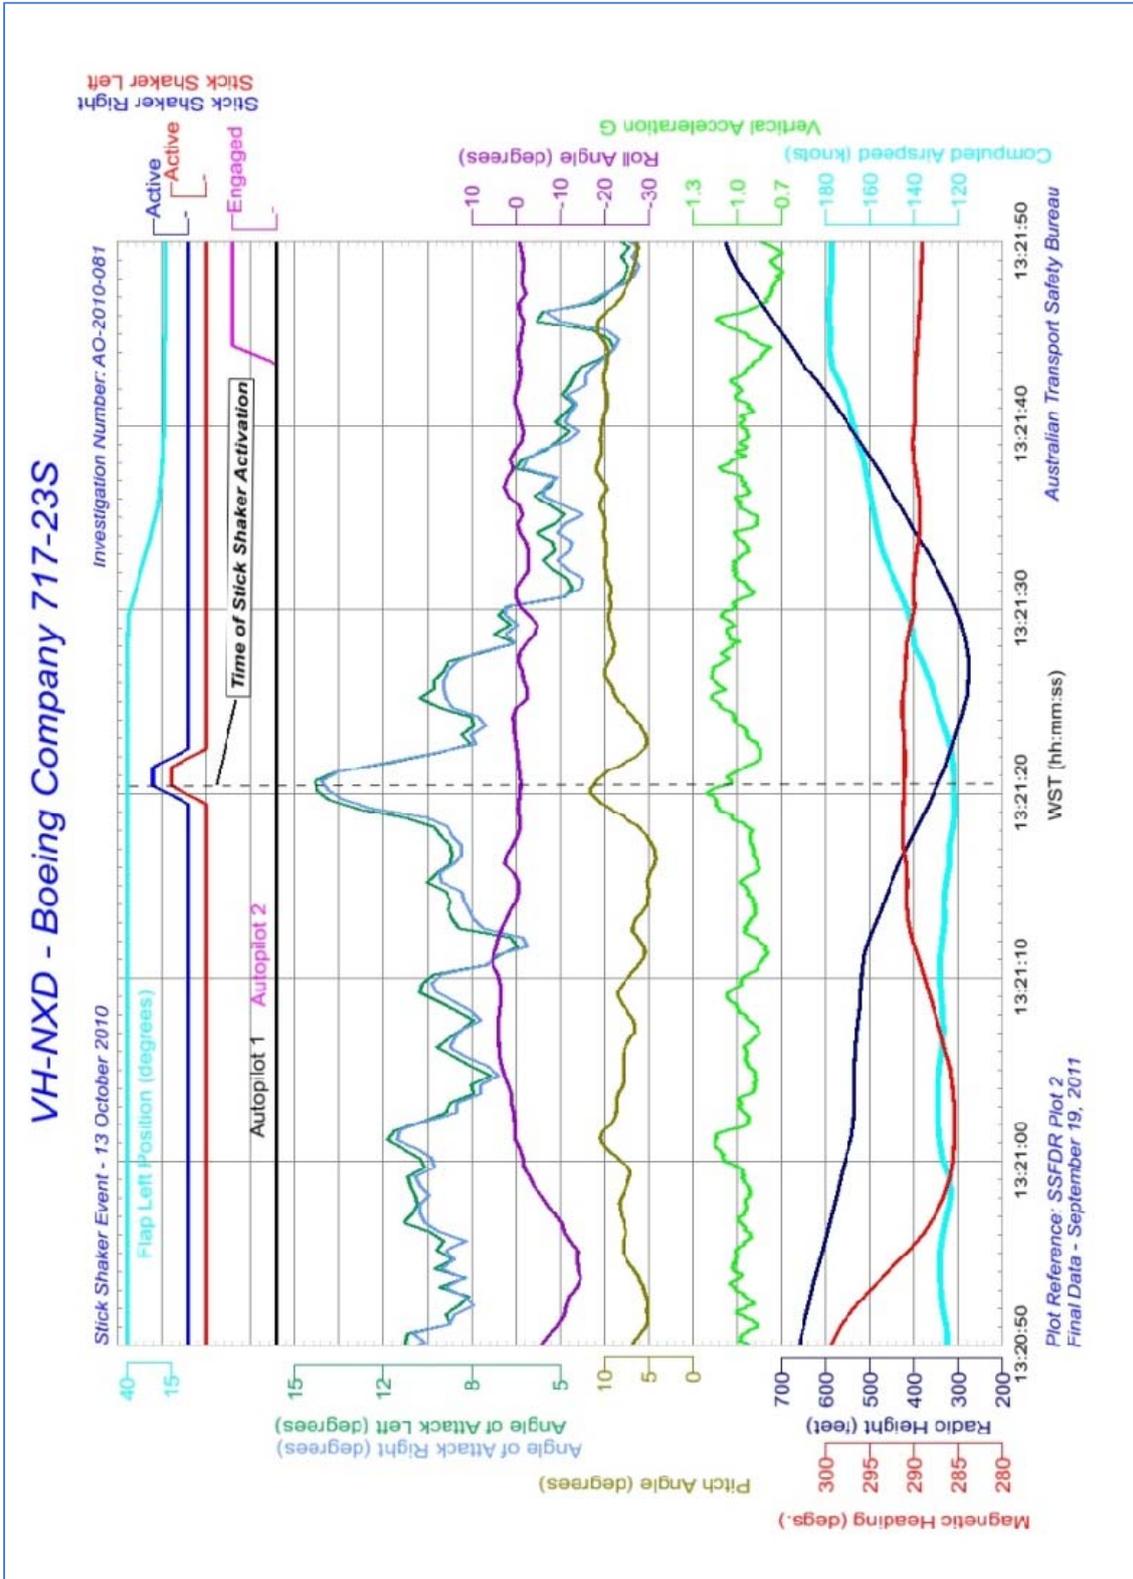
# APPENDIX B: DATA PLOT - 2<sup>nd</sup> STICKSHAKER EVENT

At about 1321 and after establishing the aircraft on final approach, the copilot noted that the aircraft was below the required approach path. As the copilot increased the aircraft's pitch attitude, the stickshaker activated for about 2 seconds. Following the necessary recovery actions, the approach was no longer stabilised and a go-around was conducted.
