## **AVIATION INVESTIGATION REPORT A11Q0028**

### **RISK OF COLLISION**

**AIR INUIT LTD.  
BETWEEN DHC-8-314 C-GUAI  
AND DHC-8-102 C-FCJD  
PUVIRNITUQ, QUEBEC, 117 NM SOUTH  
07 FEBRUARY 2011**

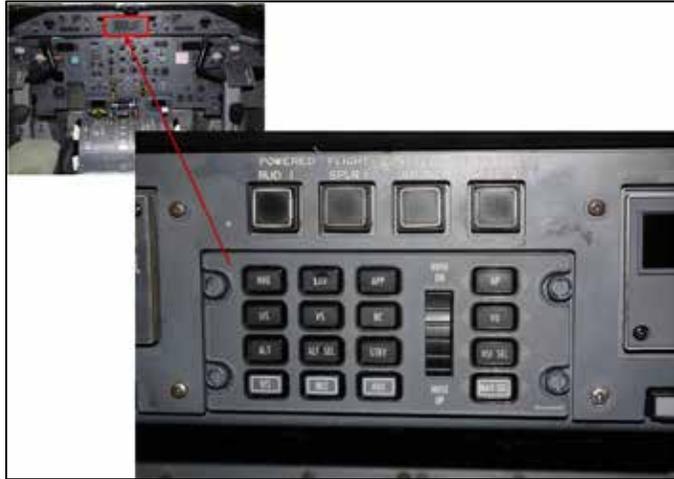
**Photo 1.** Flight guidance mode selector

In this occurrence, the aircraft used for flight AIE304 was oscillating in pitch when the autopilot was engaged in altitude-hold mode. For this reason, the crew chose to use VS mode to halt the oscillation, by displaying “0” as the vertical speed. The use of VS mode, in such a case, was customary and also used by other pilots in the company. Nothing prohibited it. Furthermore, the minimum equipment list (MEL) allows flight, with certain restrictions, despite an autopilot defect. Among other things, the MEL indicates that any mode that functions can be used. According to the Pilot’s Manual,<sup>8</sup> vertical plane oscillation is a typical issue that can arise in various modes of use.<sup>9</sup>

Pitch oscillations when the autopilot was engaged had been observed in the past, not only by this crew or on this particular aircraft, but on other DHC-8s of the company. Nothing indicates that this situation had been formally pointed out to the company’s maintenance personnel, such as by means of an entry in the aircraft logbook.

In this occurrence, the cause(s) of the pitch oscillations could not be determined. In the autopilot manufacturer’s experience, there are 2 likely causes for the problem: poor tension of the flight control cables or a malfunction of the air data computer.

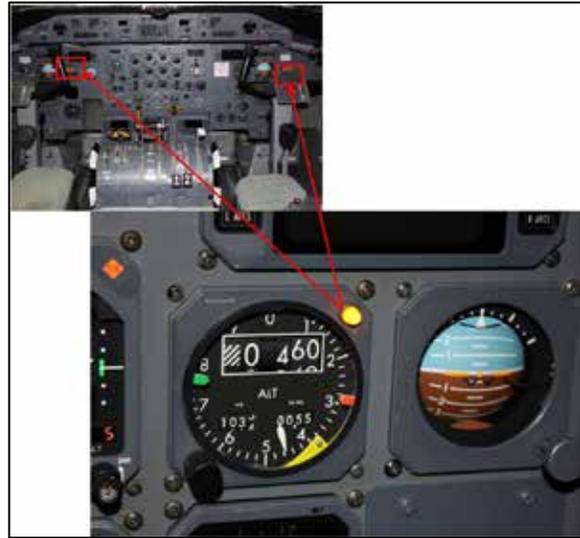
Photo 2. Altitude warning light

The altitude alerting system controller, located to the left of the engine instrument panel, consists of a set knob and a 5-figure digital display. As soon as the aircraft deviates more than 250 feet from the altitude selected, the altitude warning light located on each of the pressure altimeters lights up as a visual alarm<sup>10</sup> (Photo 2). It does not flash.

In this occurrence, the light would have illuminated when AIE304 descended below 22 750 feet, and would have remained lit until the aircraft returned to the altitude selected. The PF, alone in the cockpit at that time, did not observe the warning light. Following the occurrence, no anomaly in the warning light was reported by the flight crew in question, or by subsequent flight crews. All indications are that it operated correctly.

Although the aircraft was equipped with an altitude warning light, this light attracts less attention than it might because it does not flash. In addition, under daylight conditions, the contrast between the light when extinguished and lit is reduced. Although it is possible that the sunny day may have reduced the light's visibility, special attention to the altimeter should have made it possible to detect the loss of altitude and the illumination of the indicator light. The captain did not see that once he had deviated more than 250 feet from the altitude displayed, the altitude warning light was lit for approximately 9 minutes. The installation of an audible alarm, such as that found on the other DHC-8 belonging to the company, would have provided an additional defence against unexpected loss of altitude.

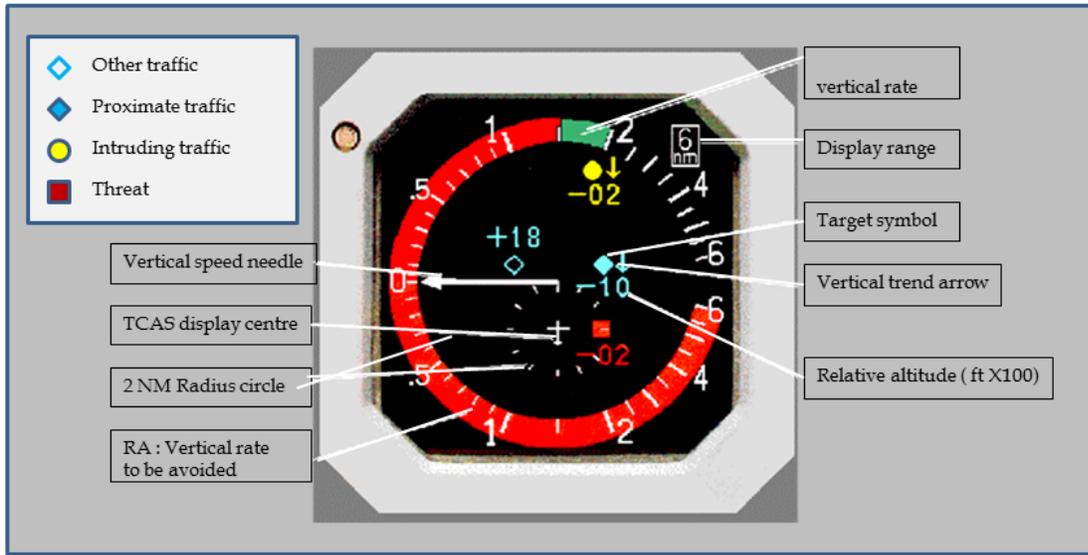
# Appendix C—Example of RA Display

The TCAS display superimposes several symbols as representations, the interpretation of which can be ambiguous if training is absent, poorly adapted or incomplete. Following the RA, the PF of AIE880 had the reflex to turn left following a misinterpretation of the RA display. It is possible that the appearance of the target in the upper right-hand corner of the display may have caused the PF to turn left. In the case of the PF of AIE304, the right turn remains unexplained considering that the intruder was to his right. It is unlikely that the PF of AIE304 had, using the TCAS display, visually identified the other aircraft considering that he initiated a right turn when the aircraft was on his right on a converging trajectory.
