Final report RL 2012: 03e

**Serious incident on 21 January 2011
with aircraft SE-LLO
and EW-303PJ at Stockholm/Arlanda airport.**

Case no: L-05/11
2012-03-08

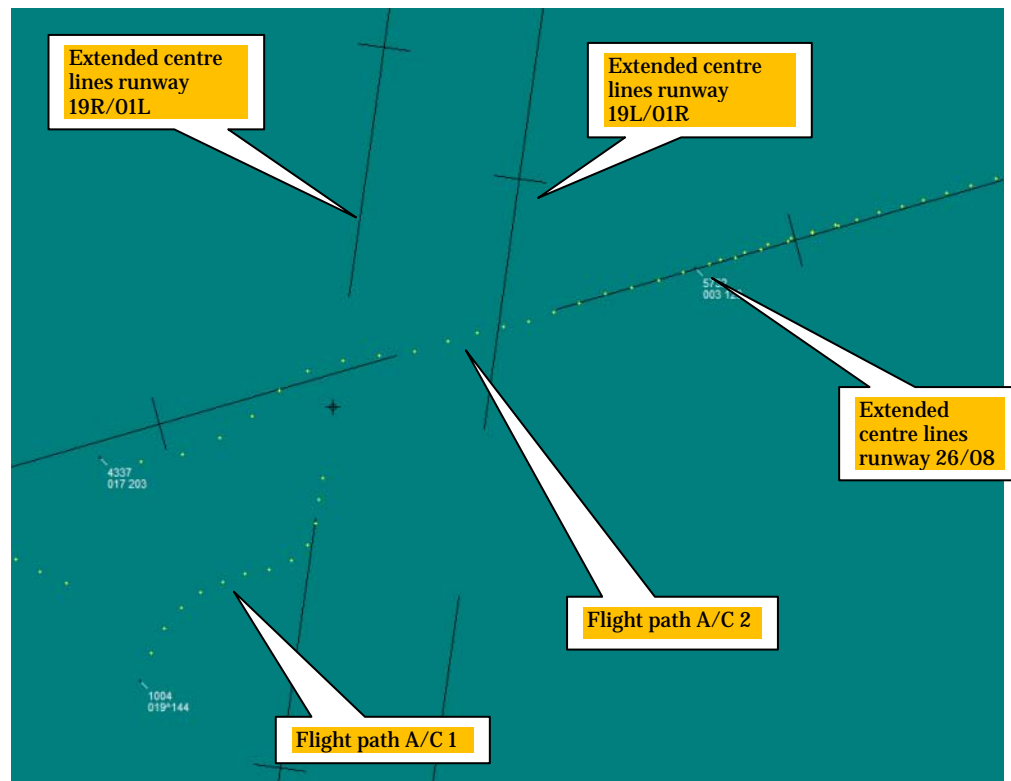
Figure. 3. Radar image of the sequence of events. Source: LFV.

The image in fig 3 above is an excerpt from radar images that graphically display the sequence of events. The solid lines represent the different runway directions (approach lines) for the three runways at Arlanda. The breaks in the lines show the location of the runways.

The yellow dotted lines show the flight paths of the two aircraft. With regard to A/C 1, it can be seen that after take-off from runway 19R the aircraft started turning towards heading 270° , but had to cancel the turn when the controller instructed the crew to turn left instead on a southerly heading (200°) in order to avoid the impending conflict.

The flight path of A/C 2 can be followed from the right edge of the image along the approach path to runway 26. When A/C 2 made a go around, it can be seen that after a slight change of heading to the right, the aircraft turned left on a heading measured at 227° . During the stage that followed, the TWR-E controller instructed the aircraft three times to turn right to 300° , while at the same time the TWR-W controller cleared A/C 1 away from the conflict.

Despite the evasive actions, there was a separation infringement between the aircraft. The minimum separation permitted between aircraft in this situation is 3 Nm. The minimum horizontal distance when the aircraft were at the same altitude (1600 ft) was 1.38 Nm, or just over 2500 metres, in this case. Both aircraft were in clouds and never had visual contact with each other. The incident also triggered an STCA⁵ Alarm with the radar controller who was monitoring the traffic in the actual sector (DIR-E).

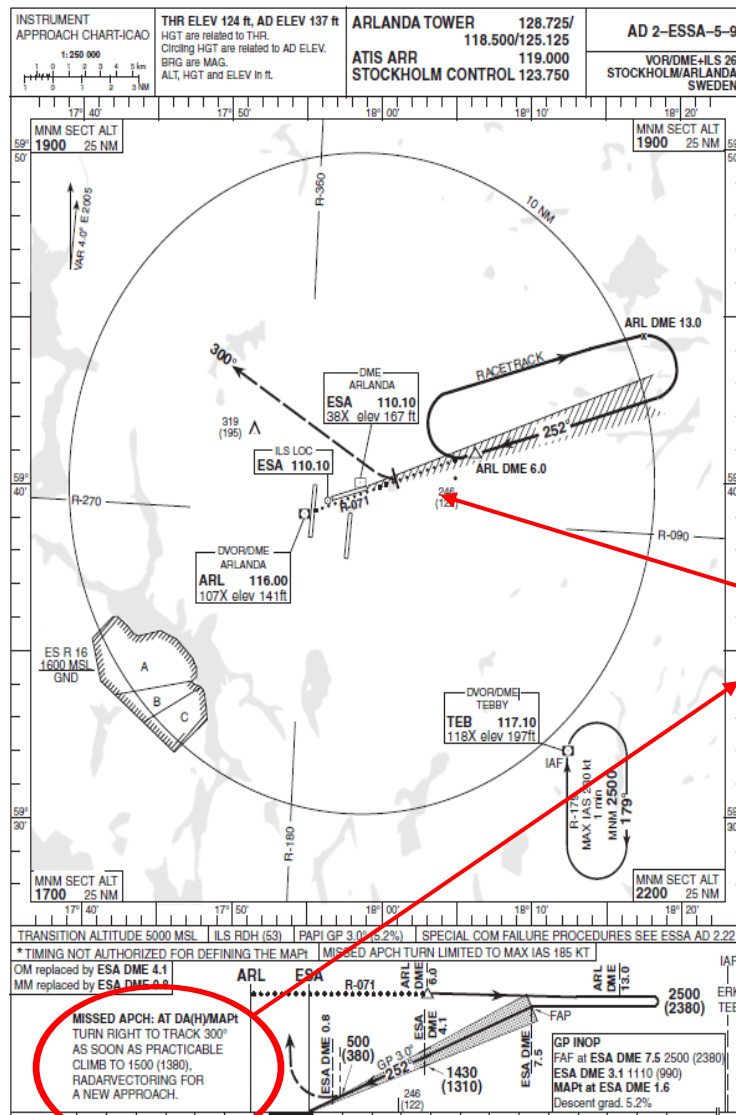
Figure. 5. Approach chart for runway 26 at Arlanda.

MISSED APCH: AT DA(H)/MAPt
 TURN RIGHT TO TRACK 300°
 AS SOON AS PRACTICABLE
 CLIMB TO 1500 (1380)
 RADARVECTORING FOR
 A NEW APPROACH

The image shown in fig 5 above is an extract from AIP showing the instrument approach procedure for runway 26 at Arlanda. The chart also contains information about the procedure for missed approach (go around – GA). The information on this procedure is both drawn and described in text as follows:

The chart instructions above describes the procedure to be followed by an aircraft making a go around at decision altitude DA. There is no alternative procedure described on the approach chart for go around at later stages of an approach/landing.
