**AIRCRAFT ACCIDENT INVESTIGATION COMMITTEE  
MINISTRY OF TRANSPORT, THAILAND**

**AIRCRAFT ACCIDENT FINAL REPORT**

**ONE TWO GO AIRLINES COMPANY LIMITED  
MCDONNELL DOUGLAS DC-9-82 (MD-82)  
HS-OMG**

**16 SEPTEMBER 2007**

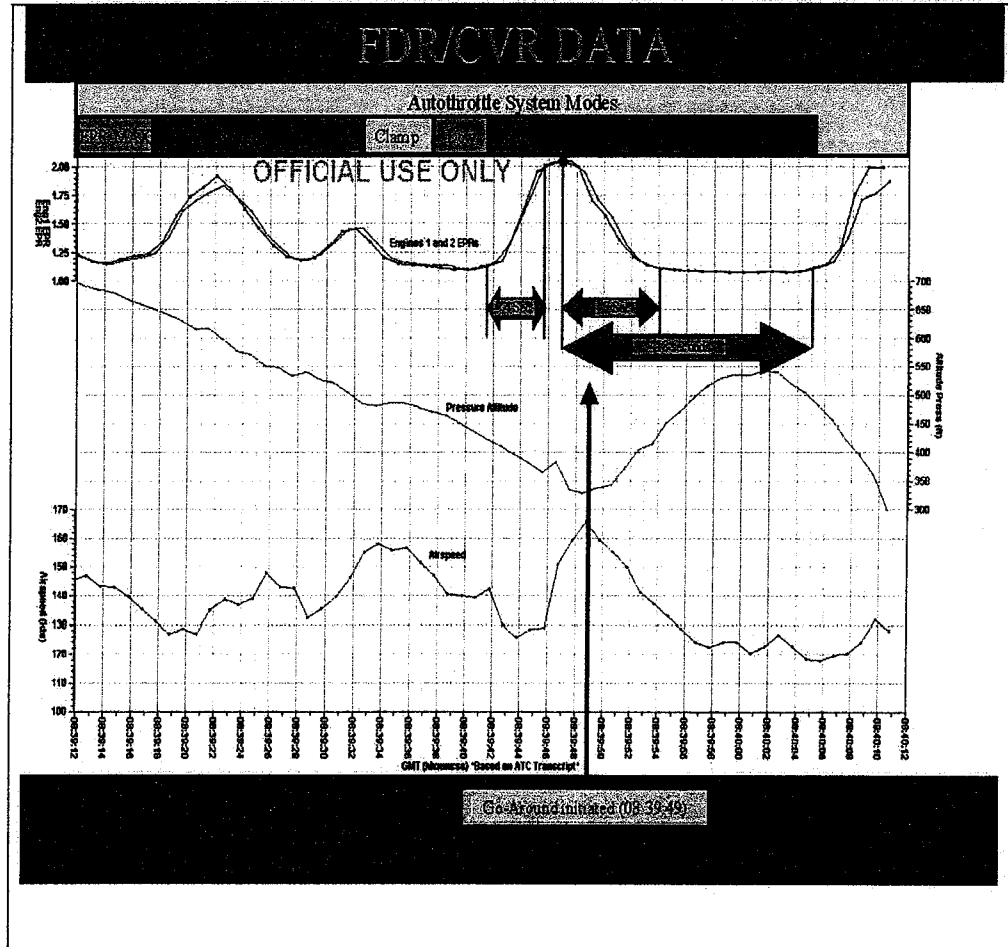
Figure 1 Autothrottle System Modes

At about 08:39:47, with the aircraft in the SPD mode, at about 50 feet (RA), airplane HS-OMG experienced an automatic reduction of all engine thrust from about 2.0 EPR to about 1.1 EPR because the retard (RETD) mode function of the autothrottle system automatically activated. Both engine's EPR remained at about 1.1 for approximately 13 seconds allowing the airspeed to drop below 120 kts. According to Boeing, the RETD mode is automatically activated as a function of radio altitude and landing flap configuration when the autothrottle is not in the EPR G/A mode. With the approach slat/flap logic applied to the autothrottle system, the flaps positioned to at least 20 degrees and the radio altitude less than or equal to 50 feet, the retard mode of operation is automatically established. The FDR data indicates the RETD mode activated when the flaps were positioned at 40 degrees and the aircraft descended below the 50-foot autothrottle retard altitude. Once activated, the FMA displays "RETD" and both throttles are driven to the aft stop at a rate dependant on the radio altitude. The autothrottle retard mode is independent of the autopilot or flight director-operating mode.

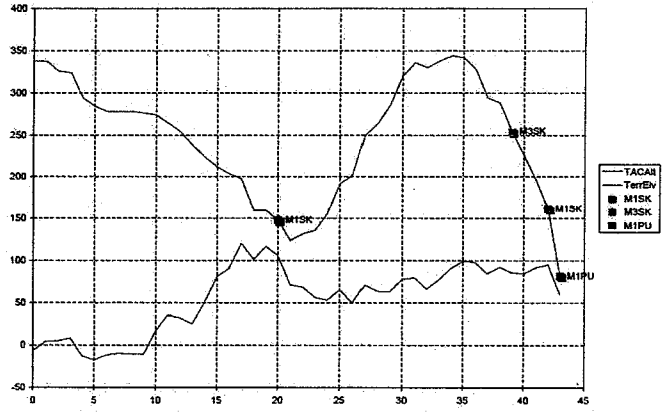
Figure 2 EGPWS Alerts

<sup>11</sup> As mentioned previously, an accurate conversion for radio altitude data recorded on the FDR could not be determined. The FDR radio altitude presented in Figure 3 is based on one of the conversions that was evaluated and is included to show the trend of the data compared to the radio altitude recorded on the EGPWS.

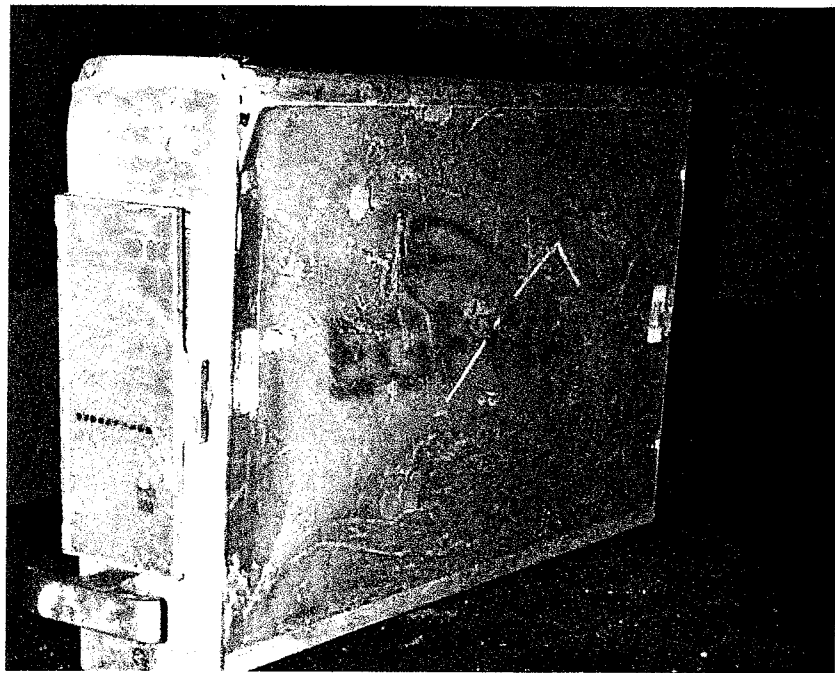
PHOTO 2

Unit removed from aircraft rack

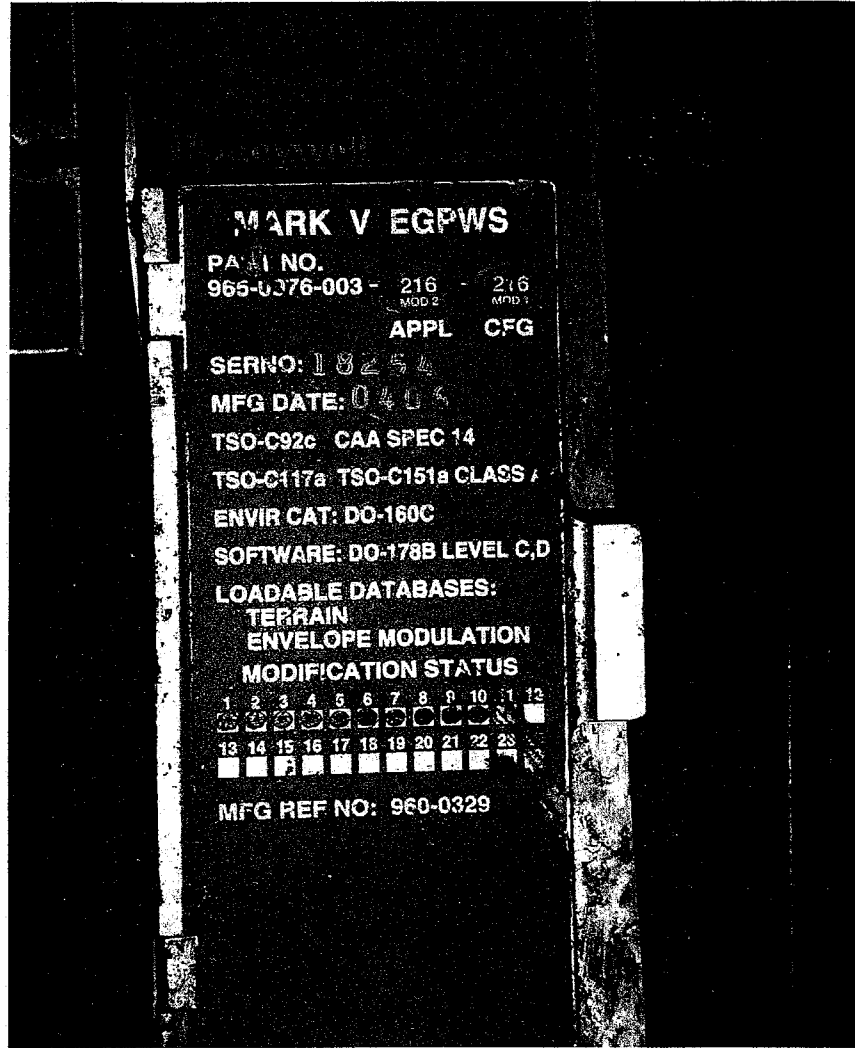
PHOTO 3

Unit Data Plate

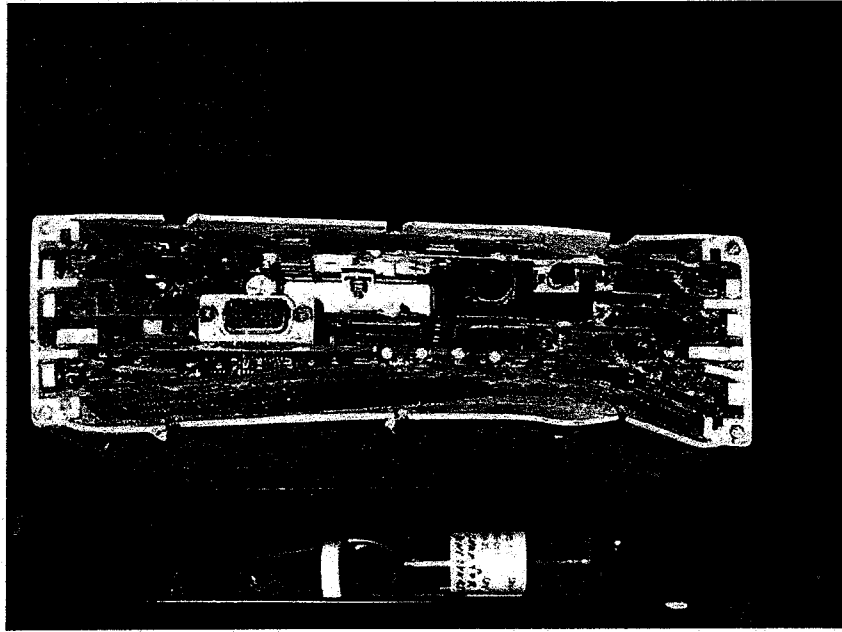
PHOTO 4

Unit with front end cap removed

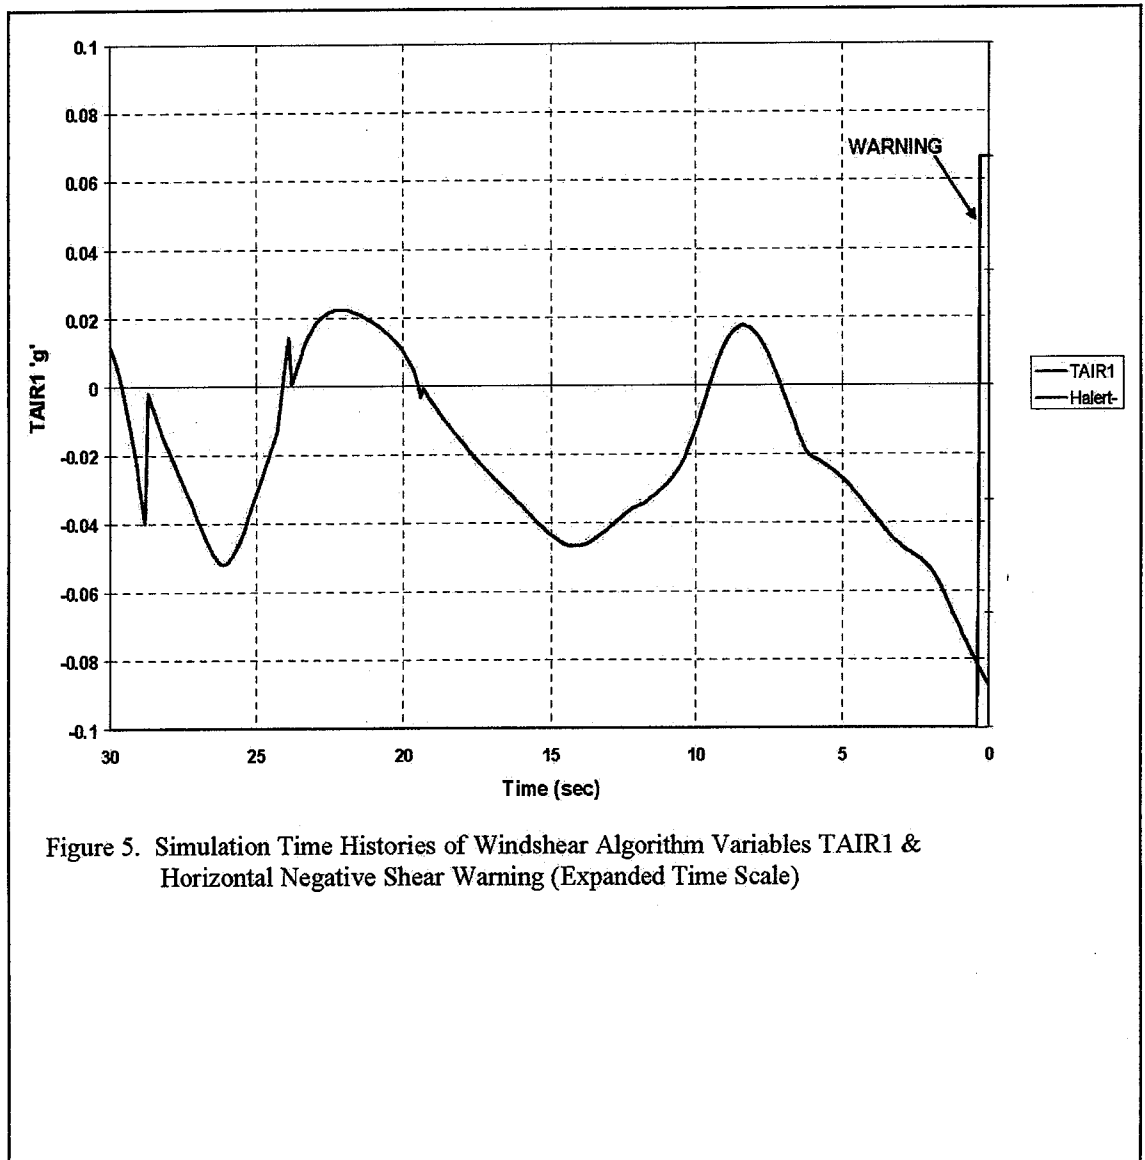
Figure 5. Simulation Time Histories of Windshear Algorithm Variables TAIR1 & Horizontal Negative Shear Warning (Expanded Time Scale)

The variables within the legacy Honeywell algorithm which are most responsive to horizontal shear are the variables TAIR1, TWIND1 and the 'wind vector rotation' variable TVIV. Plots of these variables against time from the simulation are shown in Figure 4. It is the variable TAIR1 which finally exceeds the threshold and causes an alert, as shown in Figure 5.

From the simulation data and accident data, the preliminary conclusion is that the legacy windshear detection system performed its function as intended, and that the performance was compatible with the requirements of FAA TSO-C117.
