Transport  
Canada

TP14175E  
(10/2003)

# HUMAN PERFORMANCE FACTORS FOR ELEMENTARY WORK AND SERVICING

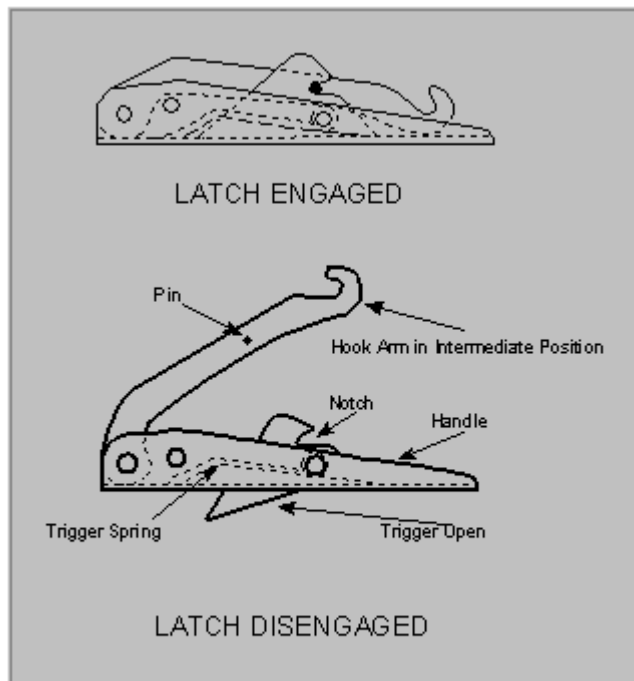
**Figure 1 Engine Cowl Latch Assembly (P/N) H296K854)**

The intact condition of the latch assemblies indicated they were unlatched at the time the cowling separated from the aircraft. The forward latch was twisted slightly; however, it operated smoothly. The rear latch was difficult to operate due to misalignment. Wear patterns indicated this condition had existed for some time; however, there were no reports that the rear latch had been difficult to operate before the occurrence.

The left cowling forward latch trigger reportedly protruded into the airstream during flight, and the latch had disengaged on at least one previous flight. Maintenance personnel had visually examined and function-checked the forward latch approximately five weeks before the accident, following the report of the in-flight opening. The latch closed securely, there was no evidence of wear, and no maintenance was accomplished.

increased the likelihood of the rear latch being improperly secured when the cowling was closed. Testing demonstrated that differential air pressure could disengage the trigger on the forward latch because of the weak trigger spring. If the front latch disengaged in flight, as had occurred on at least one previous occasion, the front of the cowling may have lifted as the airspeed increased during the descent. The rear latch could have subsequently disengaged because of the effect of ram airflow in the accessory compartment or because it was not secured properly to begin with.

6. Wear patterns indicated the rear latch may have been misaligned for some time, which would have made it more difficult to operate.
7. The left elevator tip failed as the result of a severe up/down bending vibration that was induced by buffeting from the displaced cowling.

It is probable that the left cowling opened in flight because of the combination of weak latch trigger springs and pre-existing damage on the rear latch. The left elevator failed because of buffeting induced by the displaced cowling.
