FINAL
KNKT.08.10.20.04

**NATIONAL
TRANSPORTATION
SAFETY
COMMITTEE**

Aircraft Serious Incident Investigation Report

**PT. Garuda Indonesia
PK-GWT
Boeing Company 737-4K5
Sultan Mahmud Badaruddin II, Palembang,
Republic of Indonesia**

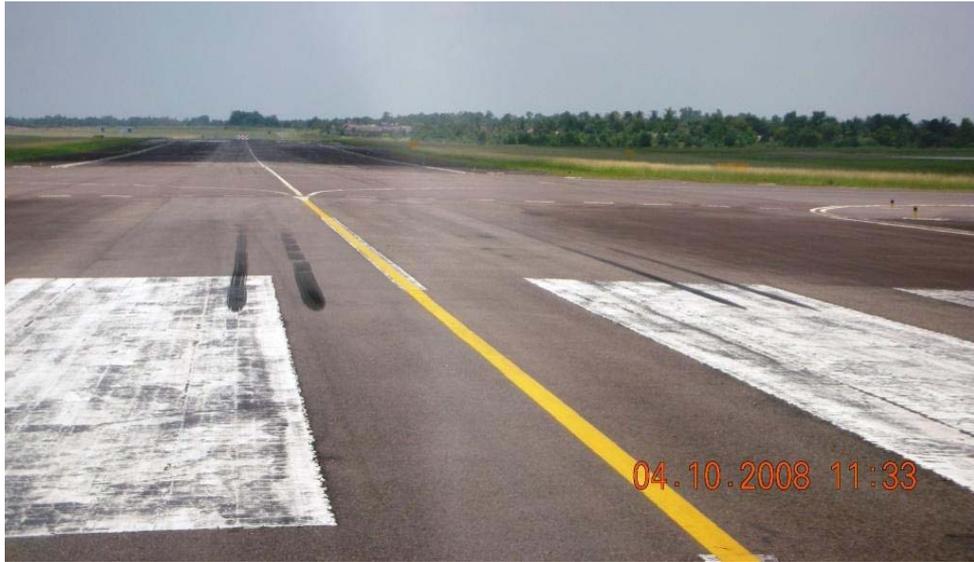
At 00:32 the aircraft landed on the parallel taxiway, touching down 500 meters from the eastern end. Both pilot then realized that they were on the taxiway and also saw the barrier on the taxiway indicated that some part of the taxiway was closed. The PIC immediately applied manual brake and the aircraft stopped at the intersection of taxiway Charlie. The landing roll distance was about 700 meters.

Figure 1: Touch down marks of the main wheel

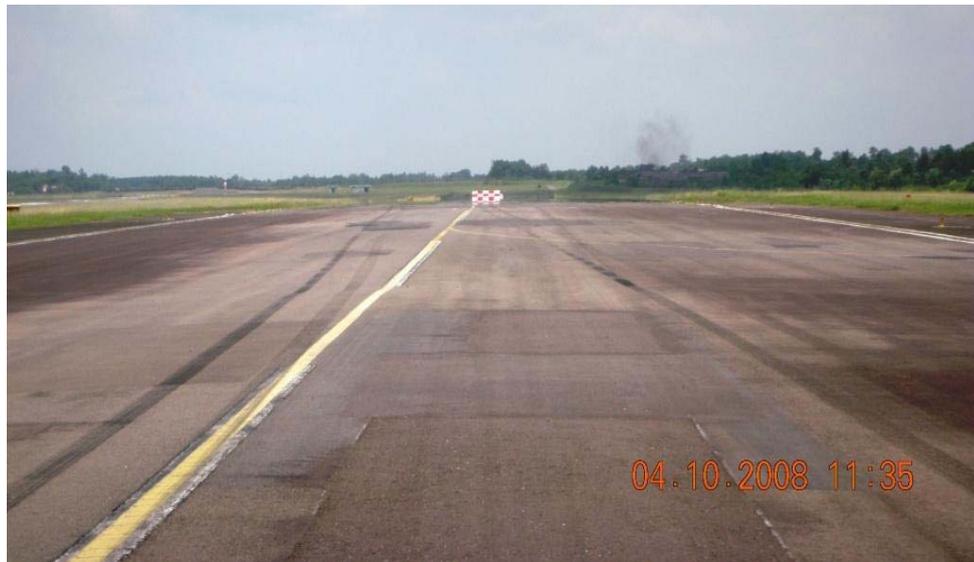
Figure 2: Brake marks of both main wheels and the barrier on intersection Charlie taxiway

The number-2 main-wheel⁴ tyre was damaged. There was no other damage to the aircraft.

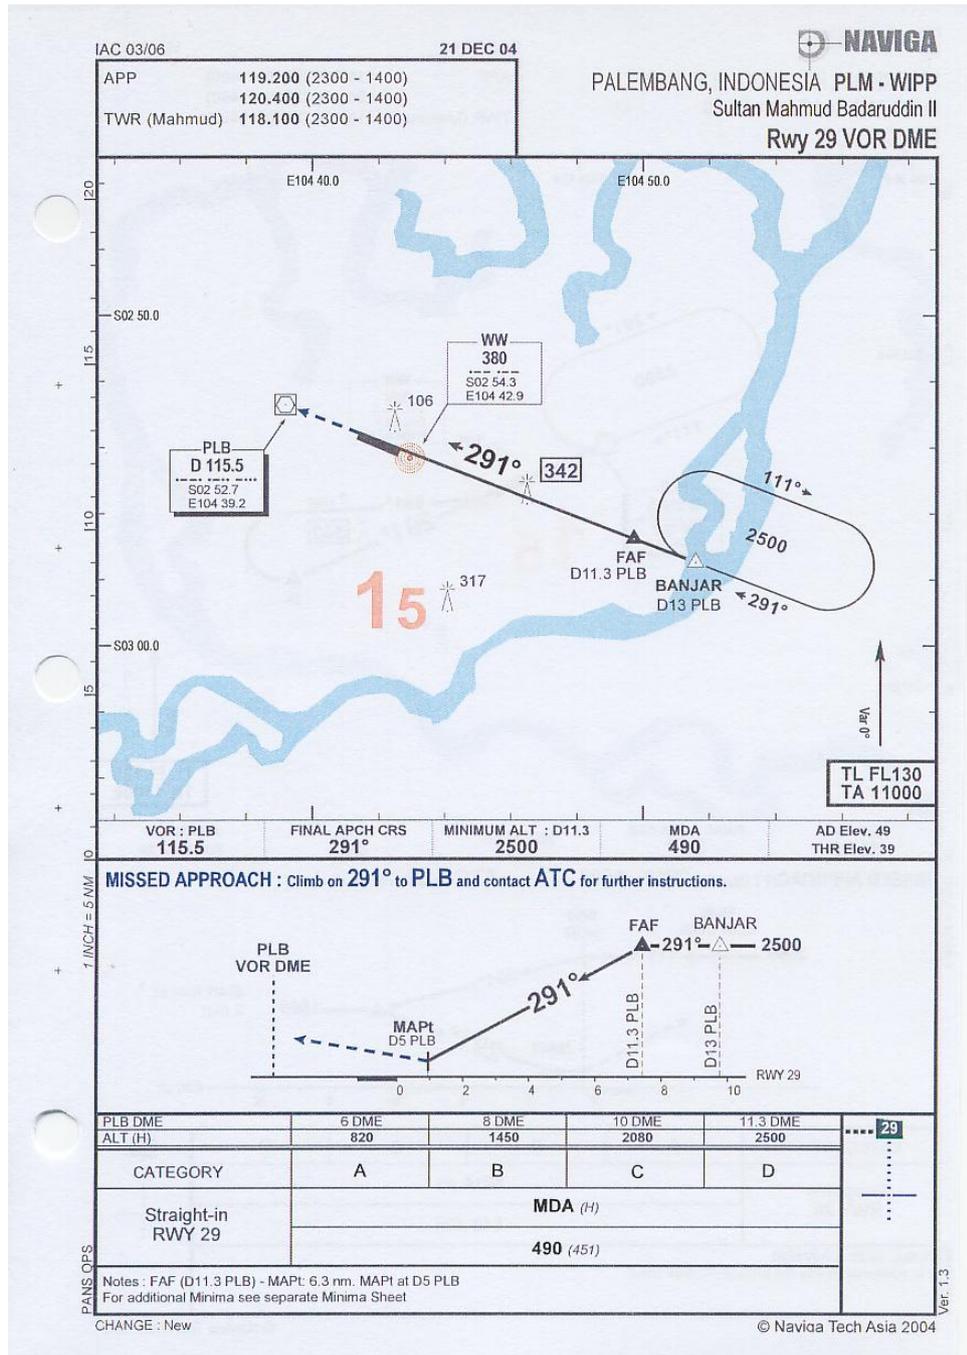
The VOR/DME antenna was located 4 NM from the runway 29 departure threshold. It was last calibrated on 17 July 2008. The VOR/DME approach chart showed the approach track to the runway 29 VOR as 291 degrees.

There had been 10 pilot reports of misalignment of the final track for the runway 29 VOR/DME approach since May 2008.

Figure 3: Palembang runway 29 VOR/DME approach chart

- Review the ATS regulation for the authority of the controller to command an aircraft to abort the landing in the case of unsafe situation arises.
- Review the instrument approach path to align with the runway.

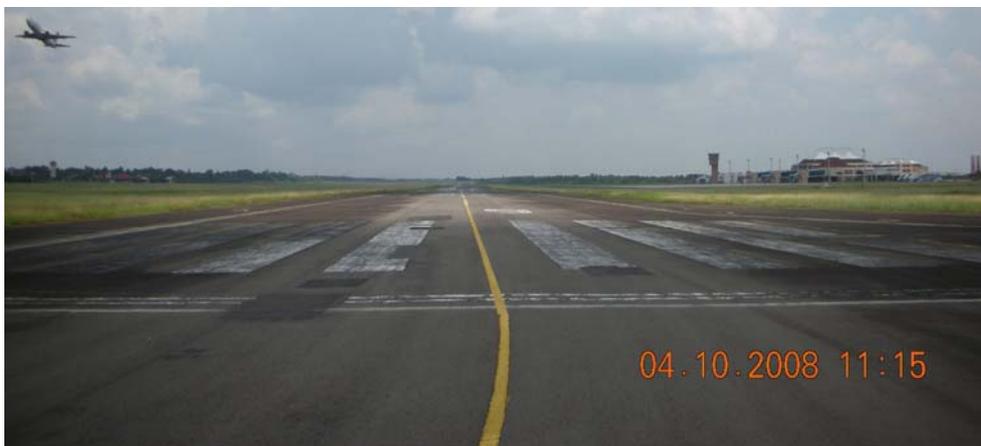
During this development, a temporary runway was built which became the parallel taxiway after the completion of the runway redevelopment work.

Figure 4: Parallel taxiway showing old threshold markings

1. Painting of the runway markings in black.
2. Turn on the runway lights and approach lights during aircraft approaches. This is to continue until the ILS is return to service.
3. Inform pilots of approaching aircraft if there are any track deviations noted on the ATC radar, during the landing approach.
4. Speed up the installation of visual aids on the new section of the runway.
5. Speed up the activation of the ILS for runways 29/11.

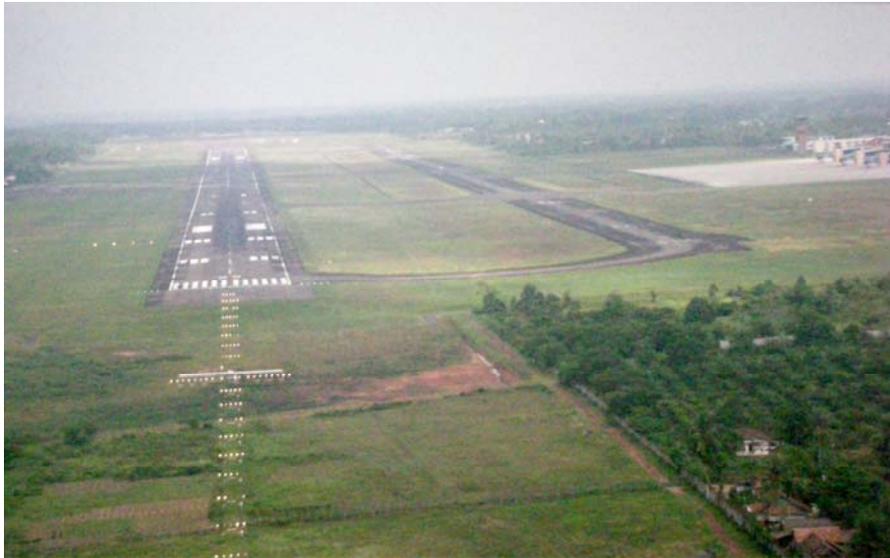
Figure 6: View of final approach runway 29

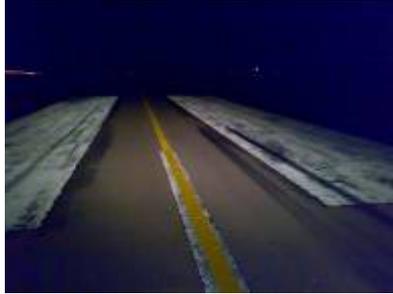
Figure 5-1: Old touch down zone marks on taxiway before cleaning

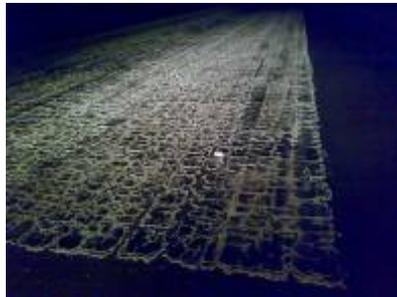
Figure 5-2: Old touch down zone mark on parallel taxiway before cleaning

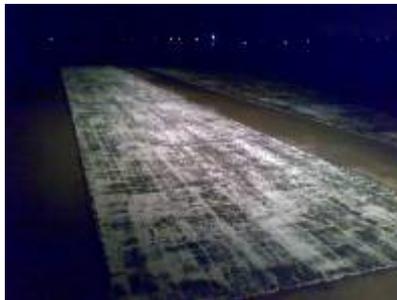
Figure 5-3: Old threshold marks on parallel taxiway before cleaning

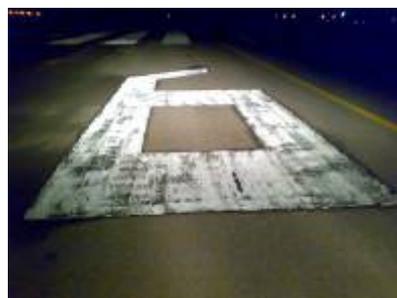
Figure 5-4: Old runway number on parallel taxiway before cleaning

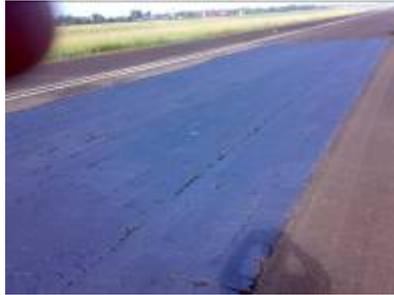
Figure 5-5: Old touch down marks on parallel taxiway after cleaning

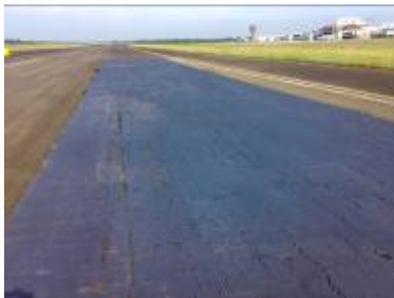
Figure 5-6: Old touch down marks on parallel taxiway after cleaning

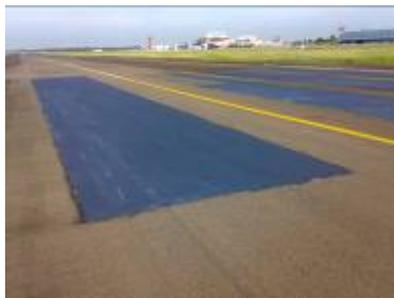
Figure 5-7: Old touch down marks on parallel taxiway after cleaning

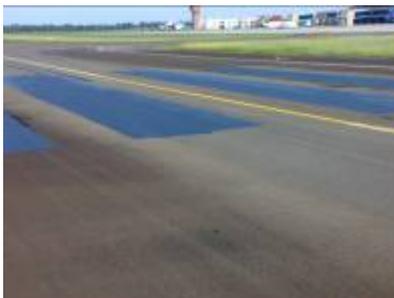
Figure 5-8: Old touch down marks on parallel taxiway after cleaning
