Runway incursion – Mackay airport safety vehicle

Mackay Airport, Queensland, 29 June 2012

ATSB Transport Safety Report
Aviation Occurrence Investigation
AO-2012-090
Final

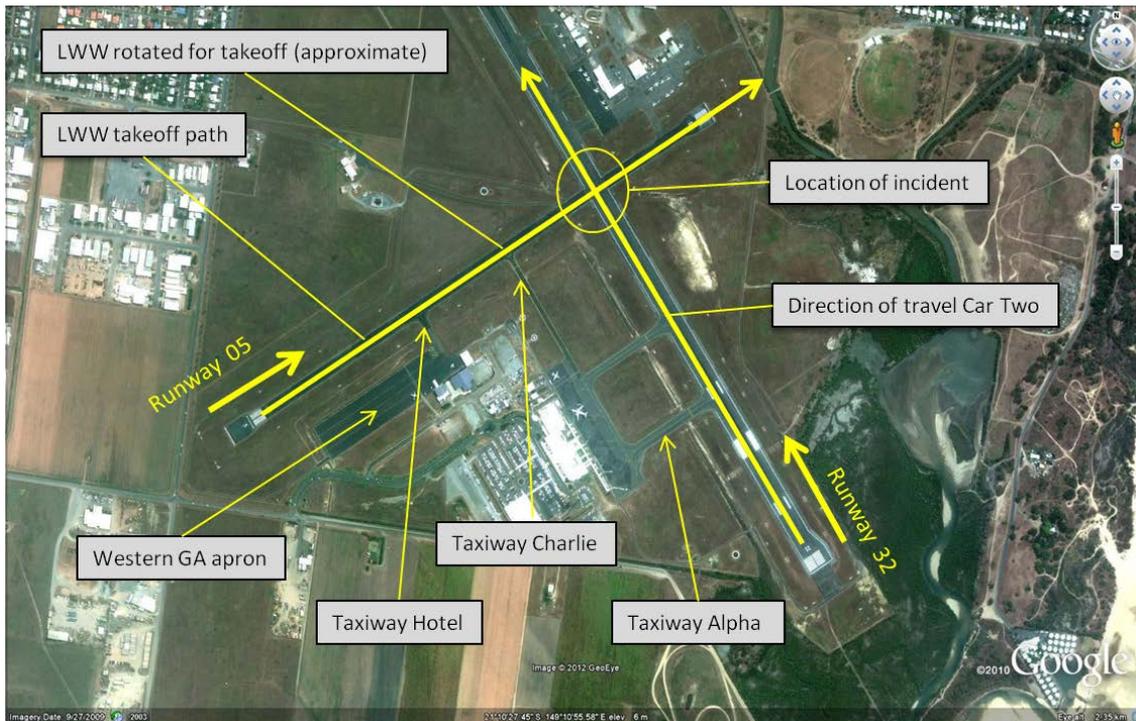
Figure 1: Mackay Airport

On 29 June 2012, at about 1754 Eastern Standard Time¹, the Airport Safety Officer (ASO) at Mackay Airport, Queensland contacted Mackay Tower air traffic control (ATC) to request a clearance for Car Two to enter the airport runway environment for a routine runway pavement and lighting inspection. Car Two was a Toyota Hilux airport safety vehicle with appropriate and serviceable hazard lighting. Mackay Tower cleared Car Two to enter runway 14 and runway 05. Car Two entered runway 14 at taxiway Alpha, and proceeded in a south-easterly direction to initially inspect the runway 32 T-VASIS² installation. The ASO planned to inspect the T-VASIS installation, then position at the threshold of runway 32 before proceeding in a north-westerly direction along the runway to continue the runway pavement and lighting inspection (Figure 1).
