DUTCH
SAFETY BOARD

Loss of separation over Uitgeest

The Hague, May 2013

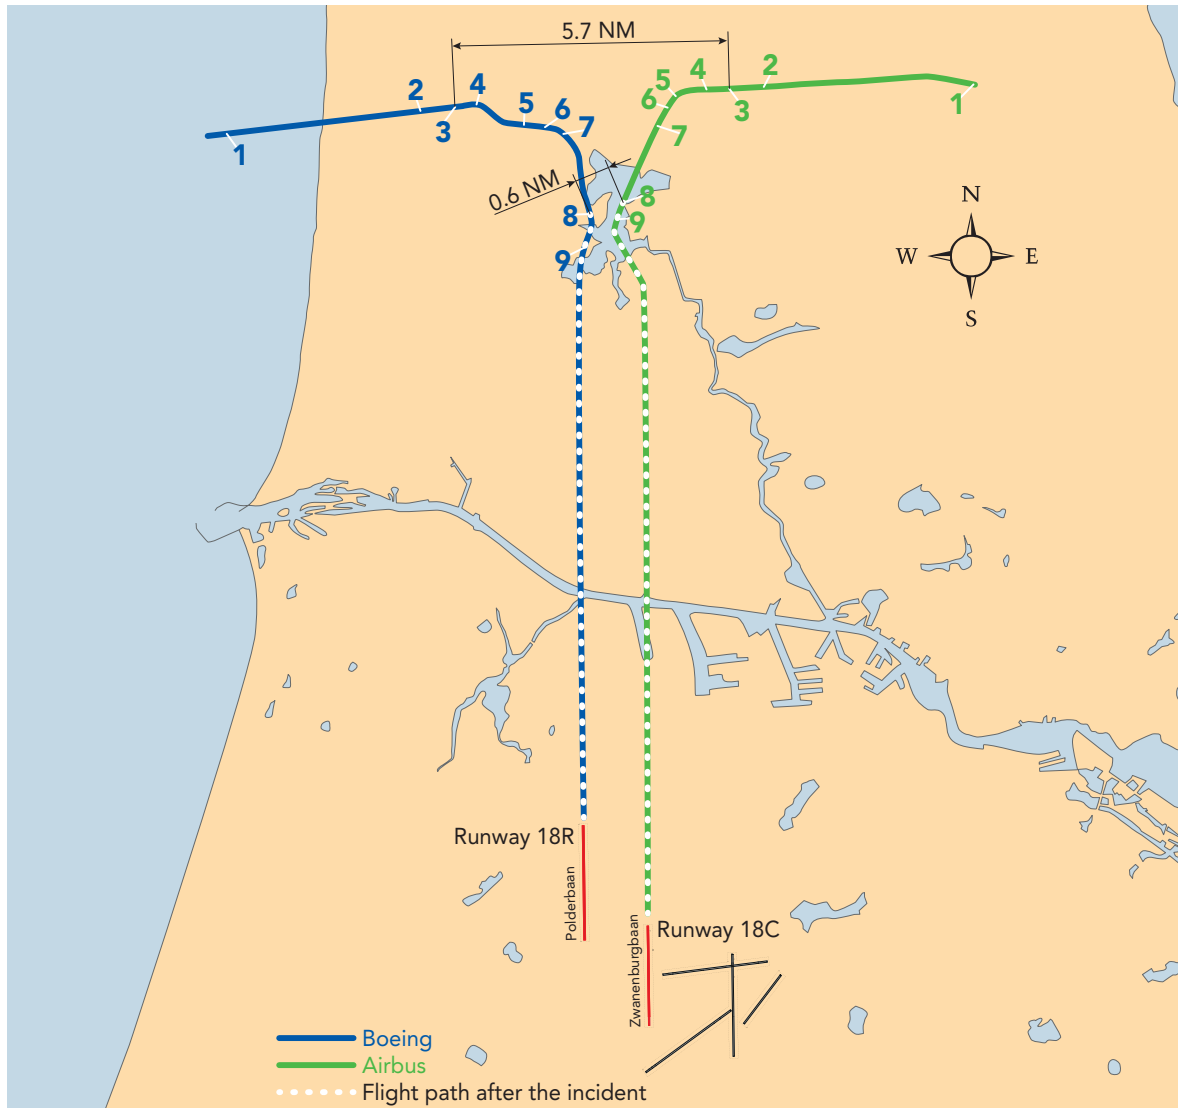
Figure 3: Overview of the approaches of both aircraft to Schiphol Airport

The ATC controller for 18R, ordered the Boeing crew to steer back to a heading of 160, and continue the approach for runway 18R (figure 3, [5](#)).

The Airbus continued on heading 210. The ATC controller for runway 18C warned the Airbus crew of the presence of the Boeing. The Airbus crew stated they had the Boeing in sight (figure 3, [6](#)). At that time the Airbus was approaching the final radial⁵ for runway 18C. When the ATC controller asked the crew whether they had the Boeing in sight, the crew confirmed again and asked if they could start the approach to runway 18C (figure 3, [7](#)). The ATC controller then gave the crew a new heading of 160 to bring them back to centreline and cleared them for the approach (figure 3, [9](#)).

Position	Time	Boeing	Position	Airbus
1	06.41:39		1	Airbus is given a heading of 270 and cleared to descend to 2000 feet
2	06.42:51	Boeing is given a heading of 160	2	
3	06.42:55	Air traffic controllers recognize the conflict. Distance aircrafts 5.7 NM, altitude difference 100 feet. Boeing is given a heading of 360	3	
4	06.43:01		4	Airbus is given a heading of 210
5	06.43:15	Boeing is given a heading of 160	5	
6	06.43:29	Boeing confirms visual contact with Airbus	6	
7	06.43:34		7	Airbus confirms visual contact with Boeing
8	06.44:08		8	Minimum distance between Boeing and Airbus 0.6 NM 0 feet.
9	06.44:12		9	Airbus is given a heading of 160

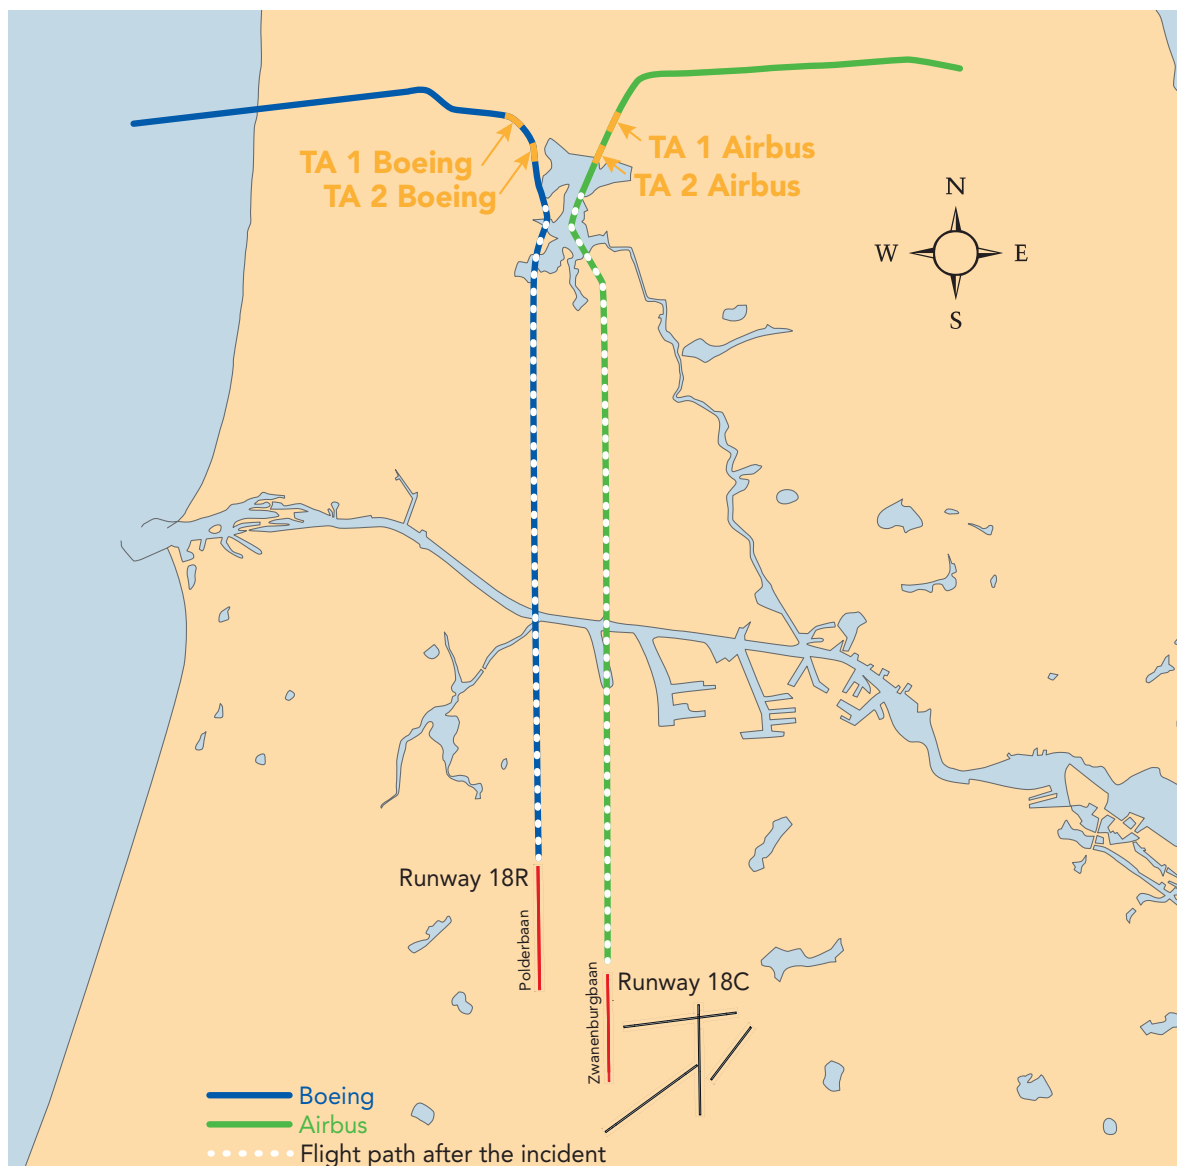
Figure 7: Position of aircraft during TA warnings

TCAS generated a 'traffic advisory' at 06.43:35 (during 4 seconds) and again at 06.43:49 (during 5 seconds). The minimum distance between the two aircraft during the approach was 0,6 NM (1,1 km, figure 3, 8). No collision warning (RA) was given by either system.

The crew of both aircraft were given two TCAS 'traffic advisory'-warnings (figure 8). Crews were prepared to take the necessary actions if needed (evasive manoeuvre in case of 'resolution advisory'). Until the moment of the first TA warning, both crews were following ATC instructions.
