DATA SUMMARY

Date and time	Sunday, 27 May 2012; 05:00 UTC¹
Site	Barcelona-El Prat Airport (LEBL) (Spain)

Registration	F-GJVG	EI-EBN
Type and model	AIRBUS A320	BOEING B737-800
Operator	Air France	Ryanair

REPORT

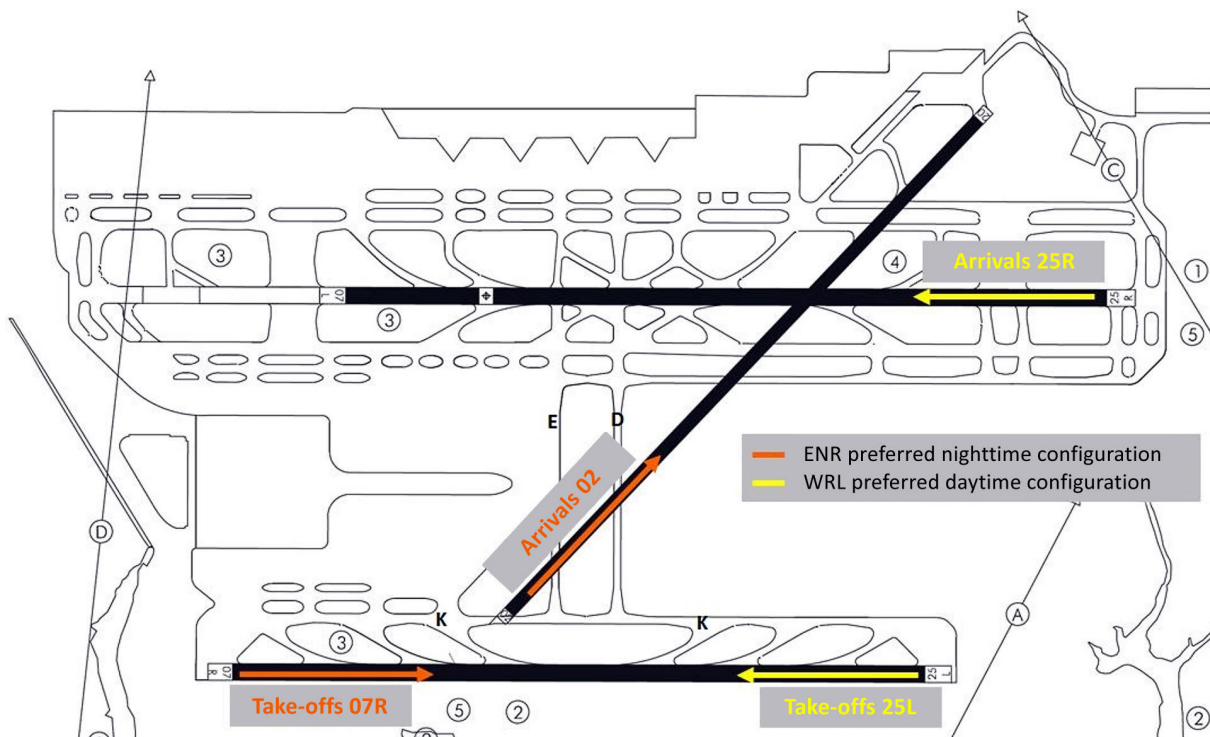
Figure 1. ENR and WRL configurations at LEBL

The Barcelona/El Prat Airport has three asphalt runways, two of them parallel (07L/25R and 07R/25L), and a runway in a 02/20 orientation that crosses runway 07L/25R. Runway 02/20 is also crossed by mutually parallel taxiways D and E and by taxiway K, which runs parallel to runway 07R/25L (Figure 1).

The ENR configuration became inoperative on 22 September 2011 due to work needed to repair patches of pavement along the runway, the centerline pavement and the shoulders of RWY 02/20. The runway was returned to service on 2 May 2012⁵.

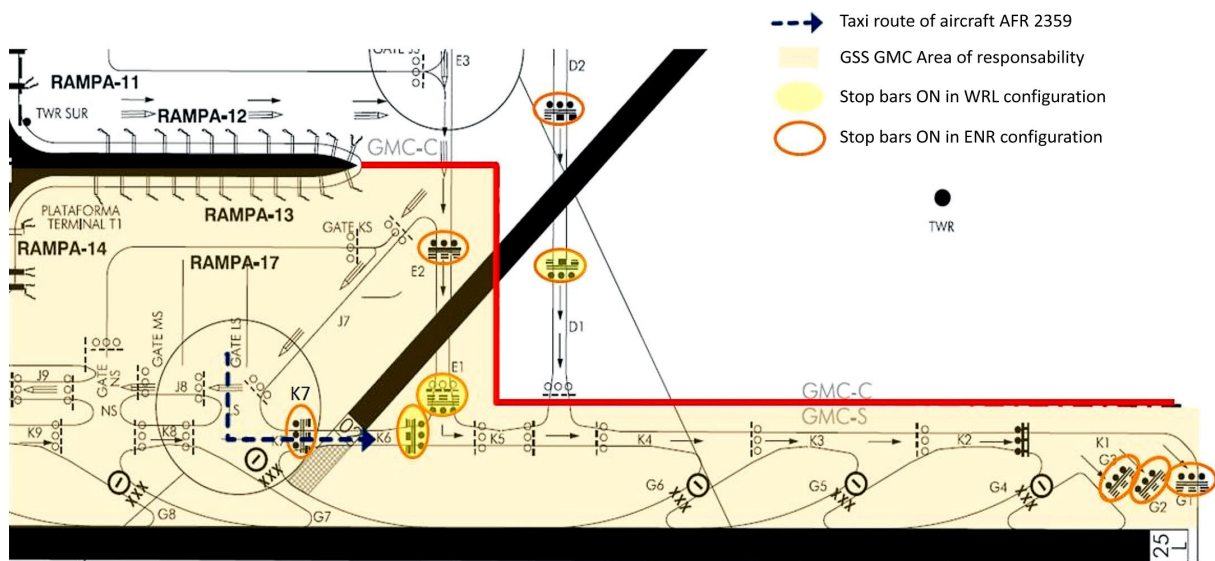
Figure 2. Taxi route of aircraft AFR2349

At 04:57:48 the SS controller cleared aircraft AFR2349 to taxi via LS, turn left onto taxiway K, cross runway 02 and taxi to the runway 25L holding point, an instruction that the crew acknowledged.

The recording of the communications between the SS controller and aircraft AFR2349 did not reveal any mention of the stop bar situated on taxiway K7, which protects the intersection of the taxiway and runway 02 (Figure 2).

- At 05:00, when aircraft AFR2349 contacted ground with the expression “we cross”, it had barely completed the turn to line up with taxiway K and it was some 50 m from the stop bar on taxiway K7.
- About 25 s later it reached the holding point just as the approaching aircraft was at an altitude of 600 ft and within 2 NM on final approach to runway 02.
- Aircraft AFR2349 stopped taxiing for a few seconds between 05:00:33 and 05:00:45 when it was instructed to hold, and then resumed taxiing. It had already crossed over the K7 holding point.
- According to the radar, aircraft RYR6363 reached a minimum altitude of 300 ft during its go-around maneuver.
