INTERSTATE AVIATION COMMITTEE
AIR ACCIDENT INVESTIGATION COMMISSION

FINAL REPORT
ON RESULTS OF INVESTIGATION OF ACCIDENT

Type of accident	Fatal accident
Type of aircraft	ATR72-201 aeroplane
Registration	VP-BYZ, Bermudas
Owner	BLF Limited
Operator	UTAir Aviation, JSC
Place of accident	1500 m from RWY 21 threshold; cross-track deviation about 400 m, Roschino aerodrome, Tyumen. Coordinates: N 57°09.440' E 065°16.000'
Date and time of accident	02.04.2012, 01:35 UTC (07:35 local time), day time

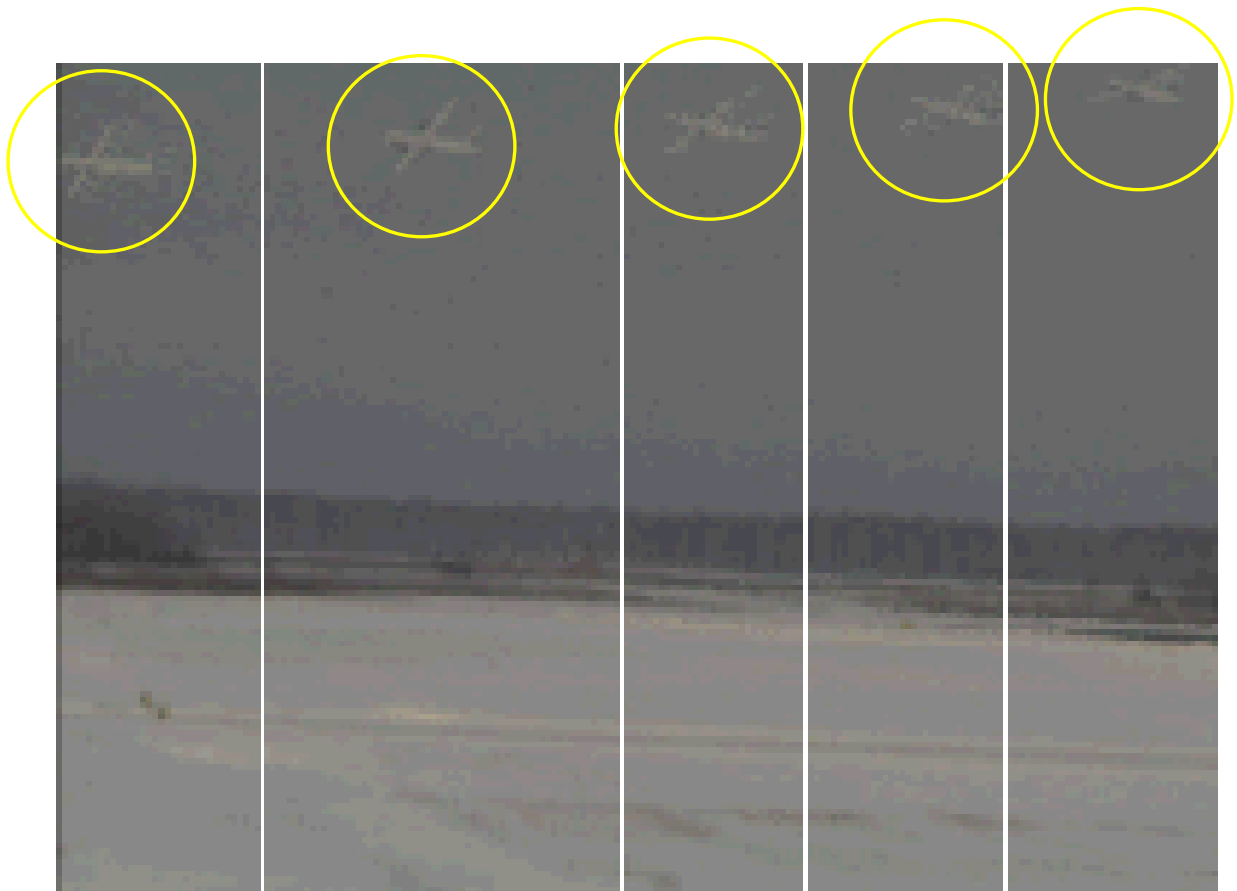
Figure 28. The trajectory of the A/C after the takeoff with developing left bank and descent

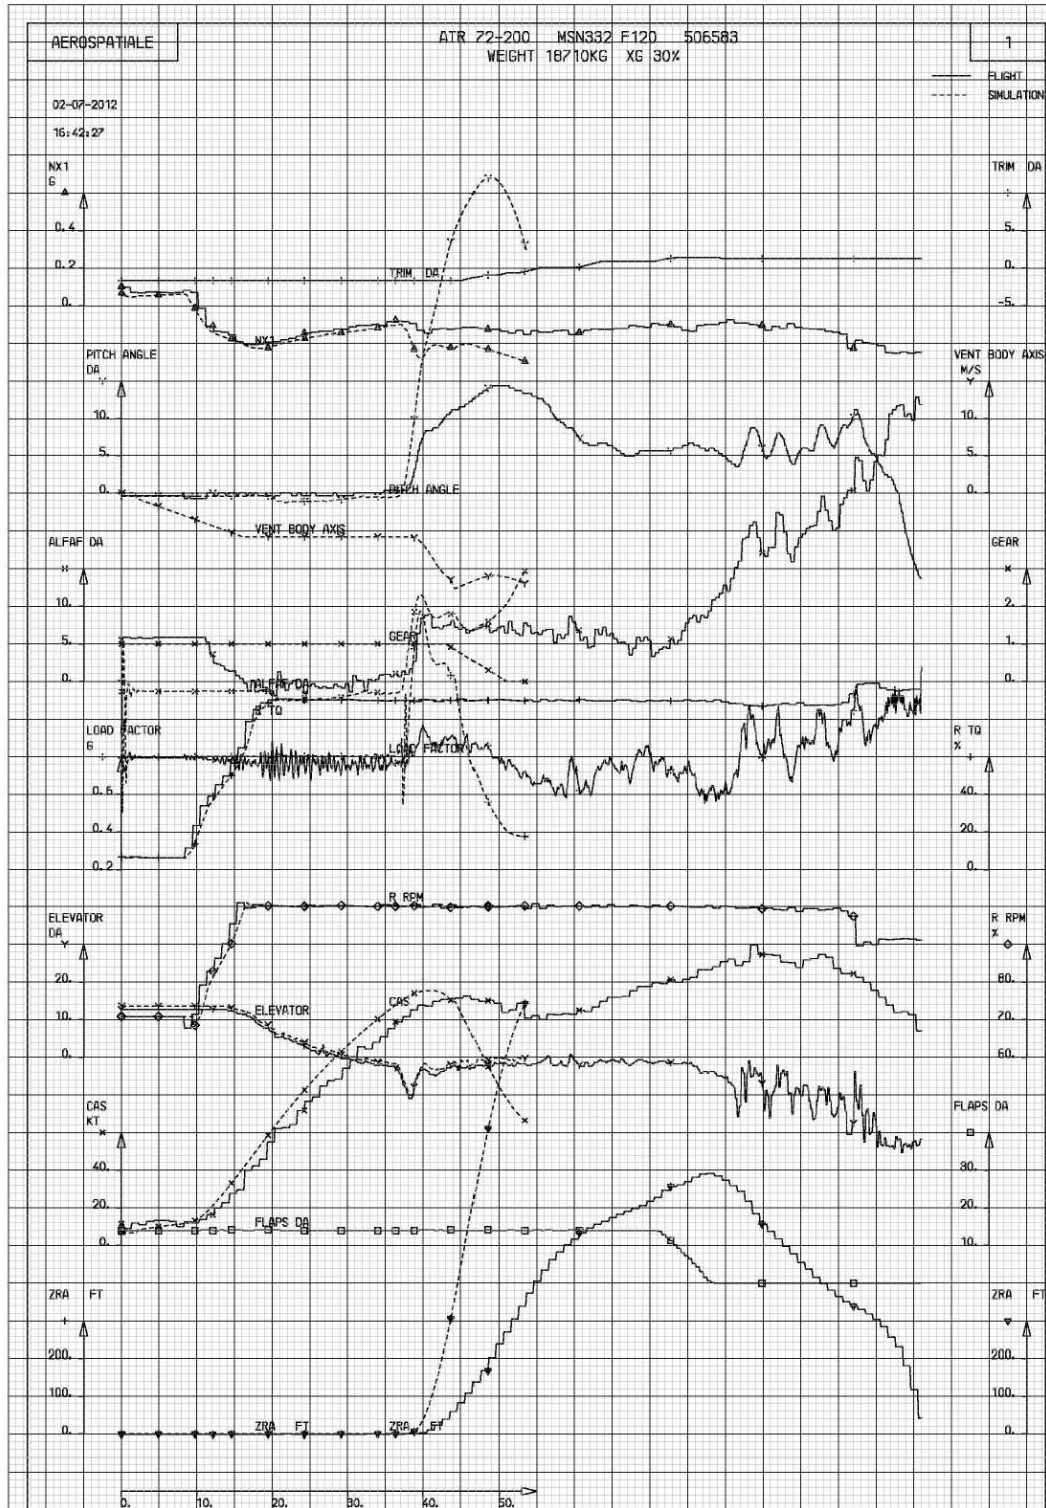
Figure 44. Simulation compared to FDR Flight UTA-119 – without extra drag and lift

The accident flight simulation (Flight UTA-120) showed that with the actually realized deflection of the flight control surfaces, engine thrust and the aerodynamic data basis, the simulation did not match the DFDR parameters (Figure 44).

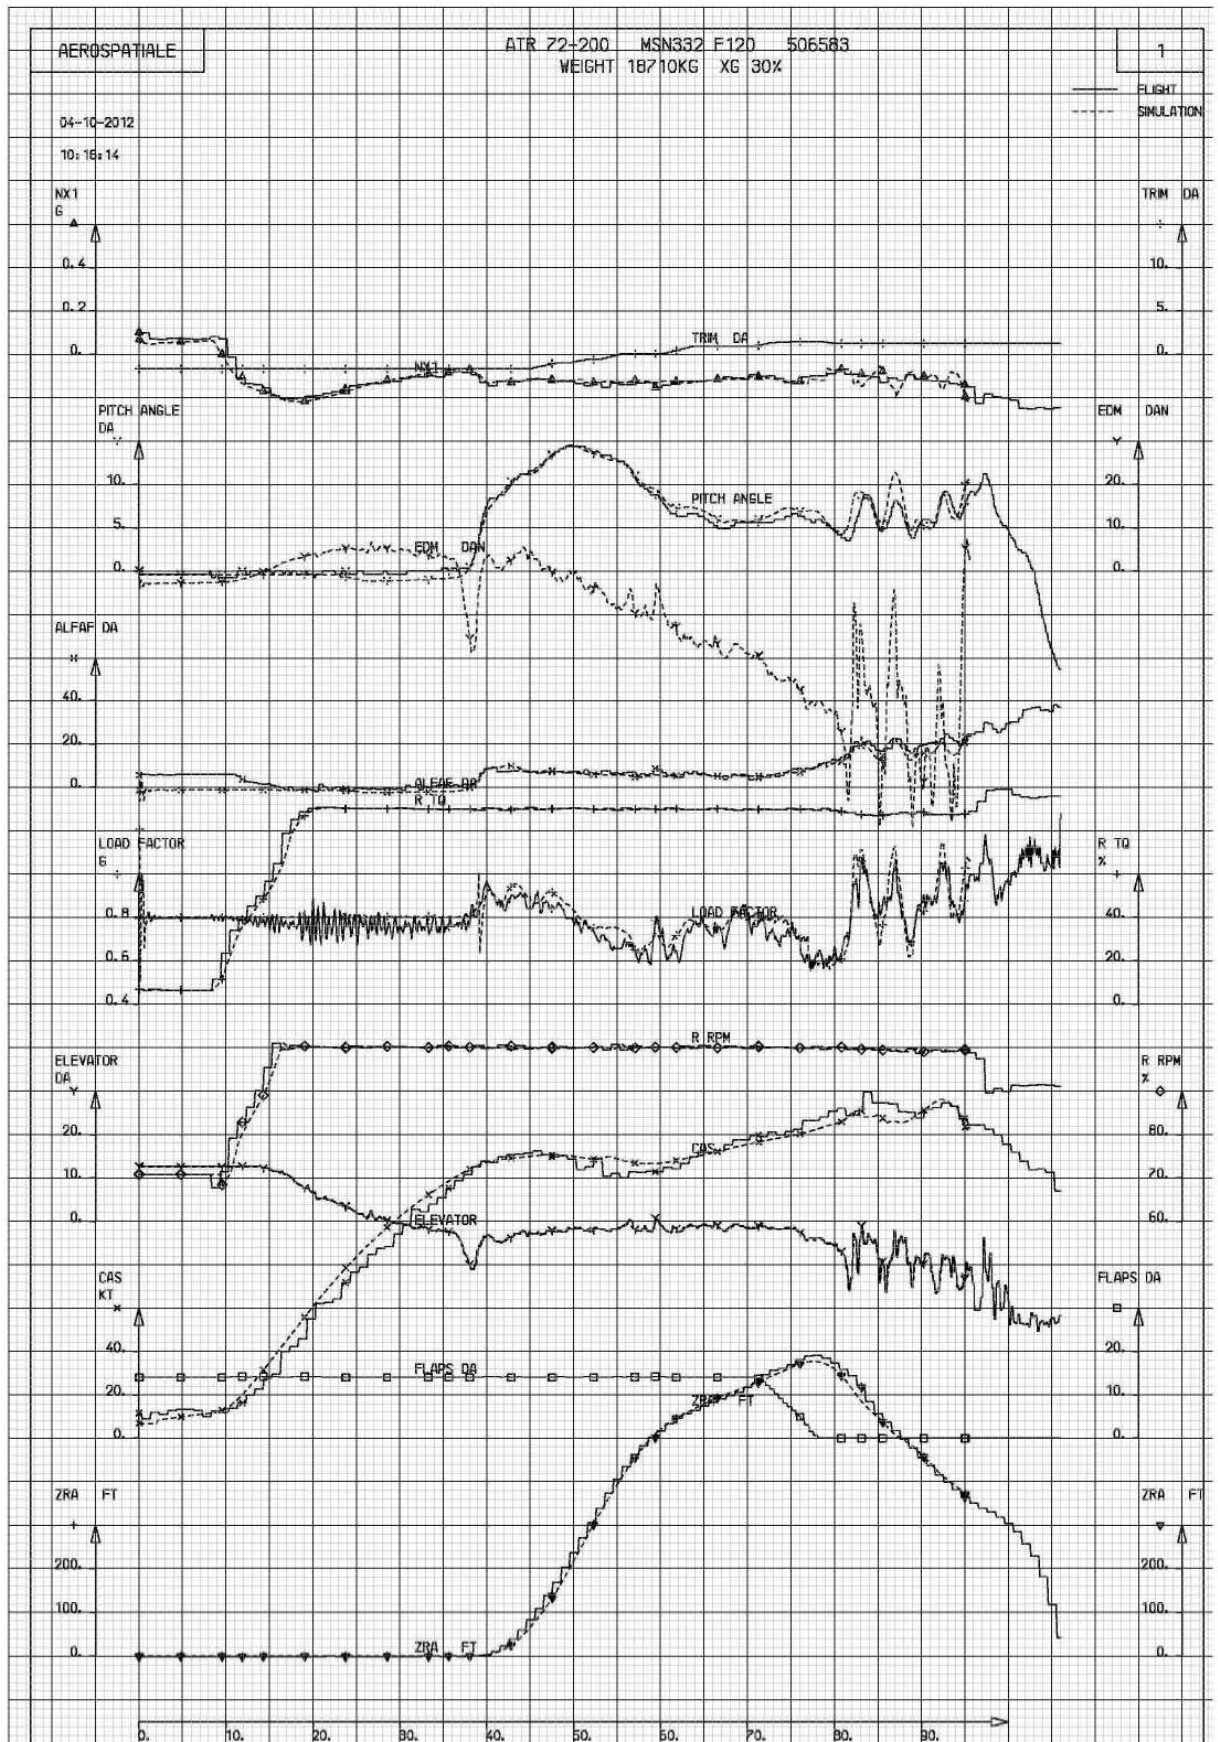
Figure 48. Simulation of Flight UTA-120 with basic hinge moment

A comparison of simulated results with ice shapes tests (“boots failures case” - ice shapes corresponding to 1.5 inch of ice on the leading edge protected with boots and 3 inches ice shapes on the leading edge unprotected areas, Figure 47) revealed that the performance degradation in the accident flight was significantly greater than in the boot failure case. Taking into account that the aircraft had stayed outside the night before, in ground icing conditions, and was not deiced before departure, its upper surfaces (wing, stabilizer and fuselage) were evidently completely contaminated, including during the takeoff run. According to the aircraft manufacturer’s estimation, the contamination level in the accident flight in term of surface roughness was about 4 mm.

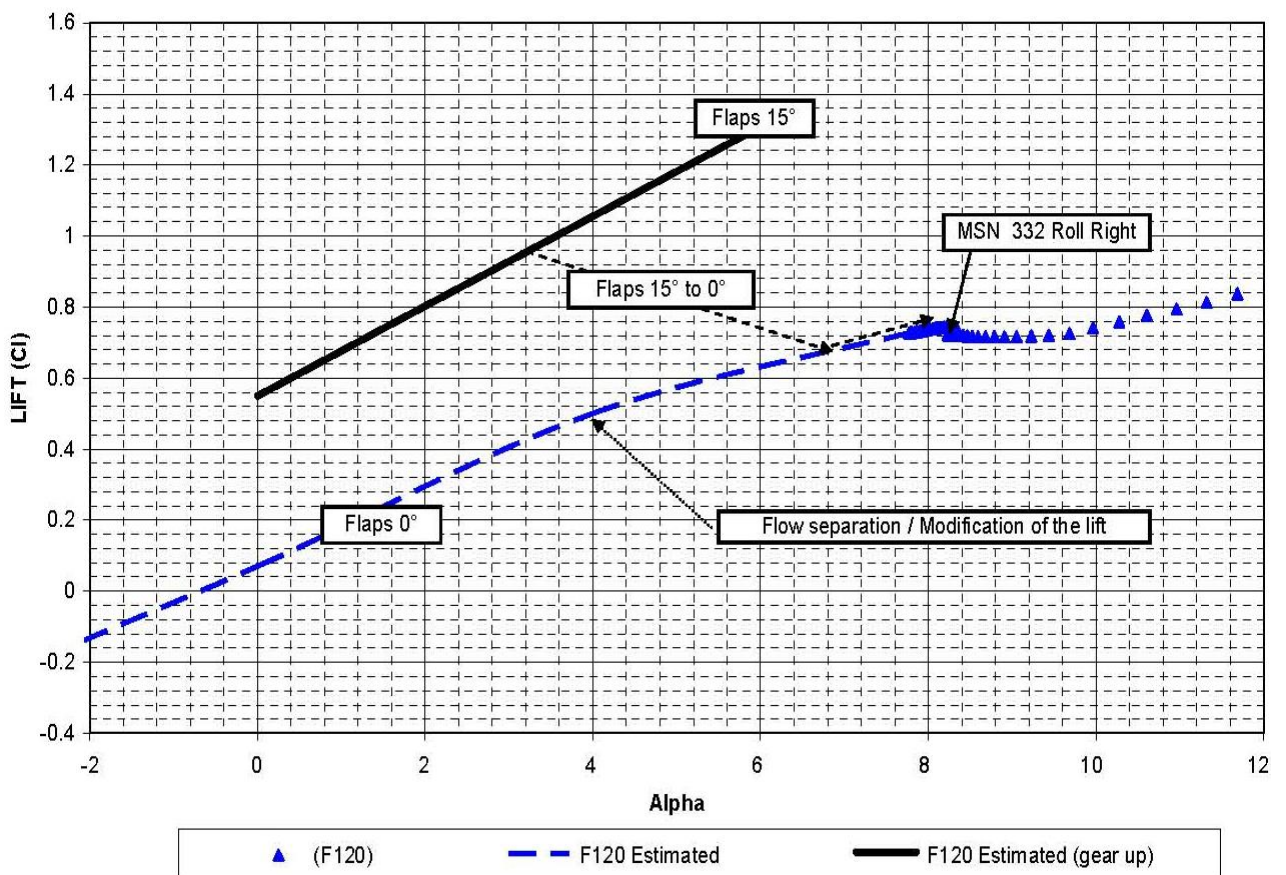
Figure 49. Simulation of Flight UTA-120 (flaps 0°)

Another conclusion drawn in the course of the simulation was that having the actual aerodynamic parameters it was impossible, after the flaps retraction, to obtain the lift required to continue flight at the current speed. It could be drawn from Figure 49 that the AOA increase cause stall before reaching the required CL. Thus, it was impossible to recover without setting flaps 15°.
