Unstabilised approach, hard landing

Aircraft	Embraer ERJ 145 MP registration F-GUBF
Time and date	1.07 p.m. ⁽¹⁾ on Monday 24 May 2010
Operator	Regional CAE
Location	Ljubljana aerodrome (Slovenia), runway 31
Nature of the flight	Scheduled public transport of passengers
(Flight) crew	Pilot-in-command, co-pilot
Consequences	Damage to landing gear and structural components

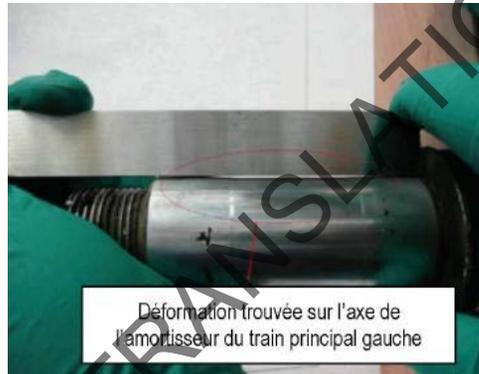
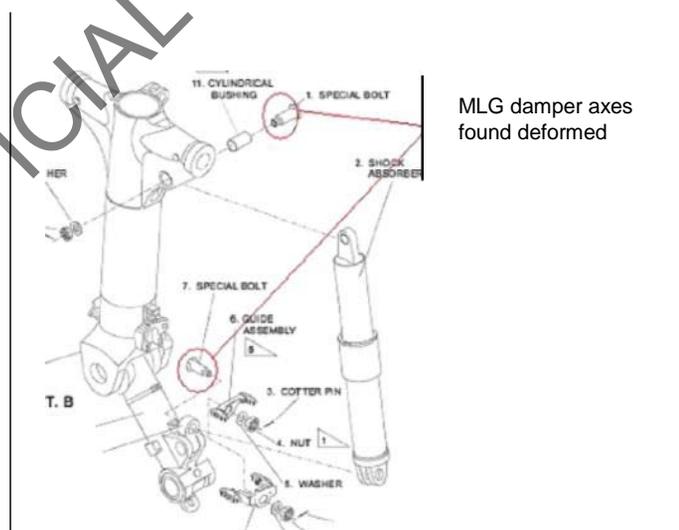
The shock-absorbers of the left and right main landing gear were found to be distorted. The landing gear had to be changed.

Deformation to the damper axes of the main landing gear

The reinforcing plate between the fuselage and the wing at the fairings was bent and some of its rivets were broken.

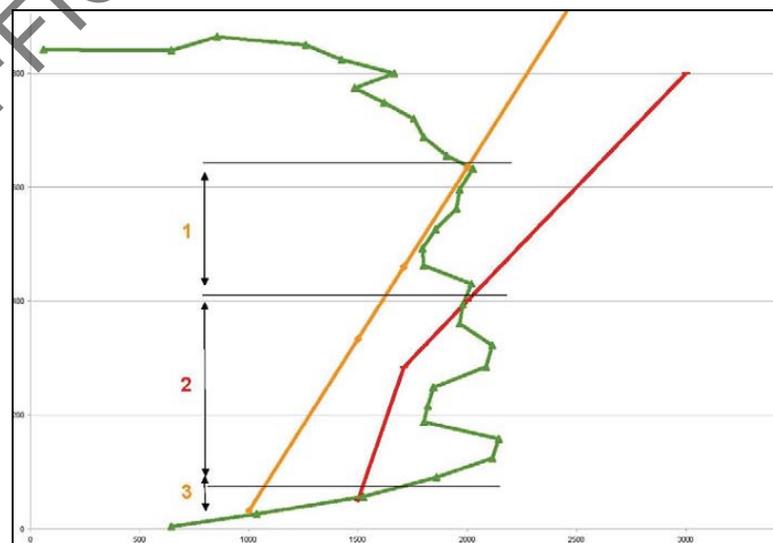
The following graph shows the activation envelope for the "excessive rate of descent" mode (Mode 1). The area between the yellow curve and the red curve corresponds to the SINK RATE Alert. The area under the red curve is that in which the PULL-UP Warning is triggered. The green curve is derived from the parameters of the aircraft⁽⁴⁾

Vertical axis shows height in ft /Horizontal axis shows vertical speed in ft/min

During the final approach, several EGPWS activation occurred. Despite a PULL-UP Warning alarm lasting 11 seconds, the crew did not commence a go-around. When the pilot-in-command took over the controls for the final approach, his experience as a glider pilot and aerobatic pilot reassured him in his decision to continue to land, and thus not to respond to the EGPWS calls.
