**INVESTIGATION REPORT OF ACCIDENT
INVOLVING GEORGIAN AIRWAYS AIRCRAFT
CRJ-100ER (4L-GAE)
AT KINSHASA'S N'DJILI AIRPORT
DEMOCRATIC REPUBLIC OF CONGO (DRC)
ON 04 APRIL 2011**

<p style="text-align: center;">Permanent office of investigations of aviation Accidents/Incidents</p>	<p style="text-align: center;">FINAL REPORT OF TECHNICAL INVESTIGATION ON THE ACCIDENT OF THE CRJ-100 PLANE, REGISTER 4L-GAE</p>	<p style="text-align: center;">Page 2</p>
-----------------------------------------------------------------------------------------------------------------------------------------------------------------------------------------------------------------------------------------------------------------------------------------------------------------------------------------------	---------------------------------------------------------------------------------------------------------------------------------------------------------	---------------------------------------------

Investigation report of accident involving Georgian Airways CRJ-100ER (4L-GAE), which occurred at Kinshasa's N'DJILI Airport, Democratic Republic of Congo (DRC) on 04 April 2011.

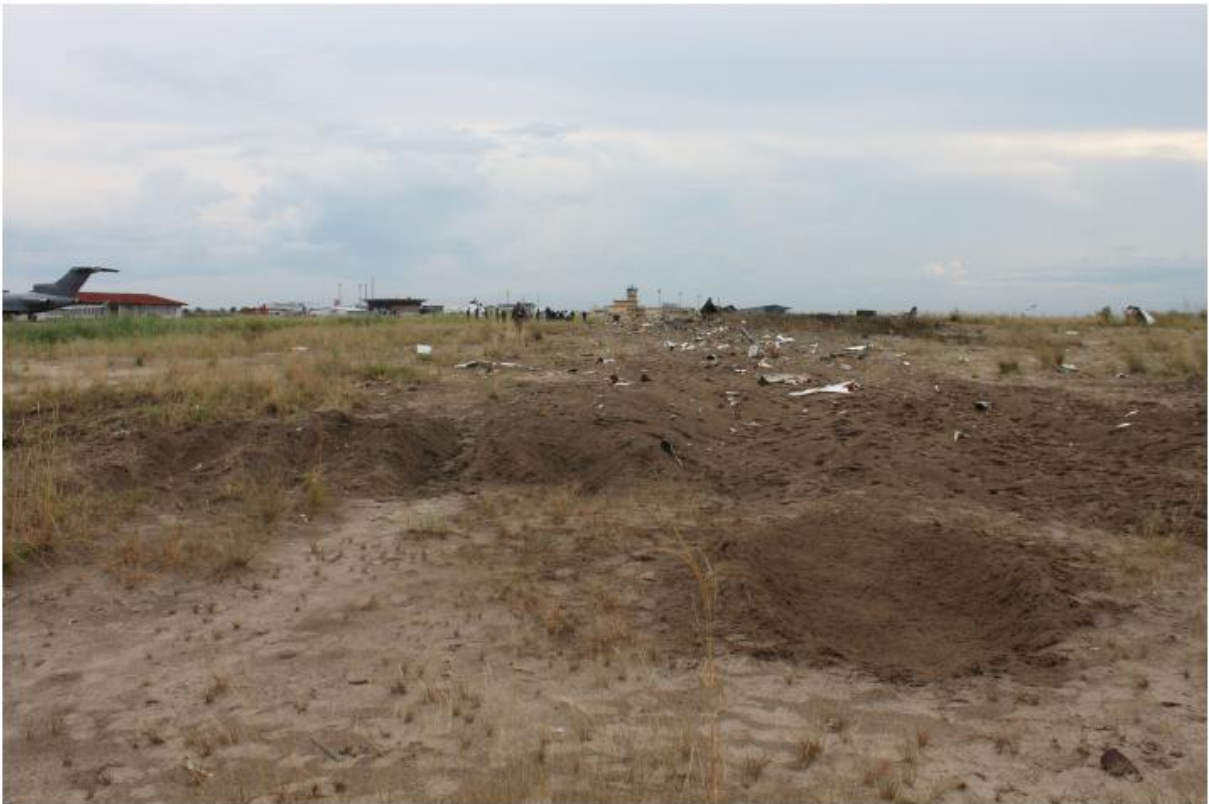
Image shows the initial impact marks of the aircraft. At the moment of impact, the indicated air speed was 180 knots, aircraft attitude was 10 degrees nose down and magnetic heading was 220 degrees. Notice that aircraft components started breaking off immediately following initial impact. The fuselage came to a rest in inverted position about 400 meters beyond the initial impact point.

At the time of impact with the ground, aircraft’s Indicated Air Speed was 180 knots, Pitch attitude was 10 degrees (nose down), Bank angle 4 degrees (left wing down) and Magnetic heading 220 degrees. The impact lead to severe damage to the aircraft, the undercarriage sheared off. Aircraft continued skidding, sliding and rolling in its impact direction. During the process, various parts of the aircraft, the engines and the tail section broke off. The main part of the fuselage slid in an inverted position for a considerable distance, before it came to rest.

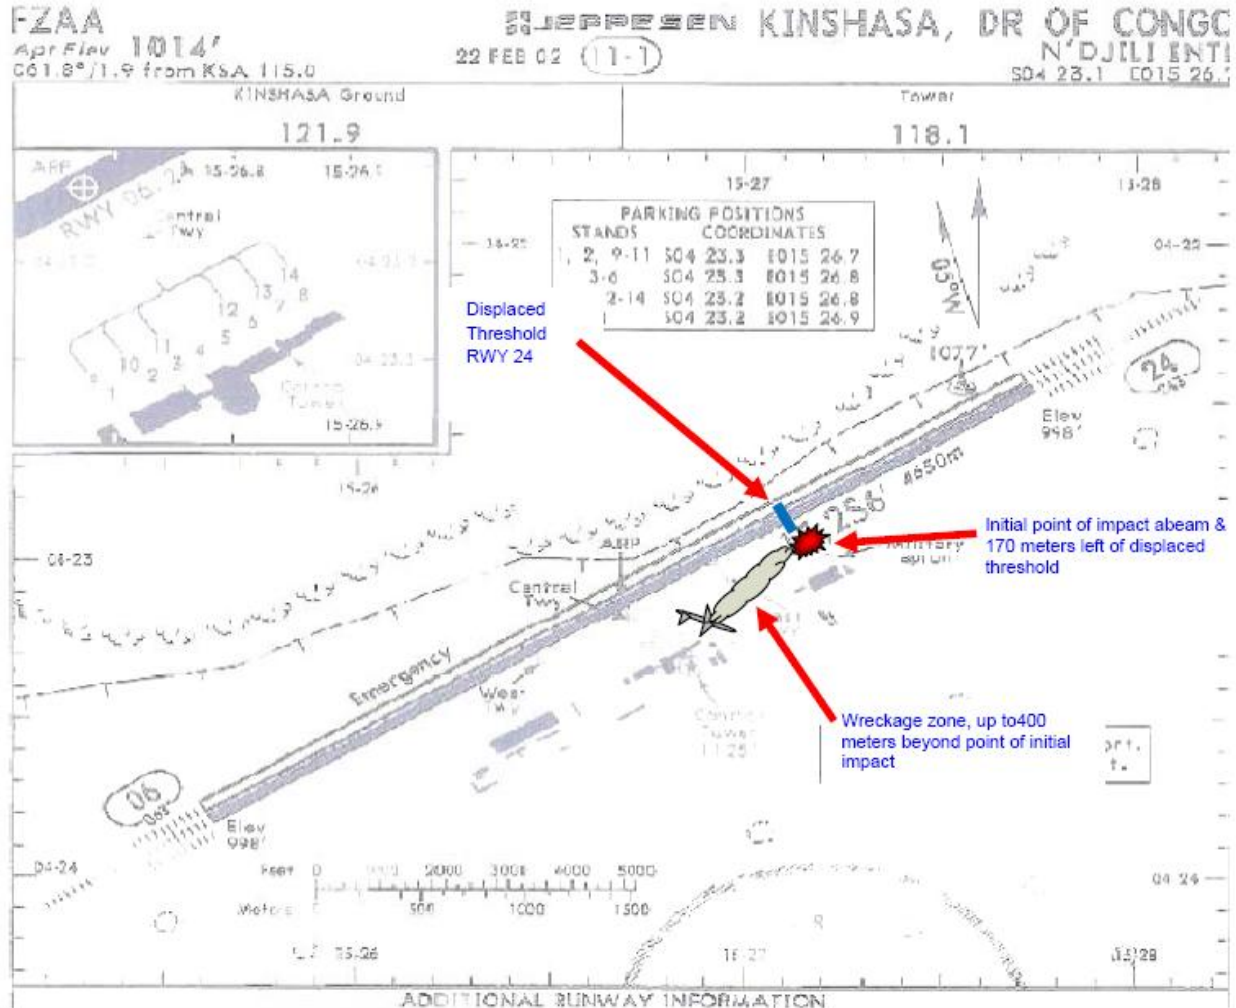
Threshold of Runway 24 was displaced by 1400 meters. Initial point of impact of the aircraft was abeam and 170 meters left of displaced threshold. Wreckage was spread over 400 meters in impact direction (about 220 degrees).

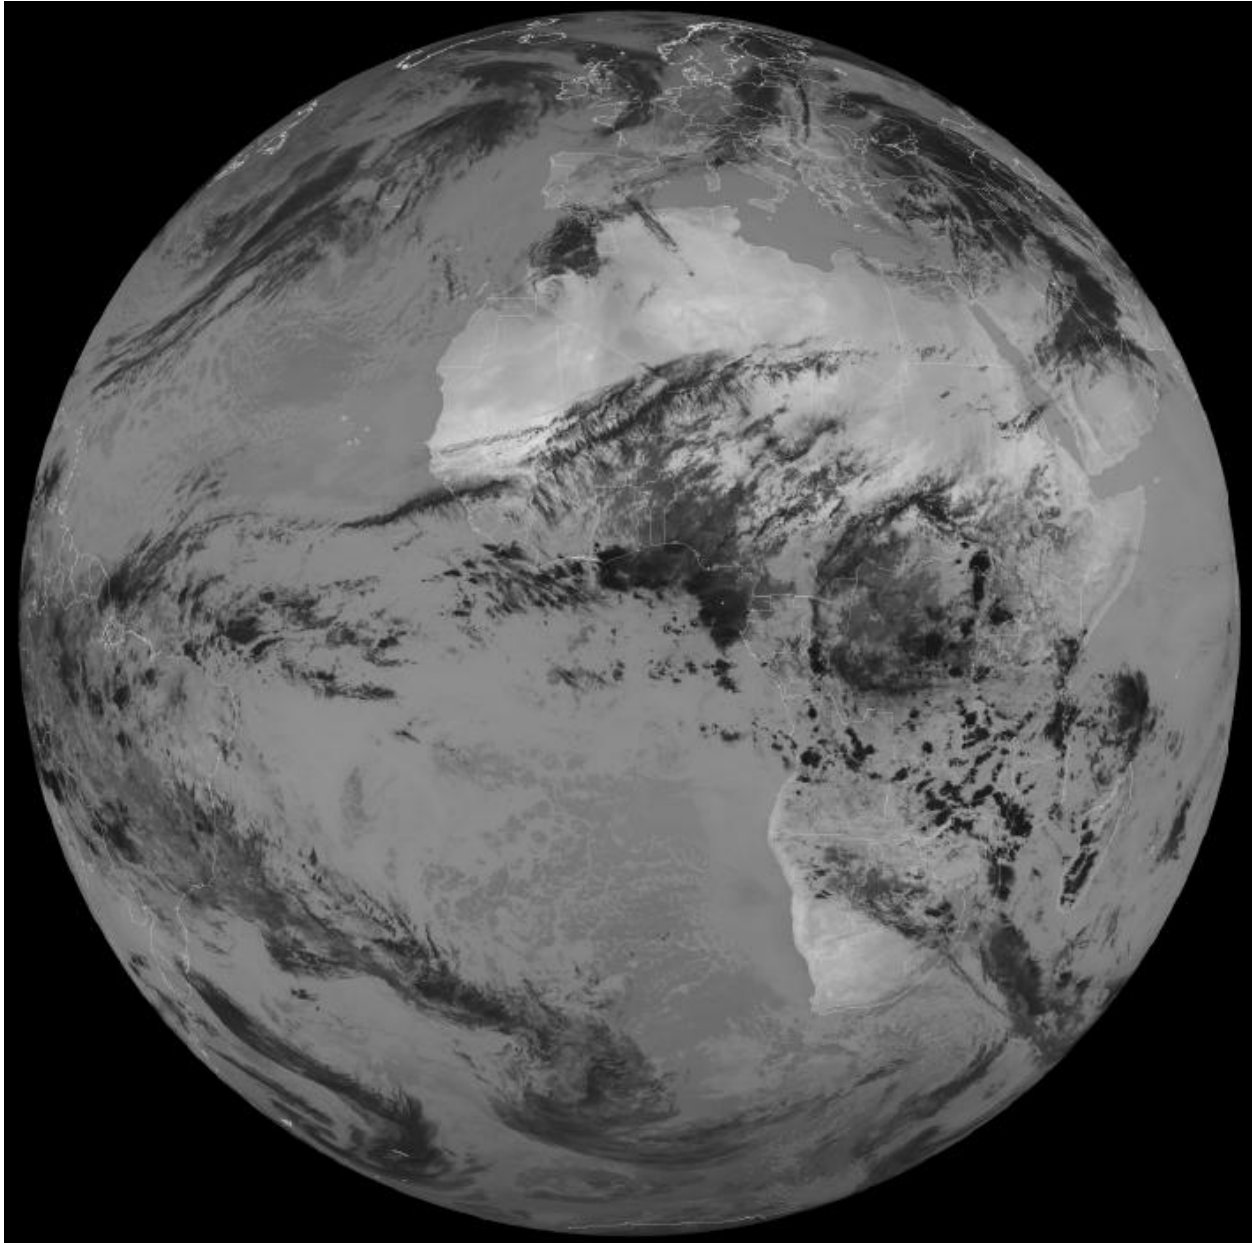
Above: EUMETSAT IR image of weather over Africa on 04/04/2011, taken at 1257 42

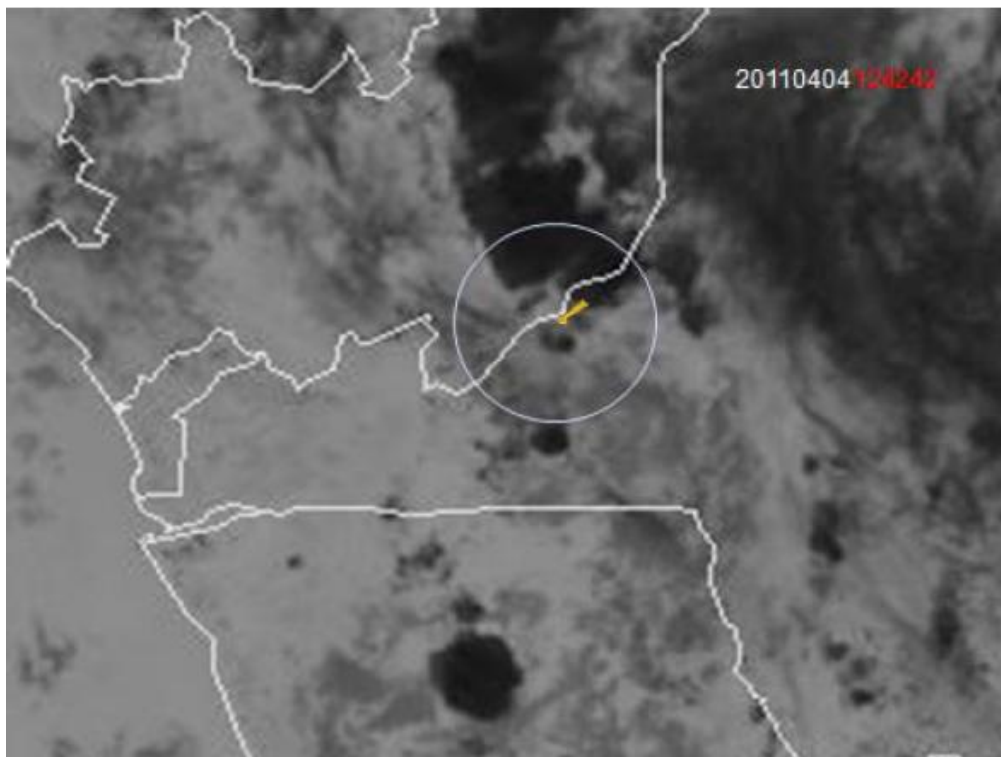
Above: EUMETSAT Infra Red photo of 1242 42 (about 16 minutes before the accident) showing Kinshasa airfield and Runway 24 Localizer Approach path (not to scale).

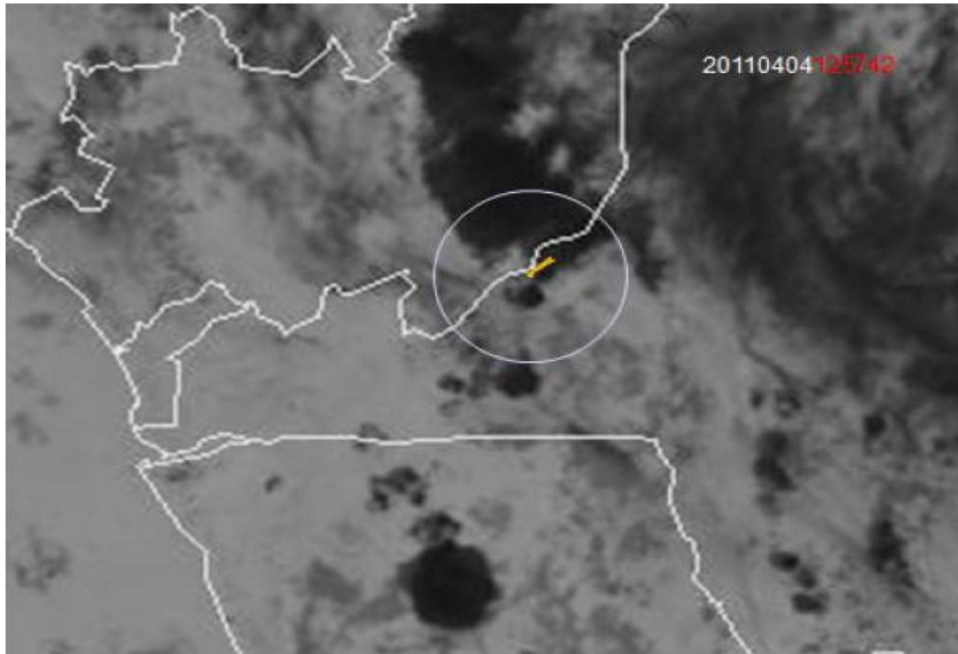
Above: EUMETSAT Infra Red photo of 1257 42 (about 50 seconds after the accident) showing Kinshasa airfield and Runway 24 Localizer Approach path (not to scale).

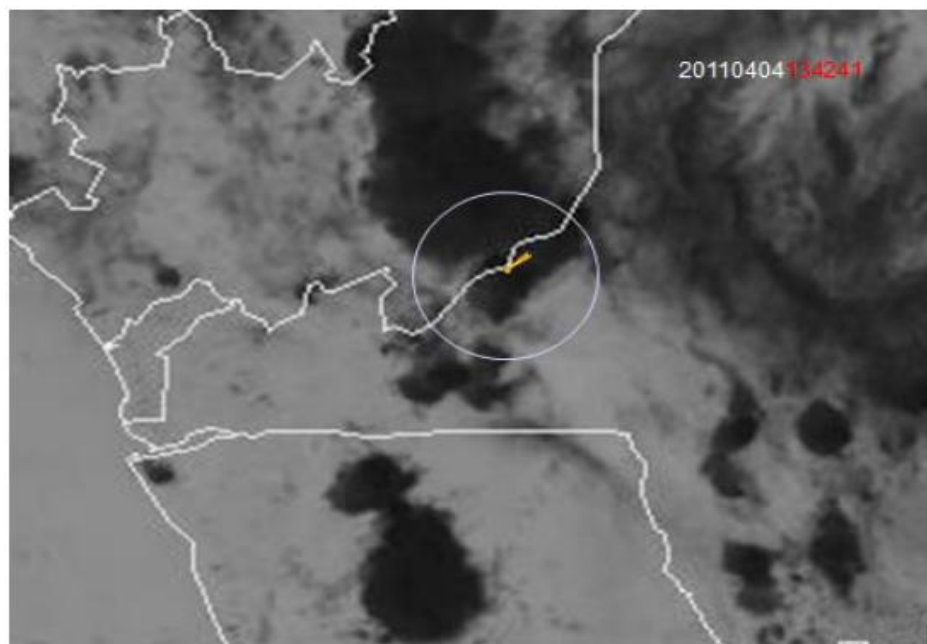
Above: EUMETSAT Infra Red photo of 1312 41 (about 16 minutes after the accident) showing Kinshasa airfield and Runway 24 Localizer Approach path (not to scale).

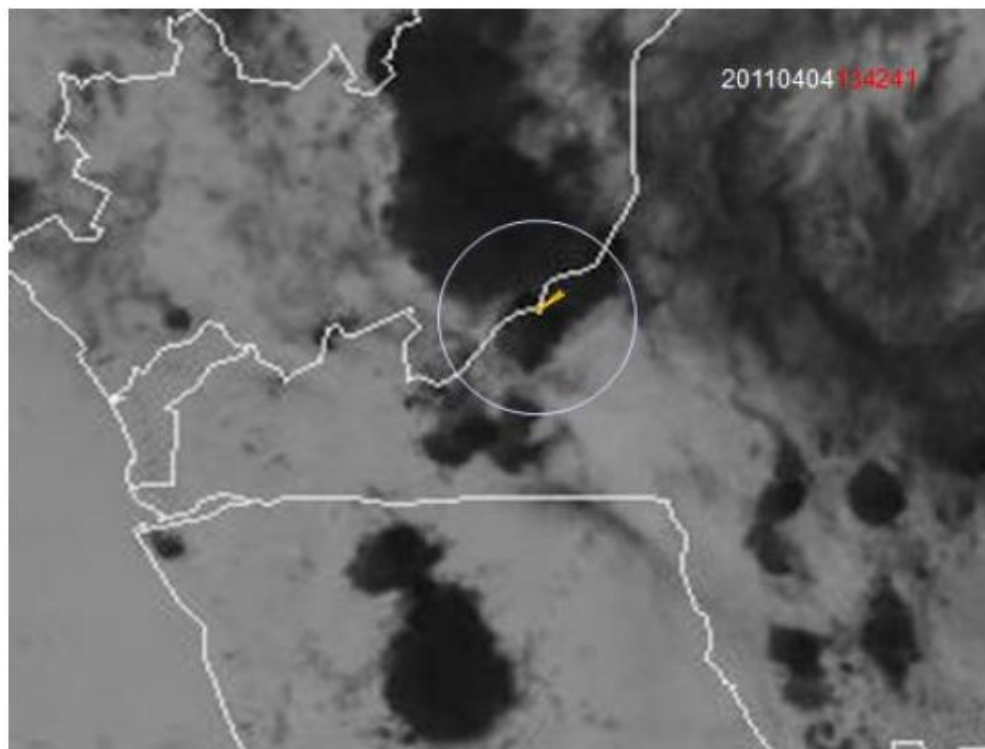
Above: EUMETSAT Infra Red photo of 1342 41 (about 46 minutes after the accident) showing Kinshasa airfield and Runway 24 Localizer Approach path (not to scale).

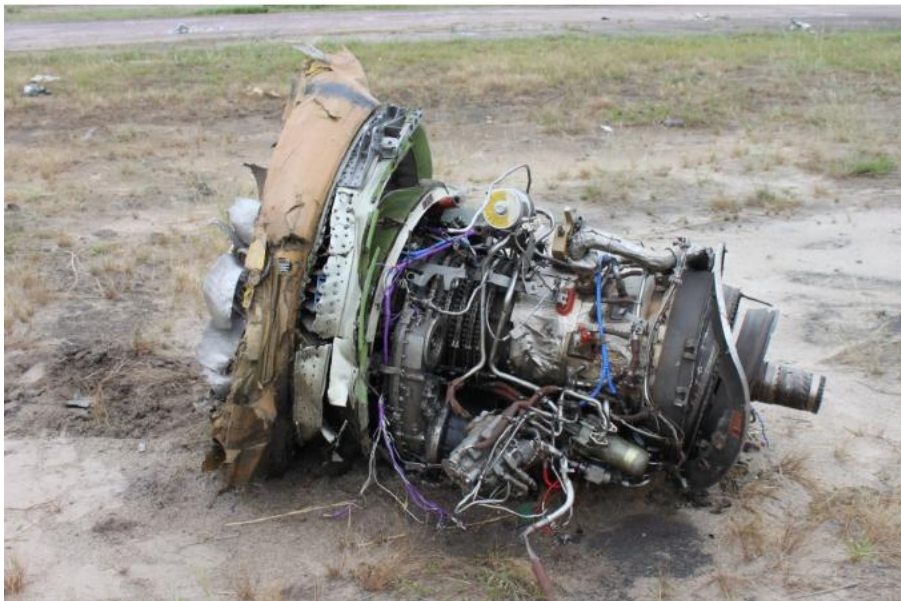
One of the engines separated from the fuselage

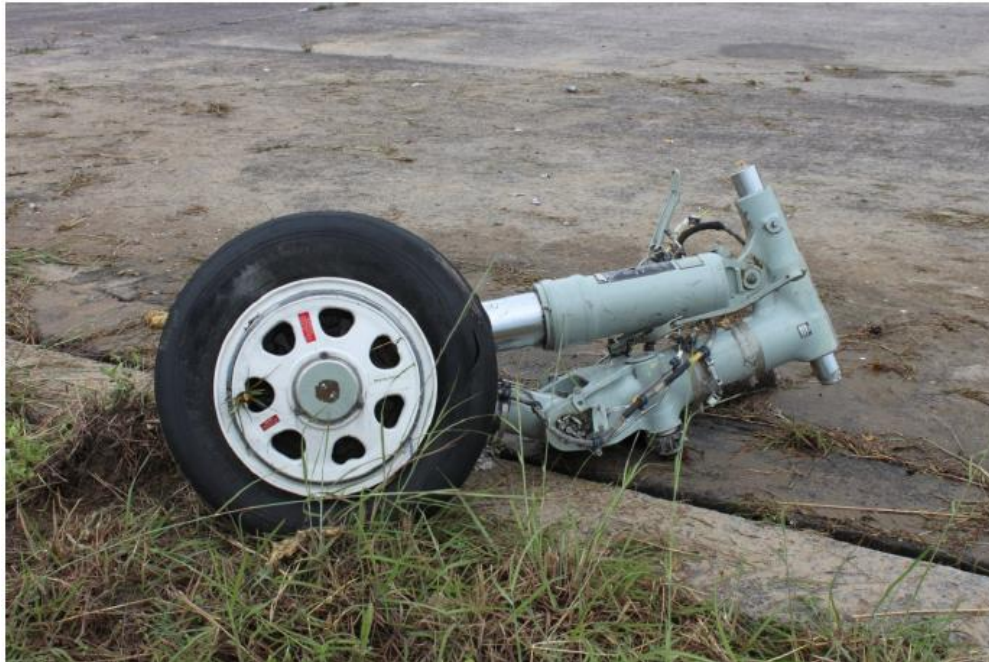
The main landing gear broke off.

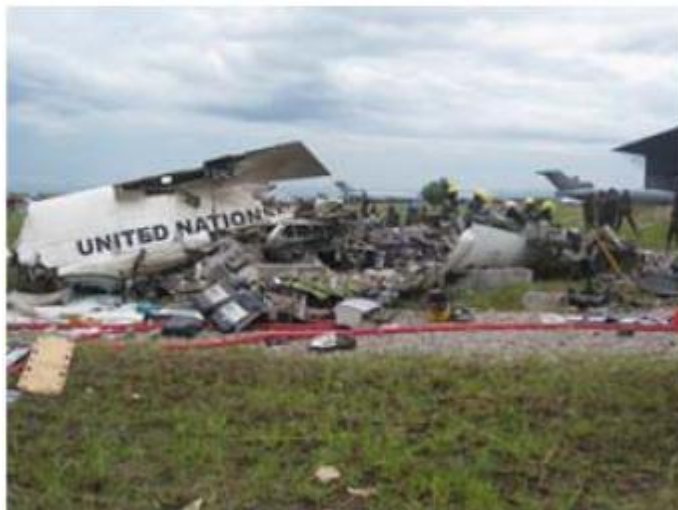
Above: Major part of the fuselage came to a rest about 400 meters away from initial impact point.

The main part of the fuselage came to a rest inverted and in a badly damaged condition. The severe nature of the accident caused massive external and internal injuries to the occupants. ECR teams brought out the crew and the passengers from the wreckage. Most of them were already dead, while a few were badly injured but alive. Nine injured survivors were rushed to a local hospital, some of them died on the way to the hospital. Amongst those who reached the hospital alive, all but one succumbed to their injuries. Only one passenger survived the accident, although he too, suffered extensive injuries.

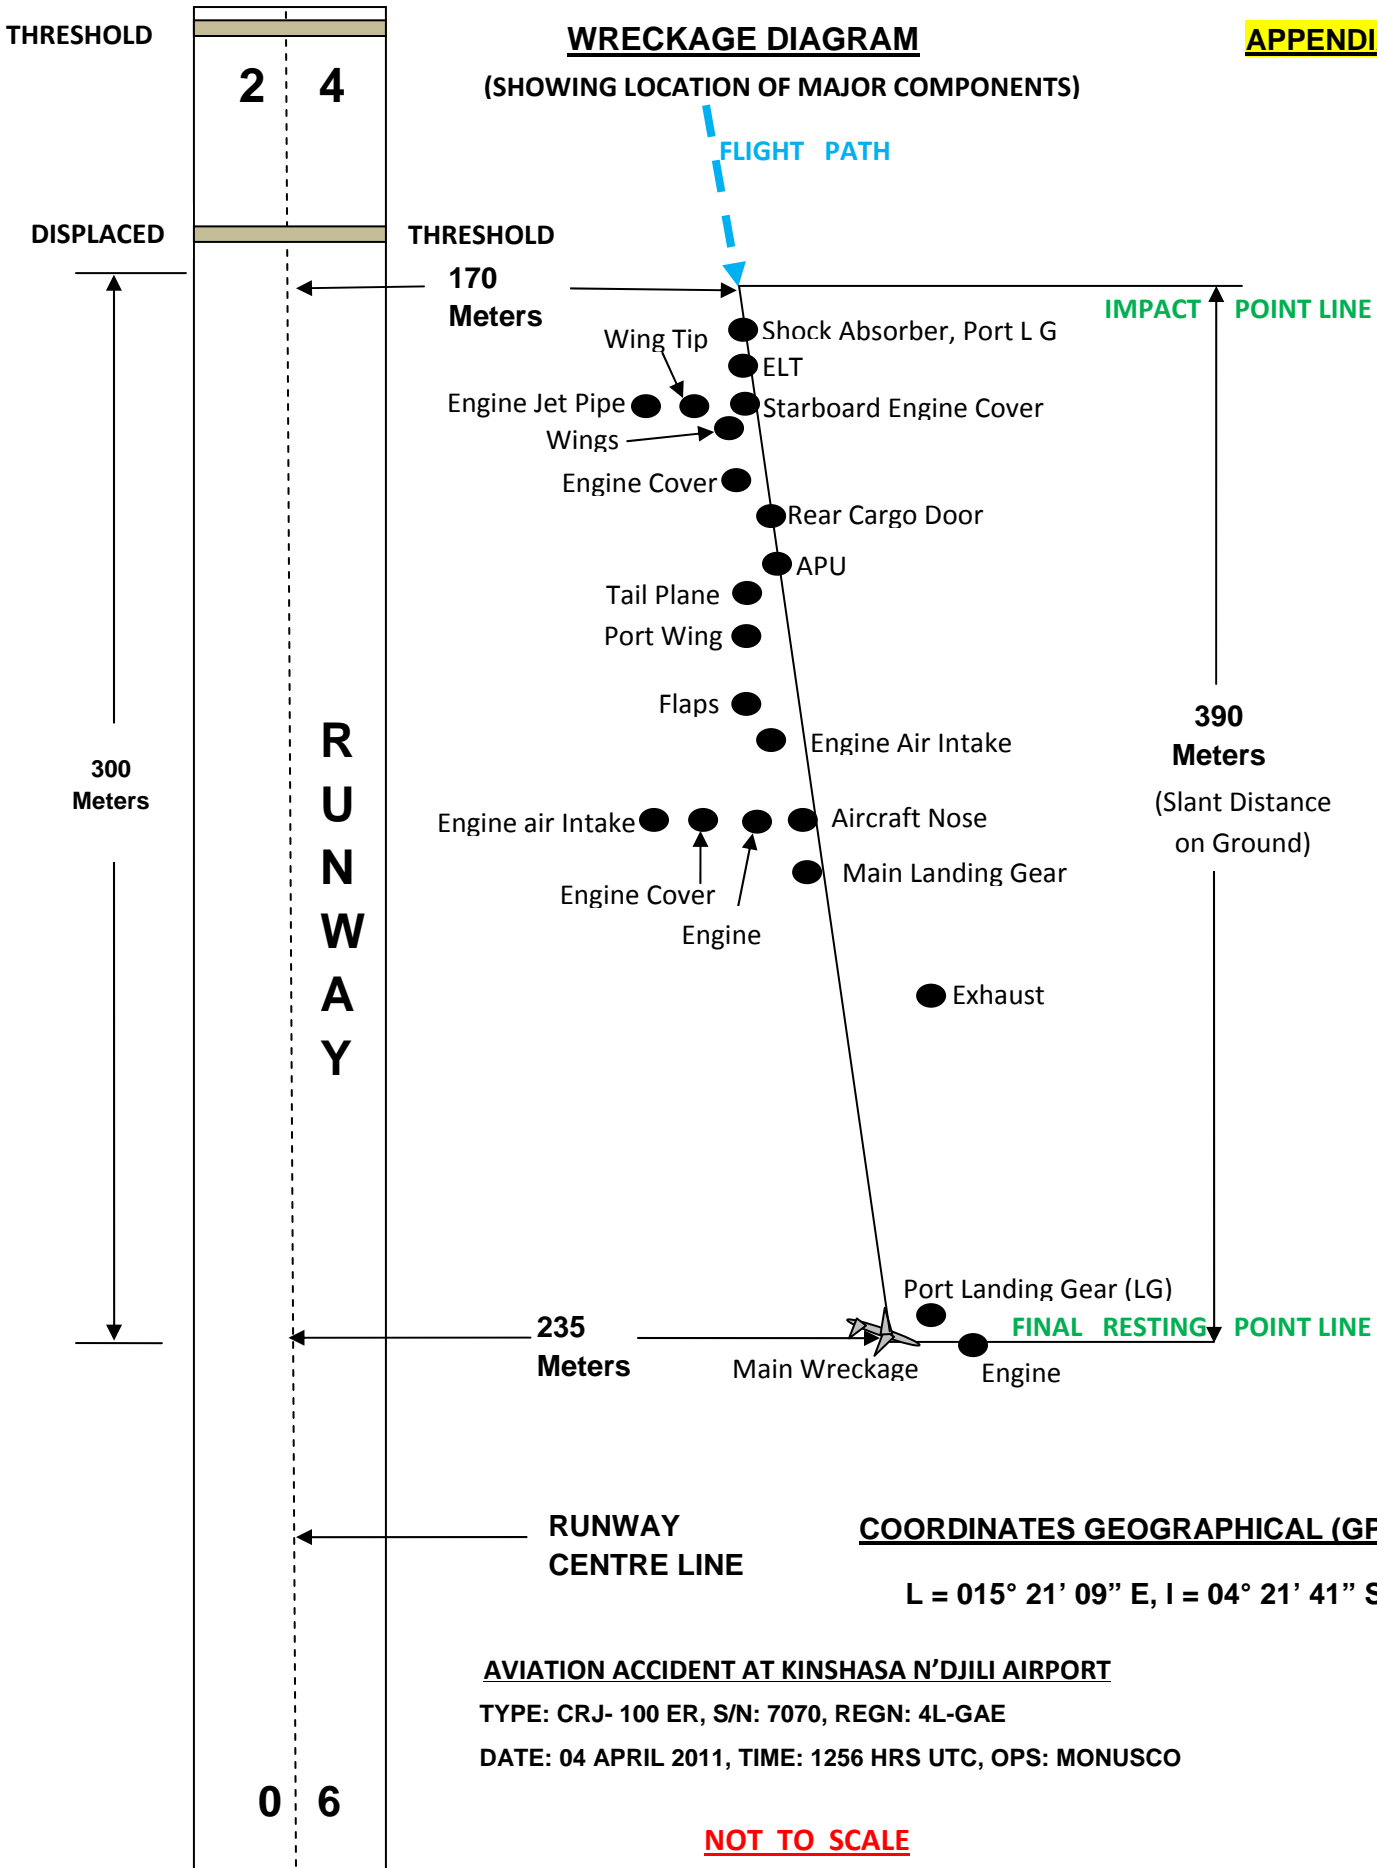
WRECKAGE DIAGRAM

(SHOWING LOCATION OF MAJOR COMPONENTS)
