Runway overrun during taxiing after landing

Aircraft	Airbus A320 registered TS-IMC
Date and time	12 March 2013 at 10 h 15 UTC ⁽¹⁾
Operator	Tunisair
Place	Paris Orly Airport (94)
Type of flight	Public transport
Persons on board	Captain (PNF), co-pilot (PF), 4 cabin crew members, 140 passengers
Consequences and damage	Nose gear slightly damaged

This is a courtesy translation by the BEA of the Final Report on the Safety Investigation. As accurate as the translation may be, the original text in French is the work of reference.

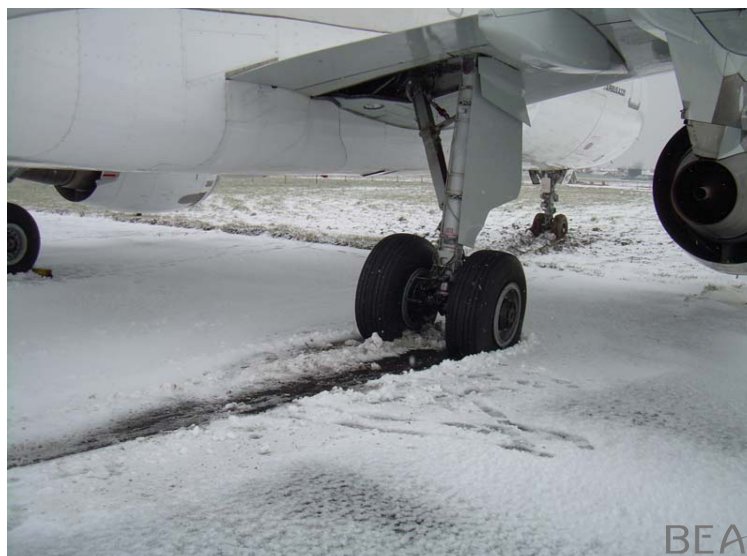
At 10 h 15 min 12, the aeroplane overran the runway at a ground speed of 17 kt (see photo below). It came to a stop four seconds later. The Captain notified ATC and indicated that braking was poor. Emergency teams took swift action.

The inability to measure runway adherence in real time did not allow the uneven runway contamination to be detected. This led to the crew’s and controllers’ degraded perception of braking conditions at the end of the runway, resulting in the overrun.
