Ref. No. CZ -12 - 514

**FINAL REPORT**  
**Investigation into the serious incident of aircraft type ATR 42-500,**  
**registration mark OK-JFJ, at LKPR aerodrome**  
**on October 31, 2012**

Prague  
May 2014

Owner/Operator : Czech Airlines J.S.C.  
Manufacturer and aircraft model: Avions de Transport Régional, ATR 42 – 500  
Registration mark: OK-JFJ  
Site: LKPR, TRA70, FIR Prague  
Date and time: October 31, 2012, 10:40 UTC (all times are UTC)

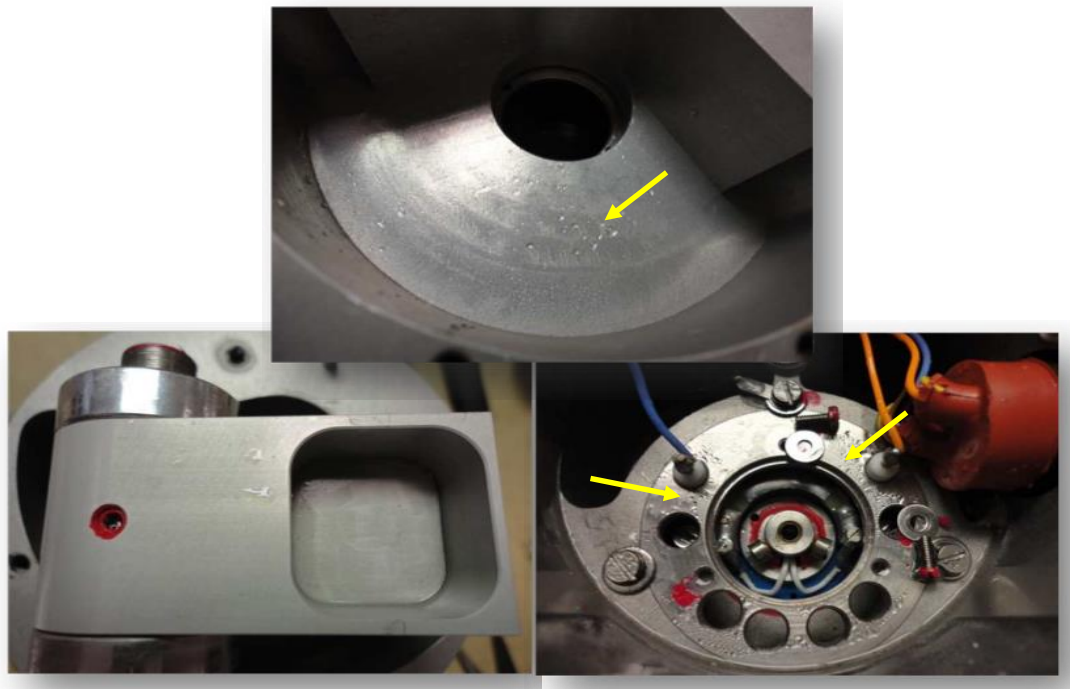
Both AOA sensors p/n C16363AAA (s/n 788 and s/n 2246) were dismantled from the aircraft and handed over to the manufacturer and repair organisation Thales Avionics S.A. in a standard manner. Thales Avionics S.A. was required to put forward a deliverance regarding the found conditions of the sensors and issued the "Teardown report". The report states that the sensors were completely disassembled and no defect in sensor sealing was observed during dismantling. Corrosion was discovered inside the ball bearing of the sensor vane axis. Occurrence of corrosion is attributable to the detected presence of water inside the AOA sensors. Corrosion caused an increase in the force necessary for rotation of sensors' vanes. The measured force value was 0.12 N instead of the permitted value of 0.03 N. The measured value of ohmic resistance of the sensor de-icing heating system was beyond the limit values.

Fig. 2 Photograph of disassembled AOA sensors with water visible in both sensor bodies

cause of malfunction was a temporary blockage of the sensors. Since they both show a similar behaviour almost at the same time, it is very likely that the cause for such blockage must be sought during that flight stage when the temperature of the environment falls below 0°C.

The aircraft stalled during a low speed test flight when the crew was intentionally reducing speed until the stall speed in spite of the Stick Shaker/Stick Pusher (caused by the freezing of the AOA sensors) not being activated. The blocked AOA sensors caused the consequent inoperability of the Stall Protection System (Stall Warning, Stick Shaker/Stick Pusher). It is very likely that water penetrated the AOA sensors during pressure water cleansing of the aircraft coating without sufficient protection of the AOA sensors in the external contractor's paint shop, which resulted in icing blockage of internal movable components of the AOA sensors in the environment with temperatures below zero.

- they incorporated in the Repainting Technical Conditions Manual the duty to cover the AOA sensors prior to commencement of pressure water cleansing in compliance with the figure below.

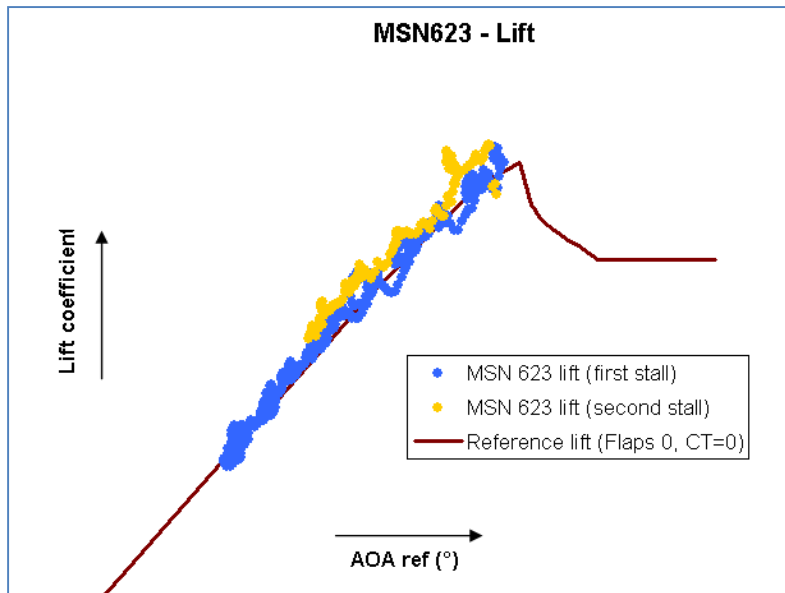
Fig. 4 Diagram AOA ref (°) / Lift coefficient

The comparison between the aerodynamic lift coefficients from the recorded data corresponded with the reference data for an icing-free aircraft in clean configuration regardless of the inaccuracy in determination of the angle of attack or the lift calculation.
