Final Report no. 2211 of the Swiss Accident Investigation Board SAIB

concerning the serious incident (Airprox)

involving the Boeing B737-800 aircraft, EI-ENK
operated by Ryanair
under flight number RYR 3595

and the Airbus A319-111 aircraft, CS-TT
operated by Air Portugal
under flight number TAP 706

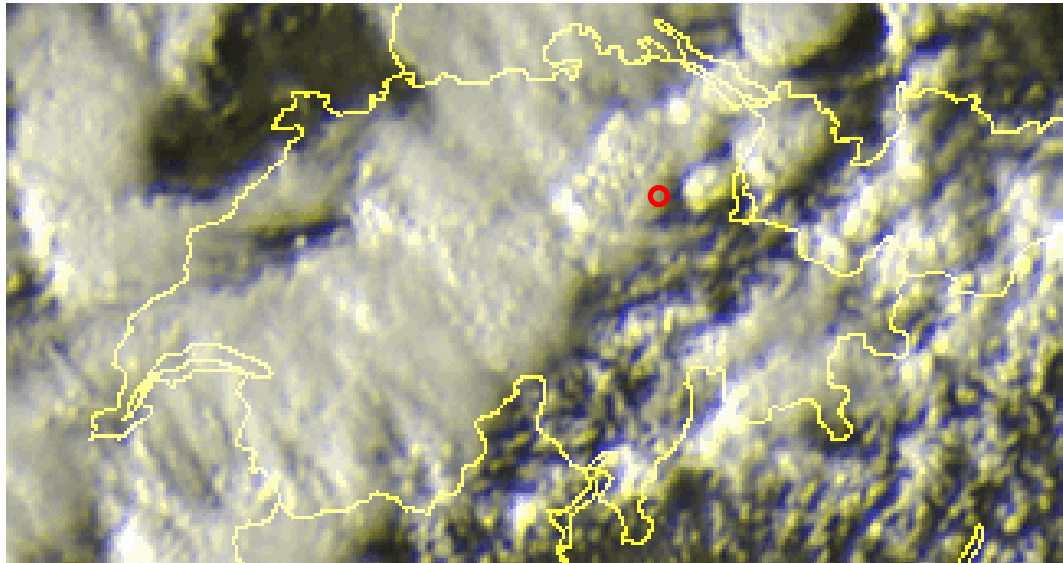
Figure 2: MET10, VIS image of 12 April 2013, 16:00 UTC (<http://www.sat24.com>) (● Location of the serious incident) maximum cloud ceiling approximately FL 295 - FL 320.

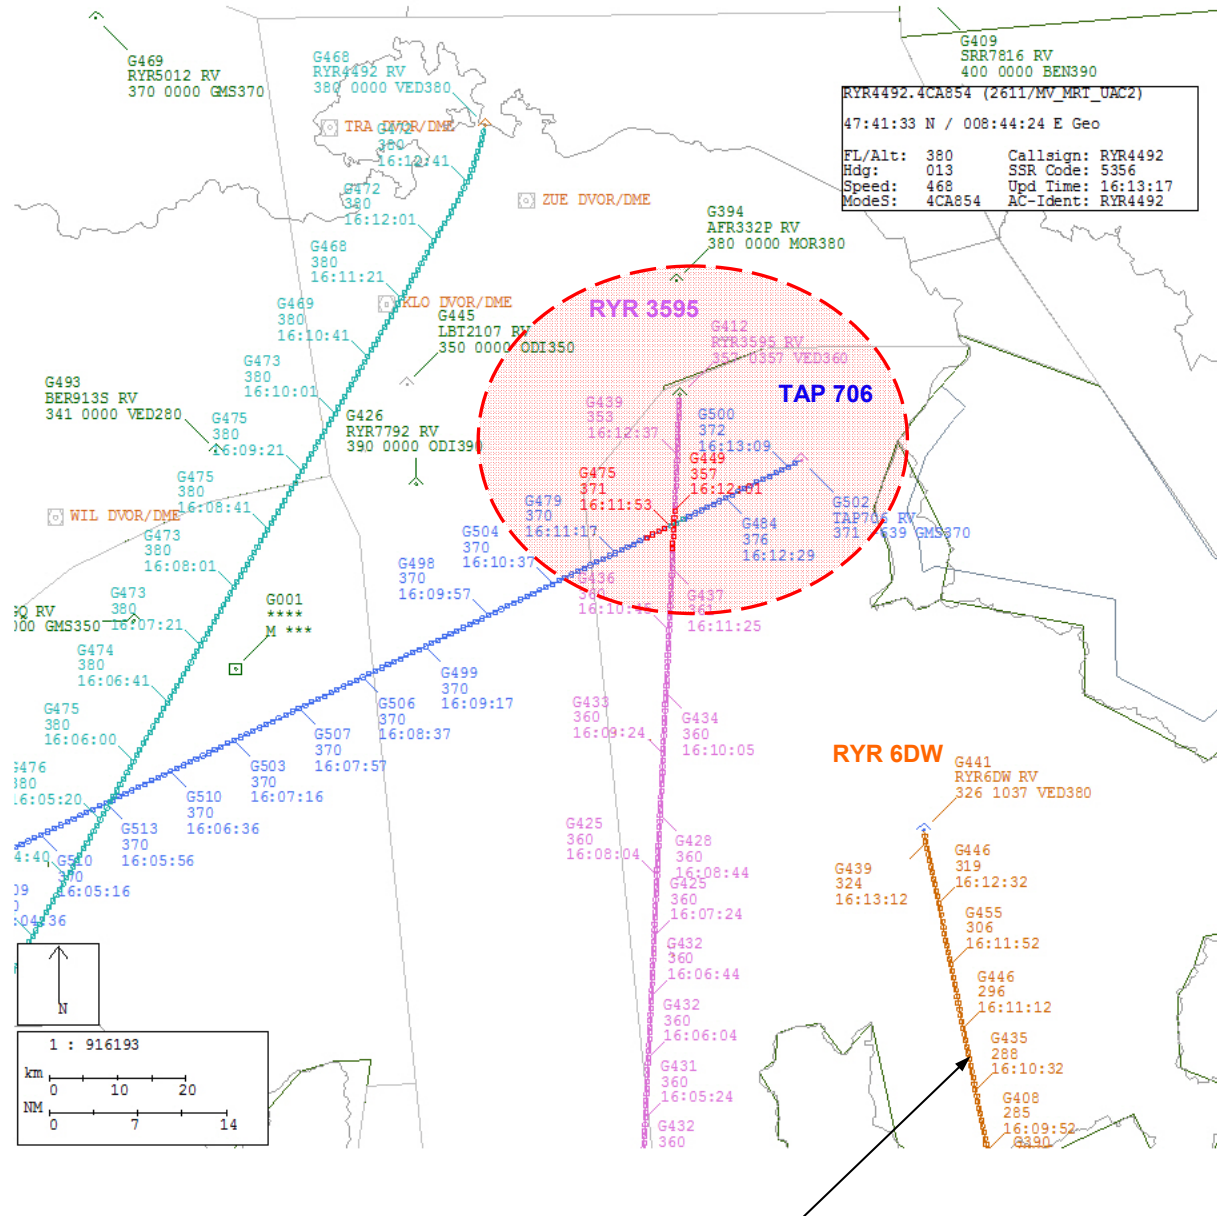
Annex 1: Radar plot of the traffic situation

Between 16:00 UTC and the time of the incident, 19 other aircraft were in contact with the RE air traffic controller, including four other Ryanair aircraft. These aircraft were identified as follows: flight plan callsign RYR 6DW with the radio callsign "Ryanair six delta whiskey", RYR 4492 with the radio callsign "Ryanair four four niner two", RYR 7792 with the radio callsign "Ryanair seven seven niner two" and RYR 5012 with the radio callsign "Ryanair five zero one two" (cf. Annex 1).

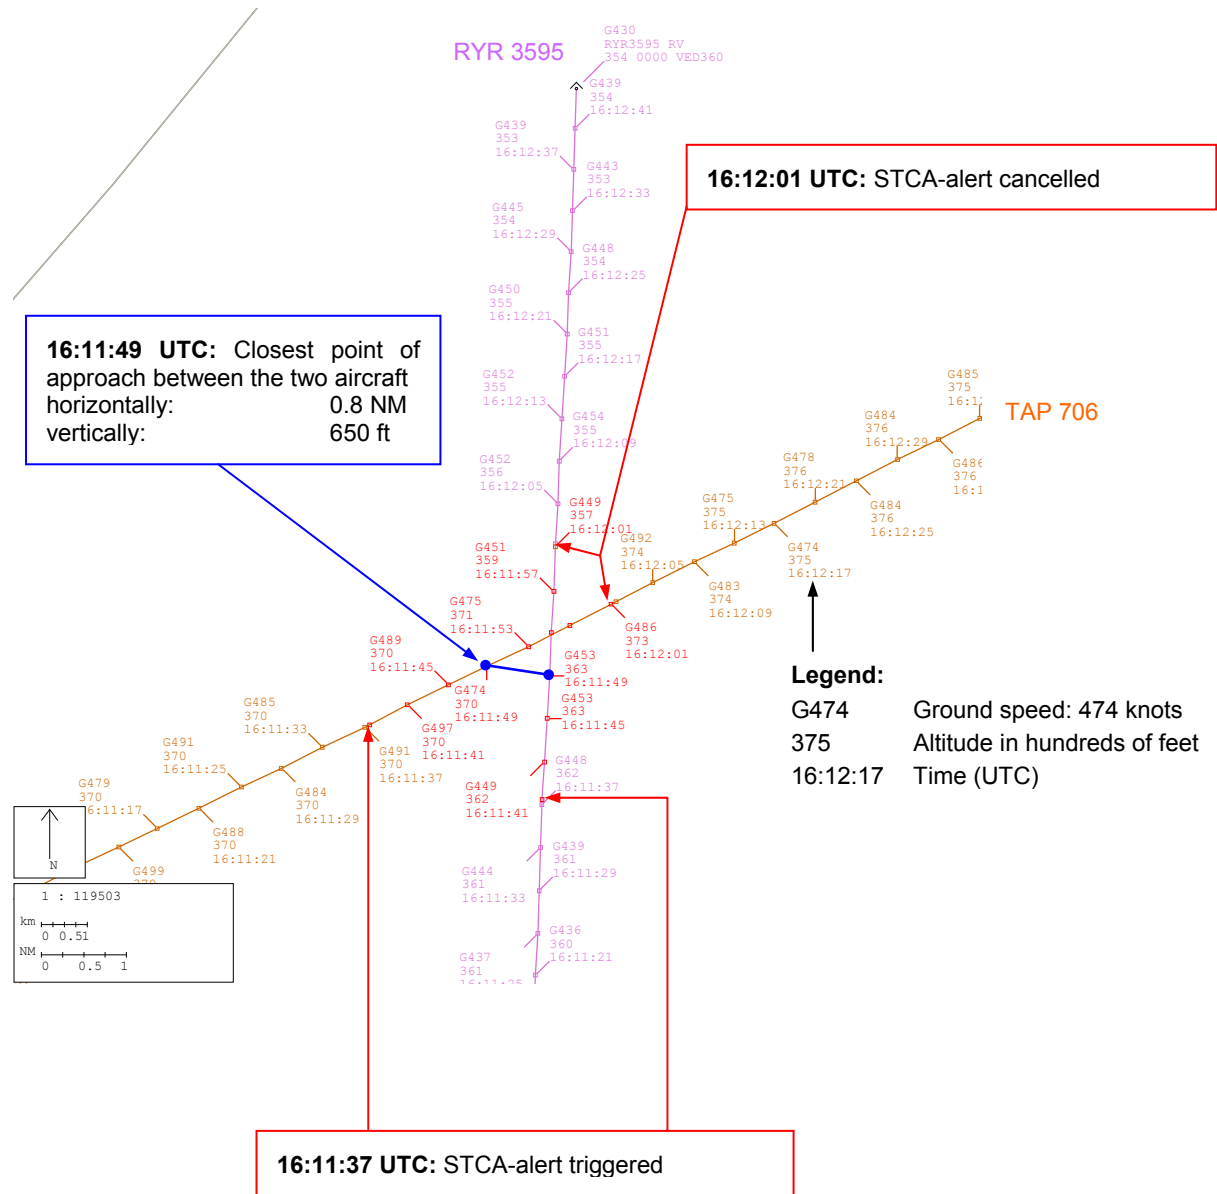
Annex 2: Radar plot at the time of the STCA-alert

At 16:11:37 UTC the Sector M4 short-term conflict alert (STCA) (cf. Section 1.7.2 and Annex 2) triggered an alert in relation to the impending conflict between TAP 706 and RYP 3595. At 16:11:43 UTC the ATCO called the crew of RYP 3595 with the following query: *"Ryanair three five niner five confirm maintaining three six zero?"* The crew answered in the negative, whereupon the ATCO immediately gave them the following instruction at 16:11:49 UTC: *"Descend immediately, traffic three seven zero above."* The crew immediately acknowledged this as follows: *"Descending, Ryanair three five niner five."*
