Fumes event involving an Airbus A330, VH-XFB

Near Perth Airport, Western Australia, 9 June 2014

ATSB Transport Safety Report
Aviation Occurrence Investigation
AO-2014-105
Final – 27 January 2015

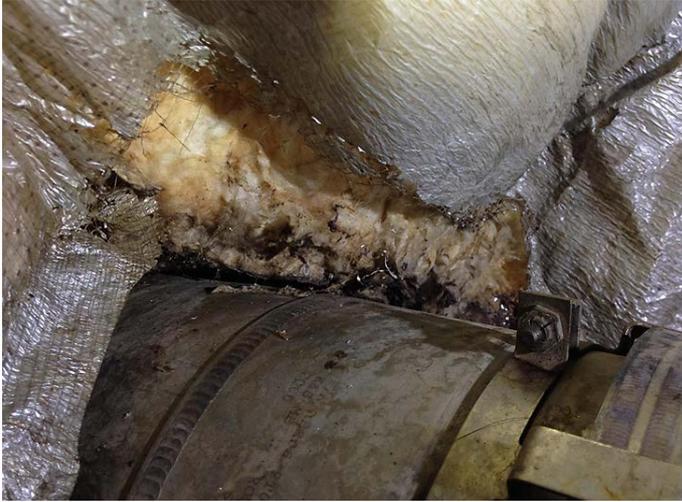
Following the flight, a subsequent engineering inspection found that a portion of insulation blanket fitted to the rear pressure bulkhead of the aircraft had collapsed and came into contact with the Auxiliary Power Unit (APU)¹ bleed air duct, where the duct passes through the rear pressure bulkhead. The engineering investigation determined that the insulation blanket had not been correctly refitted following maintenance by a previous operator of the aircraft.

The insulation blanket is constructed of glass wool encased in a wrapping material. The wrapping was damaged and heat affected where the insulation blanket was in contact with the APU bleed air duct. Damage to the wrapping exposed the inner glass wool material, which also showed evidence of having been affected by heat where the material was in contact with the bleed air duct

(Figures 1 and 2). Engineering staff determined that the insulation blanket in contact with the bleed air duct was the likely source of the fumes.

Figure 1: Insulation blanket damage adjacent to upper surface of APU bleed air duct

The operator found similar damage on another A330 aircraft, registered VH-XFA. As an interim measure, the operator prohibited use of the APU on both VH-XFB and VH-XFA. Both aircraft were then subject to an Engineering Order which required that a section of the insulation blanket adjacent to the APU bleed air ducting to be trimmed and sealed, and that the remainder of the blanket be appropriately restrained. The Engineering Order also required a detailed visual inspection of the rear pressure bulkhead structure immediately around the bleed air duct (looking for signs of heat damage, paint discolouration or distortion). The second part of the Engineering Order directed that the insulation blanket be replaced entirely, as a permanent repair.

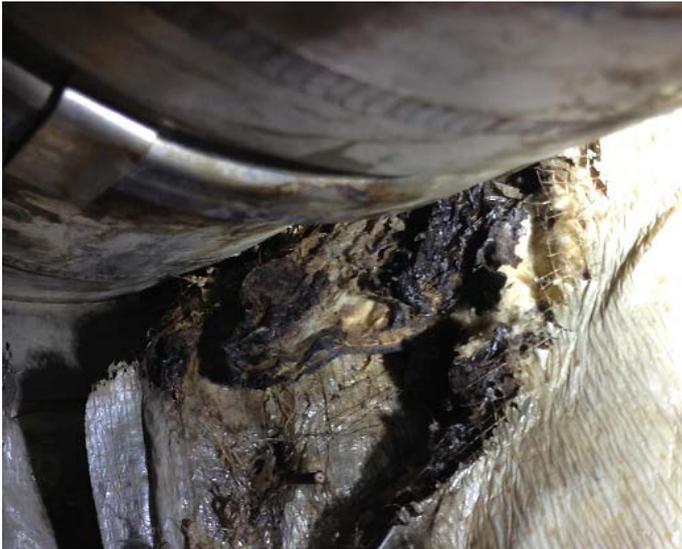
Figure 2: Insulation blanket damage adjacent to lower surface of APU bleed air duct
