**AVIATION INVESTIGATION REPORT  
A12A0082**

**RUNWAY OVERRUN**

**VOLGA-DNEPR AIRLINES  
ILYUSHIN IL-76TD-90VD, RA-76511  
ST. JOHN'S, NEWFOUNDLAND AND LABRADOR  
13 AUGUST 2012**

Report Number A12A0082

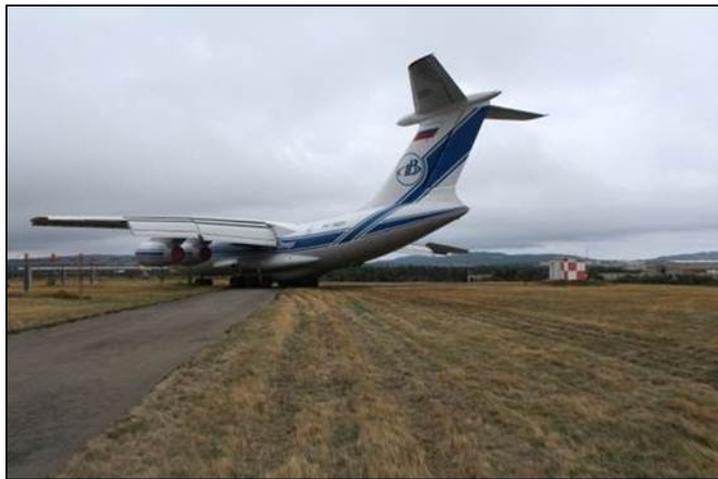
Just prior to departing the end of the runway, the crew manoeuvred the aircraft to the right of the centreline to avoid the multiple rows of approach lights. The aircraft damaged 5 runway threshold lights and came to rest on the Runway 11 localizer service road about 50 feet from the localizer antenna, on a heading of about 064°M (Photo 1).

**Photo 1.** Occurrence aircraft in overrun area

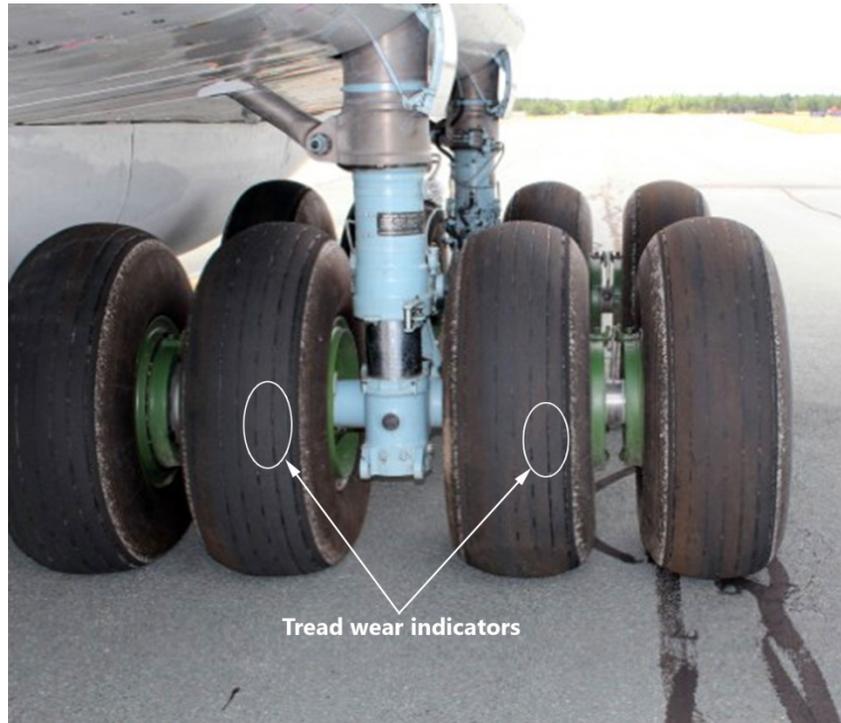
Prior to departing Prestwick Airport, Scotland, the condition of the tires was checked in accordance with the AMS requirement. No unacceptable damage was noted, and all of the tires were considered serviceable. Although the main wheel tires met the serviceability requirements, the Transportation Safety Board of Canada (TSB) noted that all 16 tires were worn to, or below, the tire tread wear indicators (Photo 2).

**Photo 2.** Right-side tires of the occurrence aircraft (after occurrence)

The tire/wheel positions are numbered from 1 to 8, from the left front row to the right front row, and 9 to 16, from the left rear row to the right rear row. A visual examination of the tires after the overrun identified signs of reverted rubber hydroplaning on 8 main tires: 2, 3, 5, 8, 10, 11, 14, and 15.

In this occurrence, all 16 of the main tires were worn in excess of 80%. Using tires that are more than 80% worn reduces wet runway traction, thereby increasing the risk of hydroplaning and possible runway overruns.
