near Adelaide, South Australia | 20 September 2013

ATSB Transport Safety Report
Aviation Occurrence Investigation
AO-2013-161
Final – 5 March 2015

On 20 September 2013, a loss of separation occurred about 17 km west of Adelaide, South Australia, between an Airbus A330 aircraft, registered VH-EBO (EBO) operating a scheduled passenger service from Sydney, New South Wales to Perth, Western Australia, and an Airbus A330 aircraft, registered VH-EBS (EBS), operating a scheduled passenger service from Perth to Sydney. Both aircraft were within radar surveillance coverage at the time of the occurrence and were equipped with a traffic collision avoidance system (TCAS).

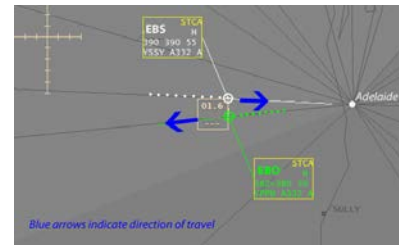
Aircraft proximity at 1213:53

The ATSB determined the en route air traffic controller did not adequately assess the traffic for potential conflicts before issuing a climb instruction to the EBO flight crew. The air traffic control computer system subsequently alerted the controller to the conflict and they promptly commenced compromised separation recovery actions. The flight crew of EBS responded to alerts generated by the aircraft's TCAS. The TCAS in EBO malfunctioned and did not provide the flight crew with traffic information or generate any safety alerts. The reason for the malfunction could not be determined and the equipment manufacturer considered it to be a unique event.

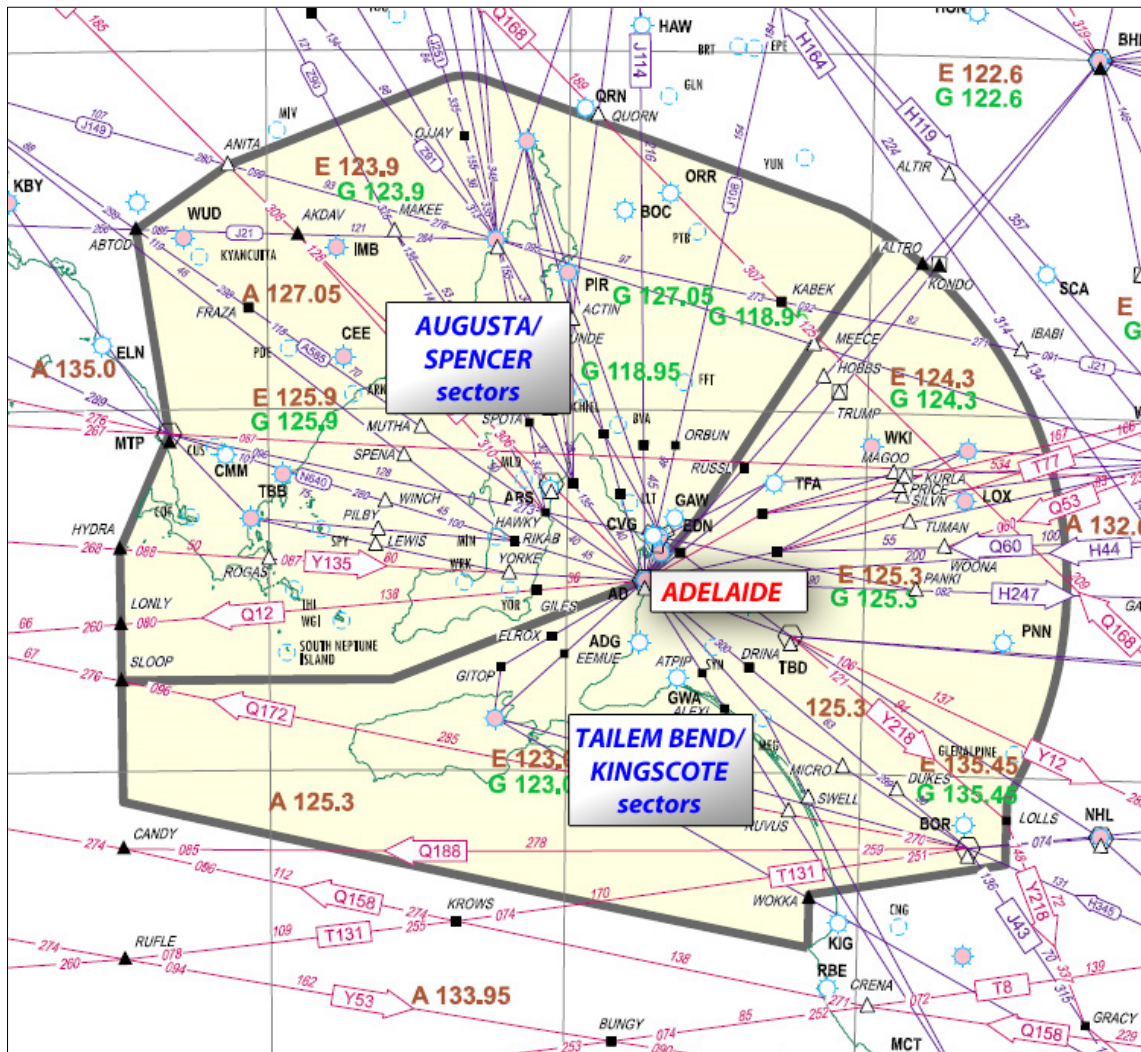
Figure 1: Augusta/Spencer and Taillem Bend/Kingscote airspace sectors

The ATSB identified a safety issue relating to the convergence of many published air routes overhead Adelaide, combined with the convergence point being positioned on the sector boundary of the Augusta and Tailern Bend sectors, which reduced the separation assurance provided by strategically separated one-way air routes and increased the potential requirement for controller intervention to assure separation.

The air routes on which the aircraft involved in this occurrence were tracking at the time of the occurrence both converged over the Adelaide Very High Frequency Omni Directional Radio Range (VOR)¹⁸ ground-based radio navigation aid. Most of the air routes that converged overhead the Adelaide VOR were one way routes. The ATC sectorisation of the high level Augusta (AUG) and Tailem Bend (TBD) sectors resulted in the boundary between the two pieces of airspace crossing overhead the Adelaide VOR, where a number of air routes converged (Figure 1).

Airservices Australia is undertaking a review of air routes and of the Australian airspace design that contributes to risk. There is also consideration to providing more flexible route structures using modern navigation technology to create traffic directional flows and remove convergence points.

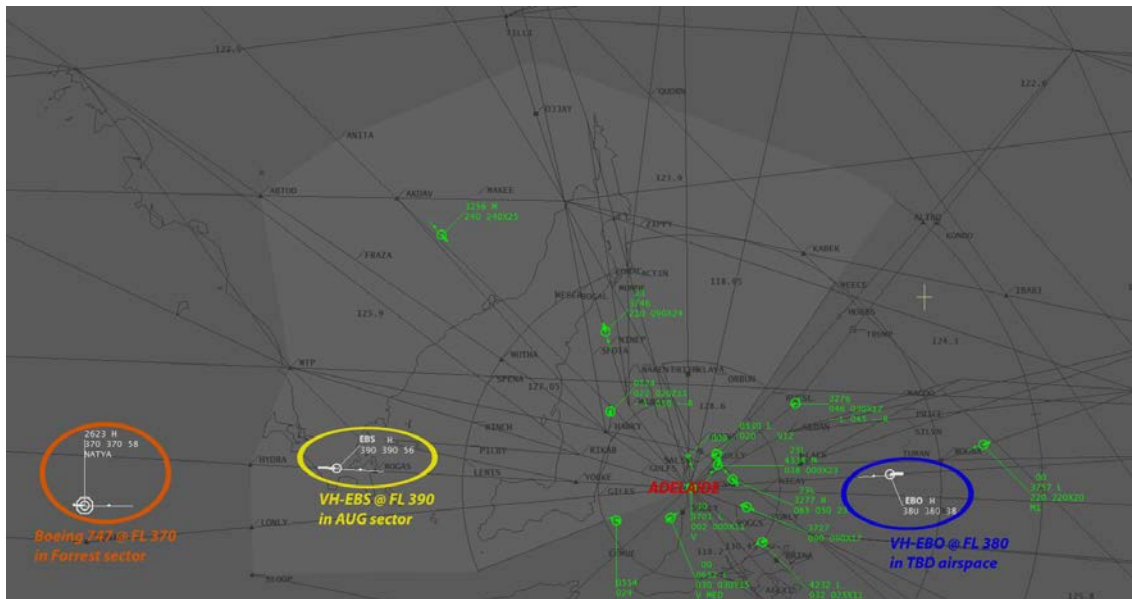
Figure 2: Positions of aircraft at 1159:54

At the time the controller assumed control of the AUG/SPN sectors, EBS was within the AUG/SPN airspace at a position 140 NM (259 km) west of Adelaide, eastbound on the one-way route Y135³ at flight level (FL)⁴ 390. EBO was within the TBD/KSC airspace, 80 NM (147 km) east of Adelaide, westbound on the H44 route at FL 380. An eastbound Boeing 747 (747) positioned to the west of AUG/SPN (in the adjoining Forrest airspace sector) was operating on a flexible track at FL 370 (Figure 2). All three aircraft were operating at conforming flight levels⁵.

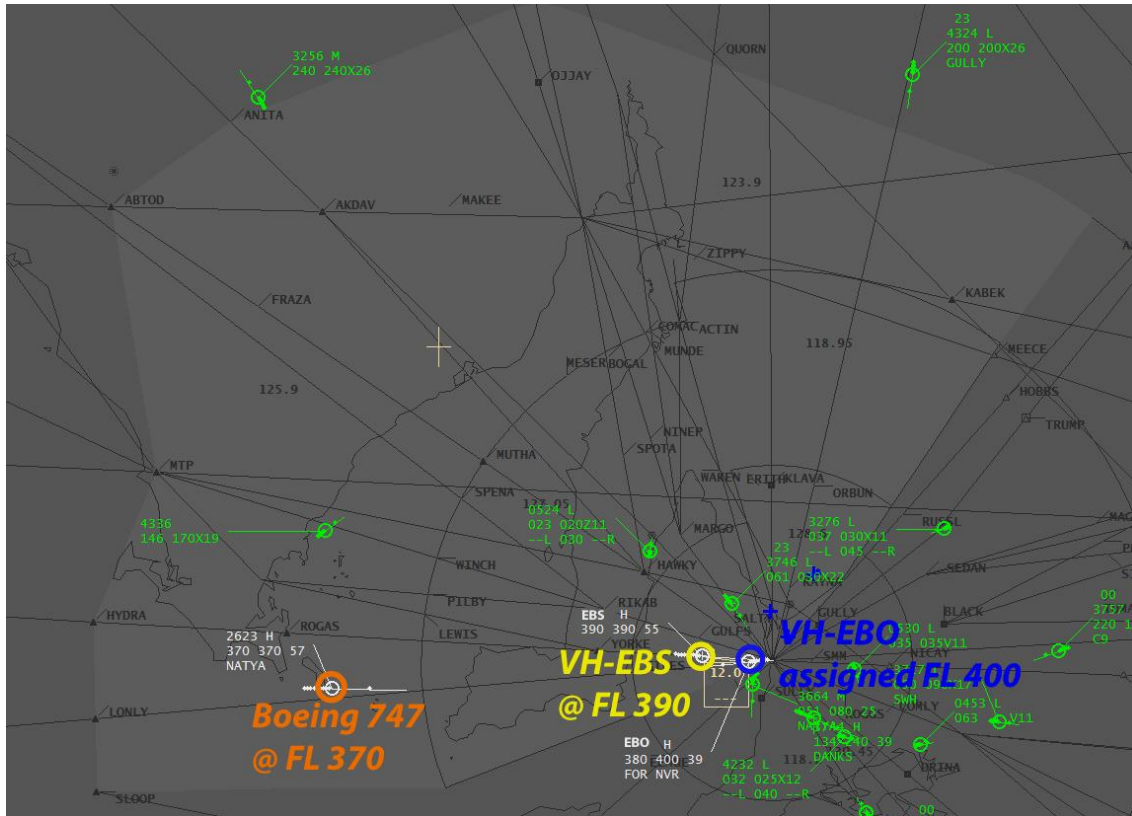
Figure 3: Positions of aircraft at 1213:10

At the time the climb request was approved, EBO was west of Adelaide and westbound on the one-way air route Q12 (Figure 1). EBS was west of Adelaide, eastbound on the two-way route J15 from waypoint YORKE to Adelaide. On receipt of the level change clearance, EBO's flight crew reported leaving FL 380 and recorded data from the aircraft showed that it commenced climbing at 1213:08.

After assigning EBO climb, the controller then designated the track for EBO, followed by the 747 to the west. At that time (1213:10), there was 12 NM (22.2 km) between EBS and EBO (Figure 3).

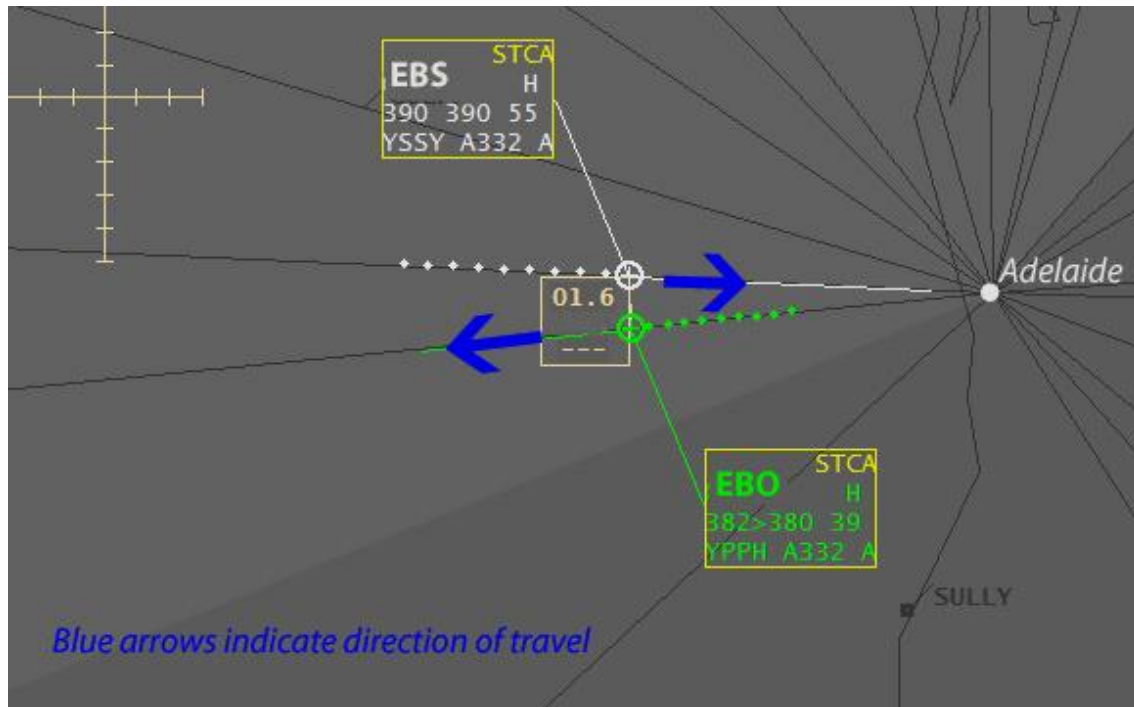
Figure 4: Aircraft positions at 1213:53

Recorded data from the two aircraft showed that the minimum vertical separation was 650 ft at 1213:37, when the two aircraft were 4.1 NM (7.6 km) apart laterally. The minimum lateral separation was 1.6 NM (3 km) at 1213:51, when the aircraft were 870 ft apart vertically (Figure 4). At that time both the vertical and lateral separation were increasing as the aircraft were tracking to intercept separate one-way routes. The vertical and radar separation standards were re-established a short time later.

Note: Data in this figure is provided from the ATC system with a different level of resolution compared to the data provided from the aircraft's recorders. The figures '55' and '39' refer to the ground speeds of the aircraft (divided by 10).
