## AIRCRAFT ACCIDENT REPORT AND EXECUTIVE SUMMARY

Reference:	CA18/2/3/9257	
<b>Aircraft Registration</b>	<b>G-BNLL</b>	<b>Date of Accident</b>	22 December 2013		<b>Time of Accident</b>	20:43Z
<b>Type of Aircraft</b>	Boeing 747- 400		<b>Type of Operation</b>		Air Transportation	
<b>Pilot-in-command Licence Type</b>		ATPL	<b>Age</b>	57	<b>Licence Valid</b>	Yes
<b>Co-pilot Licence Type</b>		ATPL	<b>Age</b>	51	<b>Licence Valid</b>	Yes
<b>Pilot-in-command Flying Experience</b>		Total Flying Hours	±20 050,00		Hours on Type	±12 500.00
<b>Co-pilot Flying Experience</b>		Total Flying Hours	± 5700,00		Hours on Type	± 1400,00
<b>Last point of departure</b>		OR Tambo International Airport (FAOR) at Gauteng in Republic of South Africa.				
<b>Next point of intended landing</b>		Heathrow International Airport (EGLL) at London in United Kingdom.				
<b>Location of the accident site with reference to easily defined geographical points (GPS readings if possible)</b>

## AIRCRAFT ACCIDENT INTERIM REPORT

**Name of Owner** : British Airways PLC  
**Name of Operator** : British Airways  
**Manufacturer** : Boeing Company  
**Model** : B747- 400  
**Nationality** : United Kingdom  
**Registration Mark

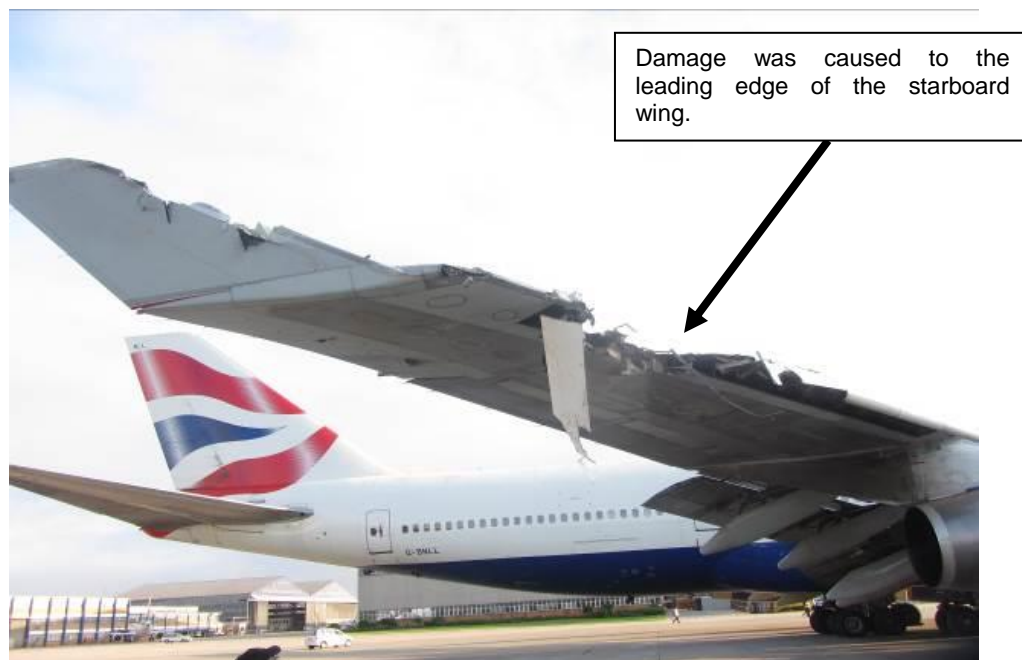
#### 1.3.1 The aircraft sustained substantial damage in the accident.

Figure 4 Damage caused to the starboard wing of the BA034 aircraft

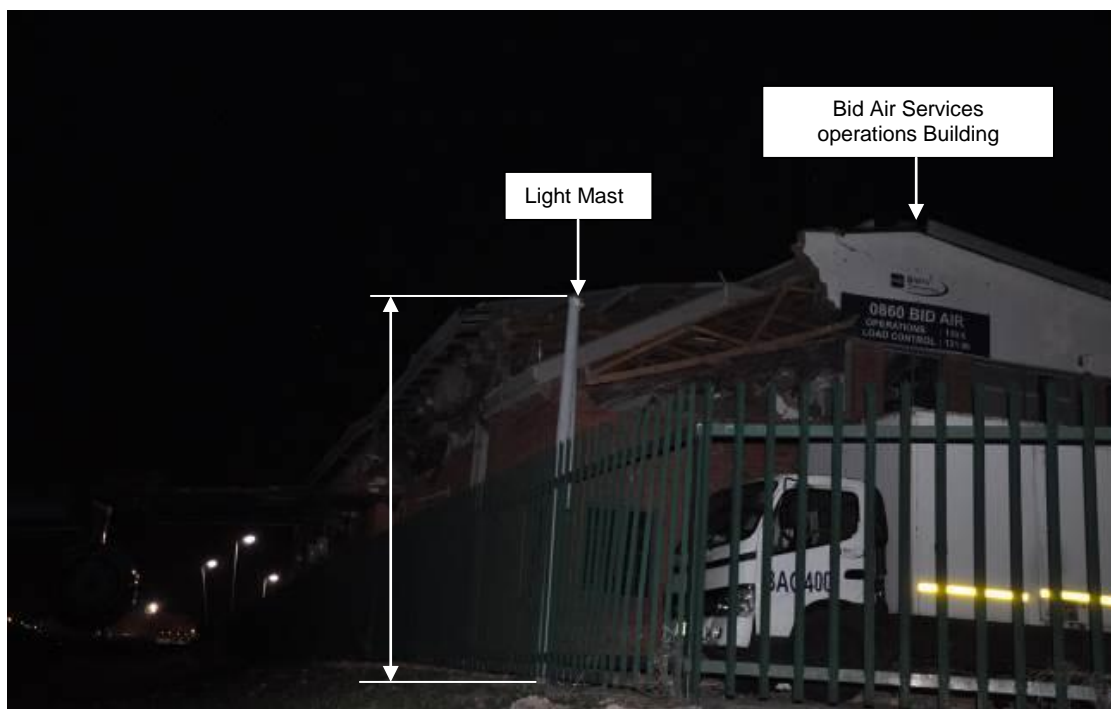
1.4.1.2.1 The first point of impact was determined to be a light mast installed next to the eastern side perimeter fence of the building. The light mast was cut at the same height as where the wing sliced through the hall. The remaining piece of the light mast was found standing at a distance of  $\pm 5$  to 10 meters from the building.

Figure 6 Light Mast damaged in the accident

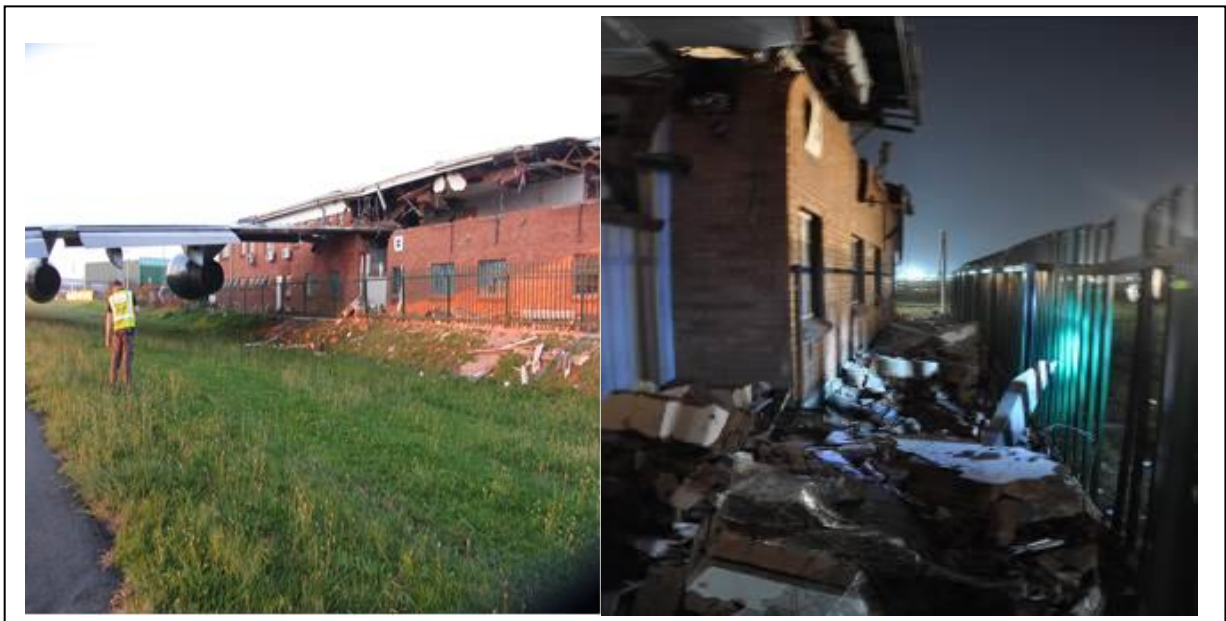
- 1.4.1.2.3 The debris of the building and light mast was found scattered on the premises. The starboard wing was visibly wedged in the building halls.

Figures 8 and 9 BA034 wing wedged in the building halls and debris of building material

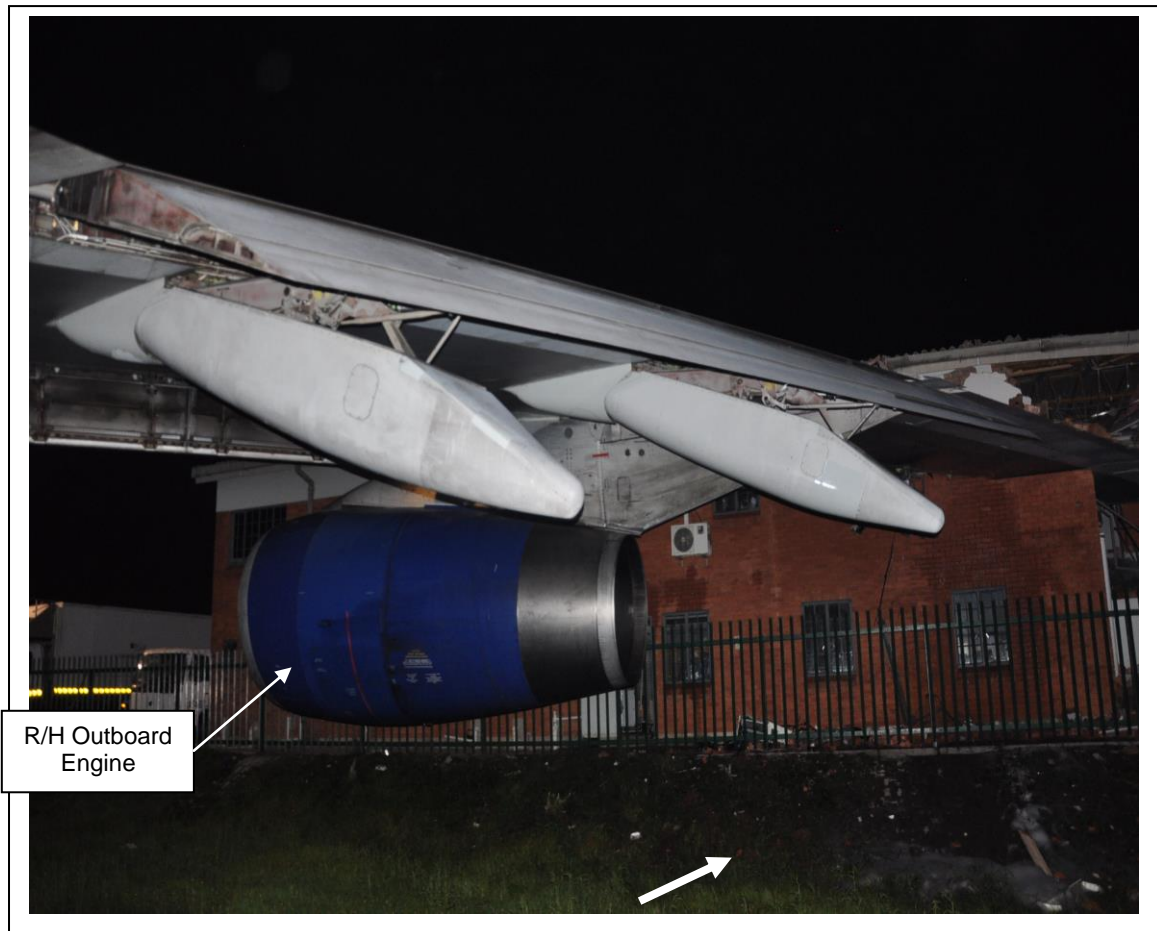
1.4.2.1 Owing to the collision with the BidAir Services building, a large quantity (kilograms) of fuel was spilled, which caused extensive environmental damage.

Figure 10 Fuel spillage and fire fighting agent (foam) stains on building hall and grass below the point where the wing came to a stop.

1.4.2.2 The evidence was that the large quantity of fuel spillage filtered through the grass into the soil off the parameter fence of the building. In order to correctly determine the extent and nature of environment damage, the Operator (British Airways) in consultation with ACSA immediately contacted a locally based service provider, namely HazRisk Solutions. The service provider had to carry out an environmental damage assessment. The result of the assessment was that a jet-fuel spillage soil remediation was required.

1.4.2.3 On 23 to 25 January 2014, HazRisk Solutions performed the soil remediation process. The last work was completed on 3 March 2014.

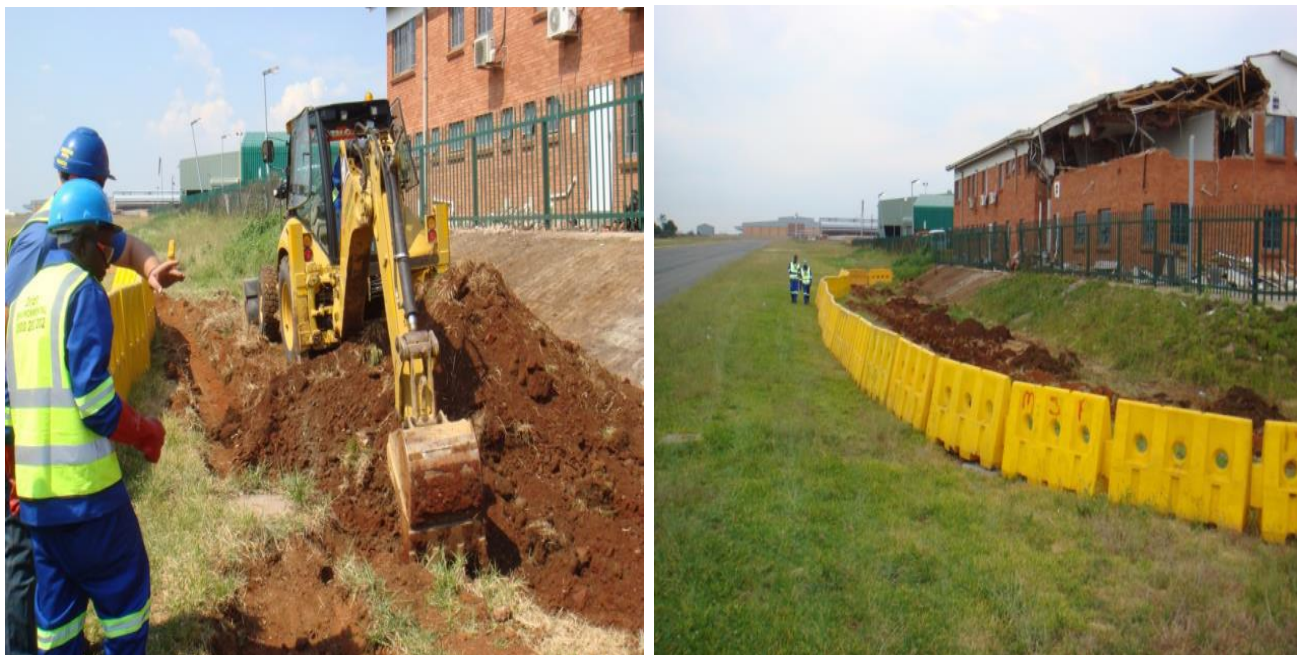
Figure 11 and 12 Remediation of the fuel spillage area

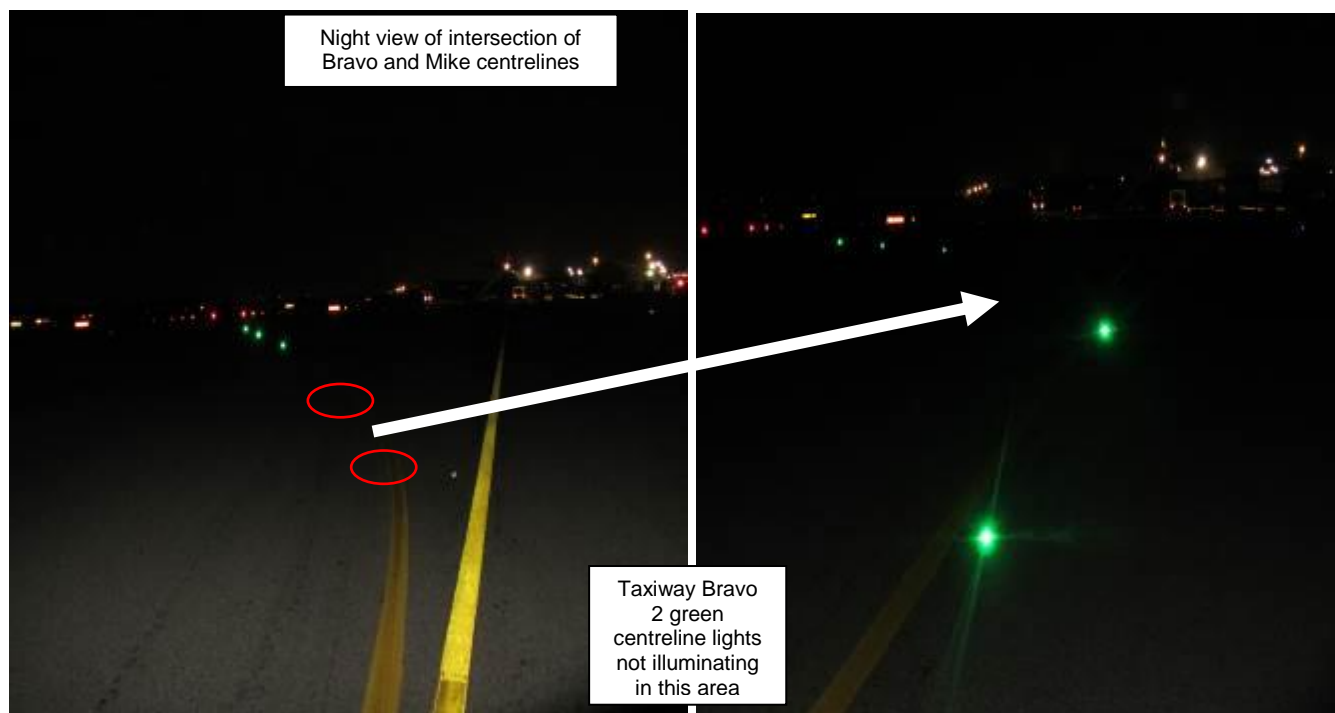
- It is important to note that 2 centreline lights installed on the curve/bend of Bravo toward the Category 2 holding point were found unserviceable (not illuminating). The picture below was taken on the night in question showing the location of the 2 unserviceable centreline lights.

Figure 18 & 19 Two centreline lights not illuminating on curve to Cat 2 holding point

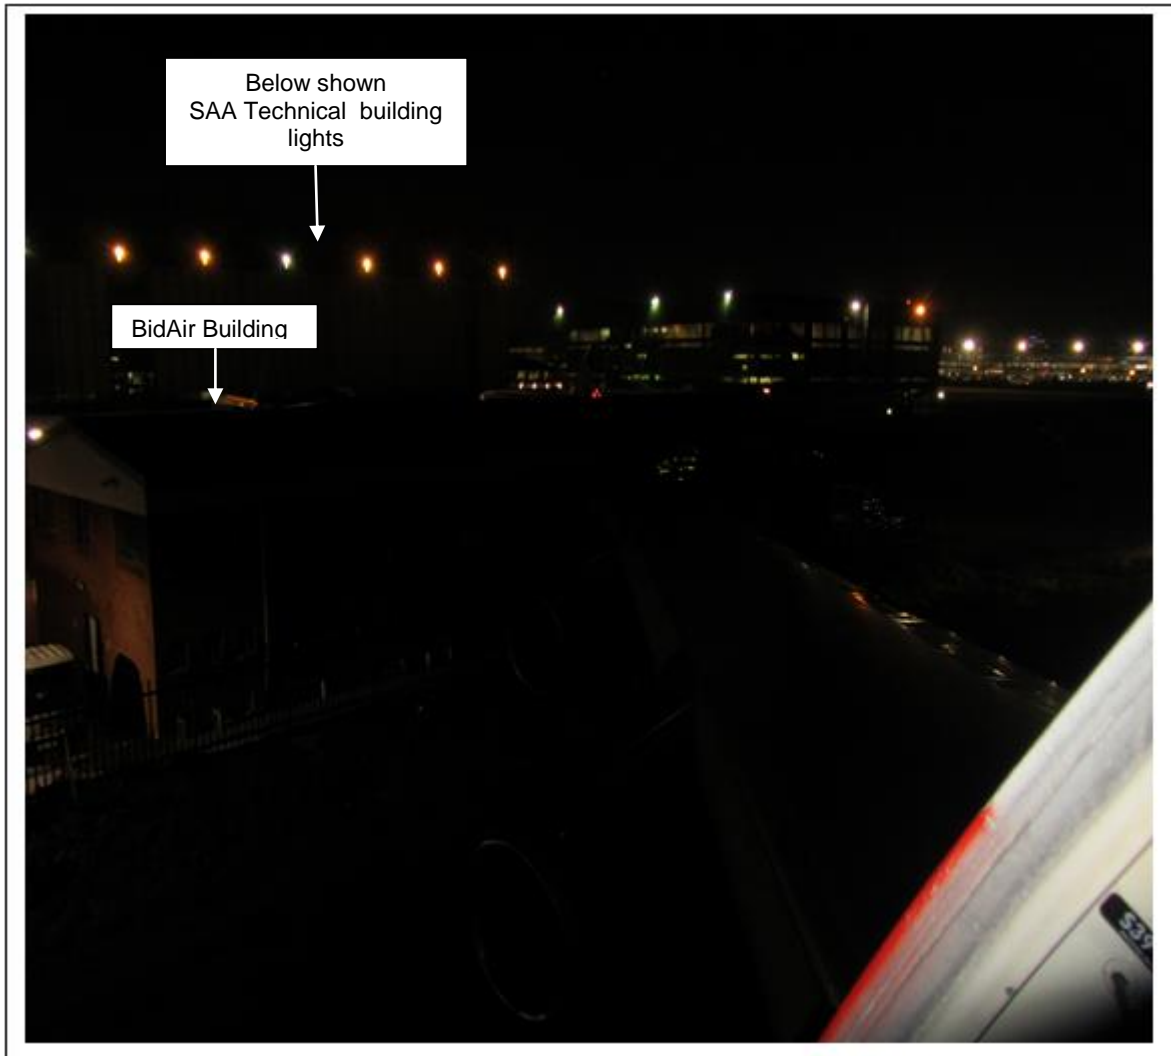
1.11.4.15 The Captain indicated that the Co-pilot could not judge the proximity of BA034 to the building because of the strong apron background glare. The evidence of the A-SMGCS, FDR and CVR shows that BA034 had long since passed the aprons. The investigation determined that the background glare which the Captain referred to might be the lights on the right side from the SAA technical building.

Figure 36 SAA technical building lights at the back of BidAir Services building toward the right side

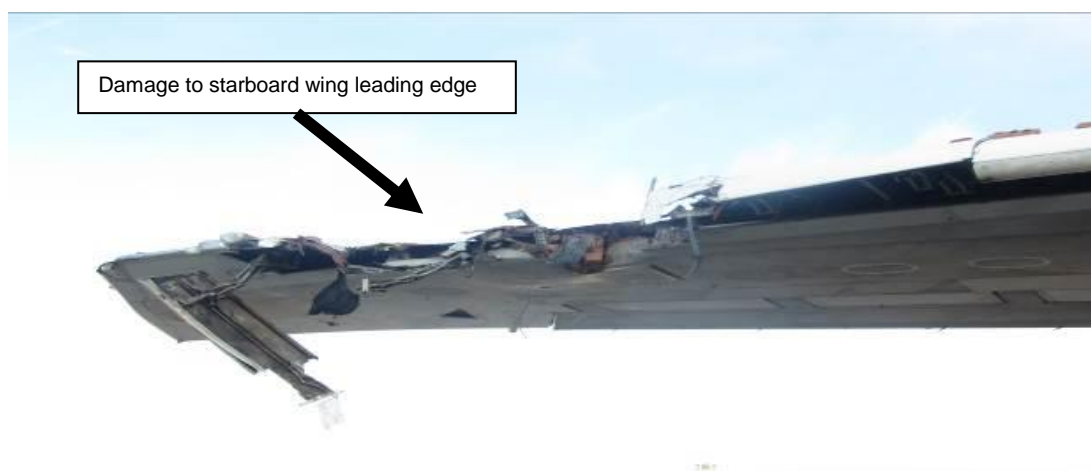
1.12.2.1 BA034 starboard (right side) wing impacted the BidAir Services building. The identified wing and its structural elements had sustained substantial damage resulting from the impact.

Figure 40 Damage caused to wing leading edge
