Final report RL 2015:10e

**Serious incident on 31 January 2014
involving the aircraft ES-PJR of the model
Bae Jetstream 3200, operated by AS Avies
at Torsby airport, Värmland county.**

File number L-0018/14

22/06/2015

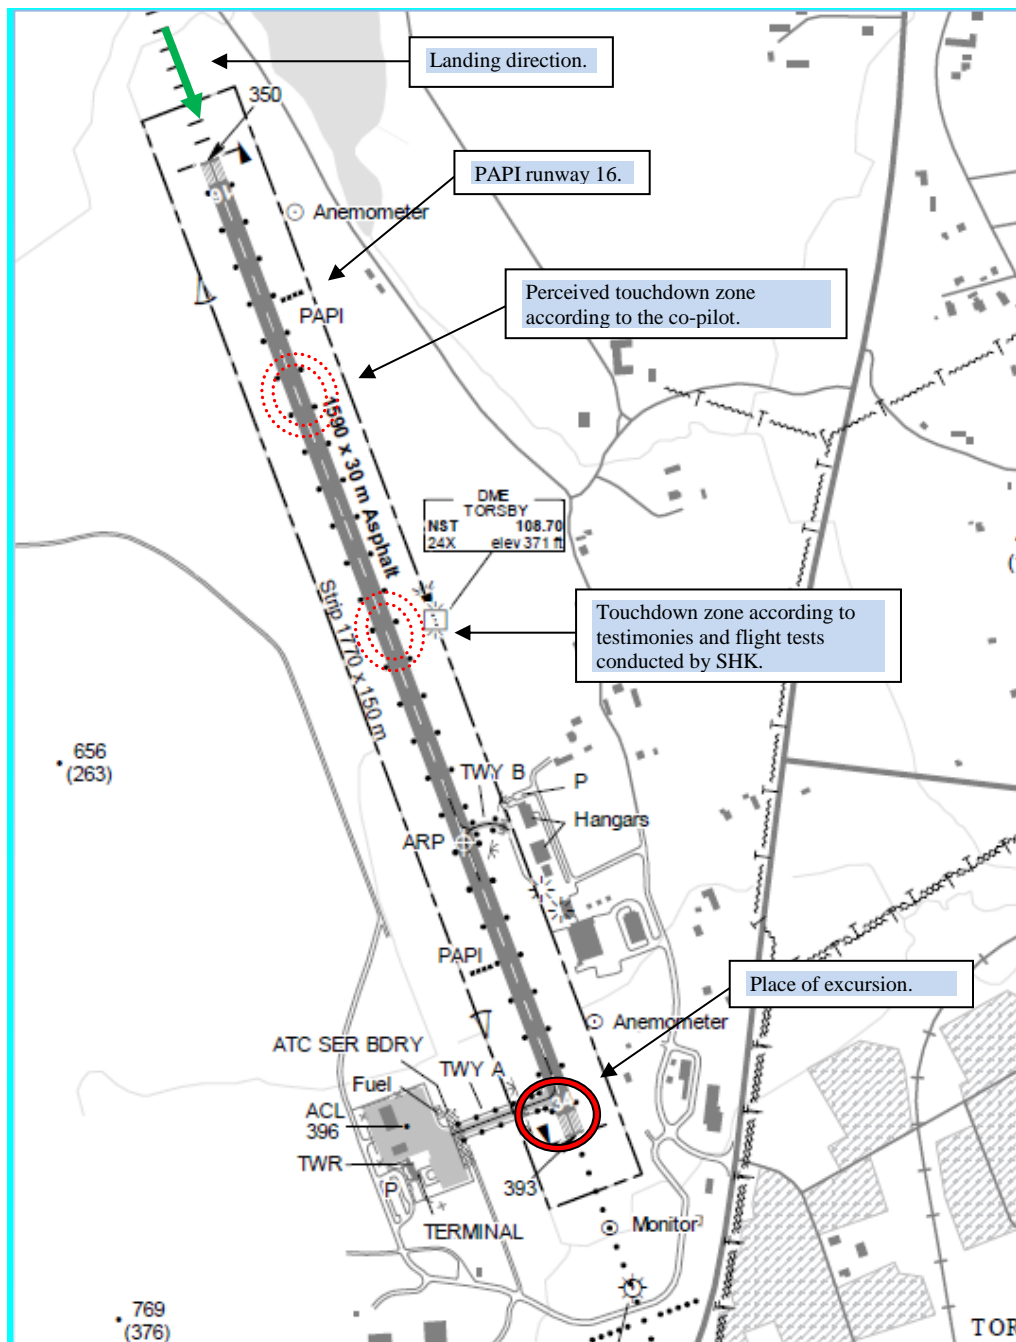
Figure 7. Torsby Airport marked with places relevance for the event.

Figure 7 above shows the zone where the crew perceived the landing to take place, as well as the zone where the touchdown was executed according to the testimonies. The remaining runway length from this touchdown zone is about 800 metres.

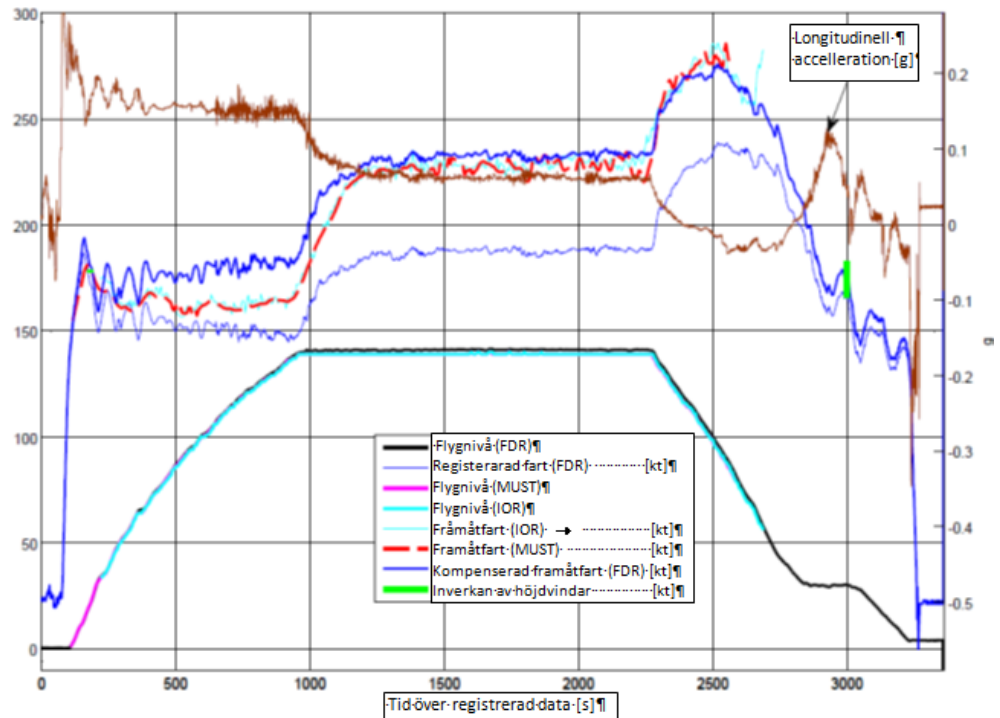
Figure 8 shows a graph of altitude, speed and longitudinal acceleration from the flight in question. The values are based on FDR data, radar data from MUST²⁹ and civil radar data in the form of IOR files. However, radar data did not cover the entire sequence.

Figure 8. The aircraft's altitude, speed and longitudinal acceleration.

The graph shows that the recorded speed during the last 50 seconds of sequence was 20 knots. However, during that time, the aircraft was standing still on the ground. It is also possible to see that where the retardation transitions to a constant value in the final phase, the forward speed is 0 knots for a short while and thereafter rises to 20 knots. The forward speed can also be calculated by means of the time integral of the acceleration. The constant term formed in integration constitutes a boundary condition and is set to 0 knots where the acceleration becomes constant.

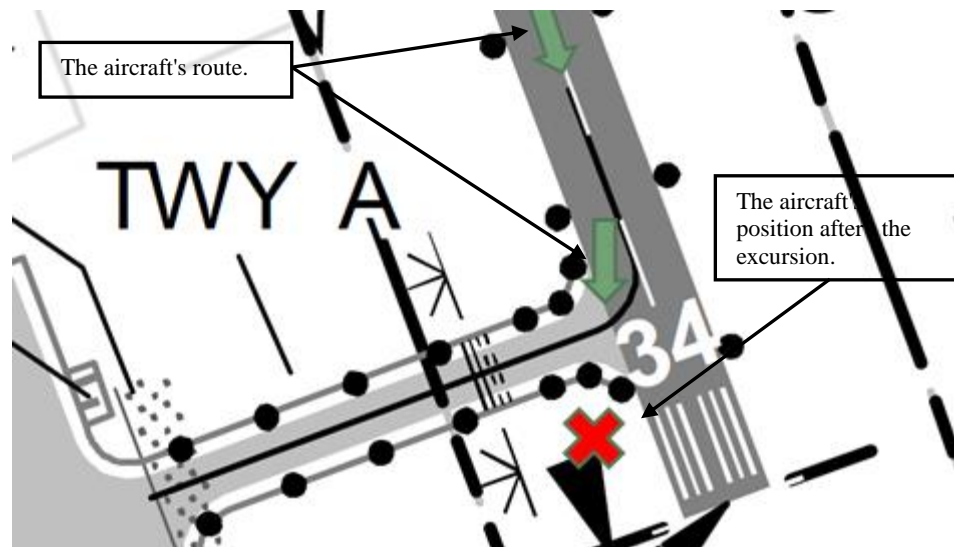
The snow depth at the site in question was about 30-40 cm, for which reason the aircraft was rapidly slowed after the excursion. In the incident, several taxiway lights were passed without being damaged

by the aircraft's wheels. Figure 10 below marks the aircraft's final position after the incident.

Figure 10. Subsection of the airport from AIP with the site of occurrence marked.

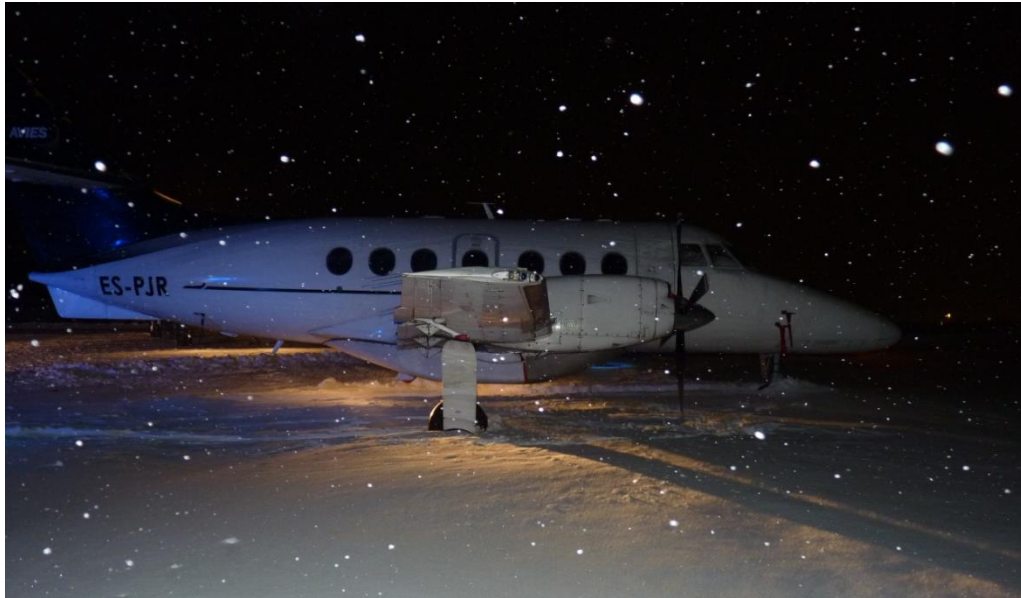
When braking, the surface was perceived as “very slippery”. SHK sees no reason to question this assertion. As previously mentioned, 17 minutes had elapsed since the latest friction measurement, and given the continuous snowfall, it is likely that the friction coefficient had gradually deteriorated.

Figure 13. The aircraft after the excursion. Photo: Torsby Airport

When the commander realised that the aircraft would not be able to be brought to a stop before the runway end, he chose to attempt to turn to the right onto the taxiway, see Figure 13. It has not been evaluated as to whether an excursion straight ahead would have entailed any other consequences, but the excursion that took place in the present case was successful in that no injuries/damage arose, either inside or outside the aircraft.
