# **Air Accident Investigation Unit Ireland**

**SYNOPTIC REPORT**

**SERIOUS INCIDENT**

**ATR 72-212A, EI-REL**

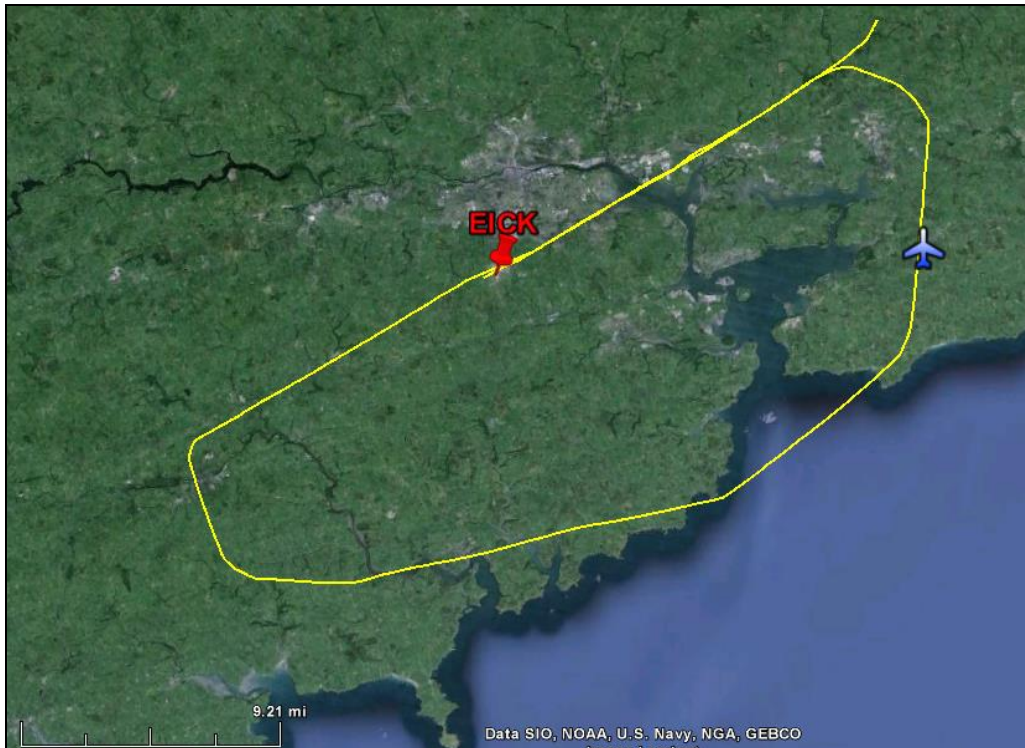
**Figure No. 1:** Track of EI-REL between First and Second Approaches.

The Flight Crew were faced with a very rare but significant issue when the forward visibility through their windscreens was obscured due to sea salt accretion on the windscreens, while attempting a night landing at EICK during a winter storm. Their first approach to RWY 25 had resulted in a go-around which was entirely due to a significant increase in indicated airspeed on finals. At that time, there was no issue with forward visibility. The aircraft was then positioned back onto finals by radar vectors issued by ATC, while two other aircraft made approaches to EICK. The track followed was initially to the southwest on the runway heading, followed by left turns under radar control, which brought EI-REL back to the east of the airport along a ground track which was south of EICK, close to the coast and at times over the sea at an altitude of 3,000 ft.

It is likely that the aircraft windscreens began picking up the sea salt contamination while flying along this track, although its presence at that stage is unlikely to have been of particular significance to the Flight Crew, in the absence of strong external light sources.

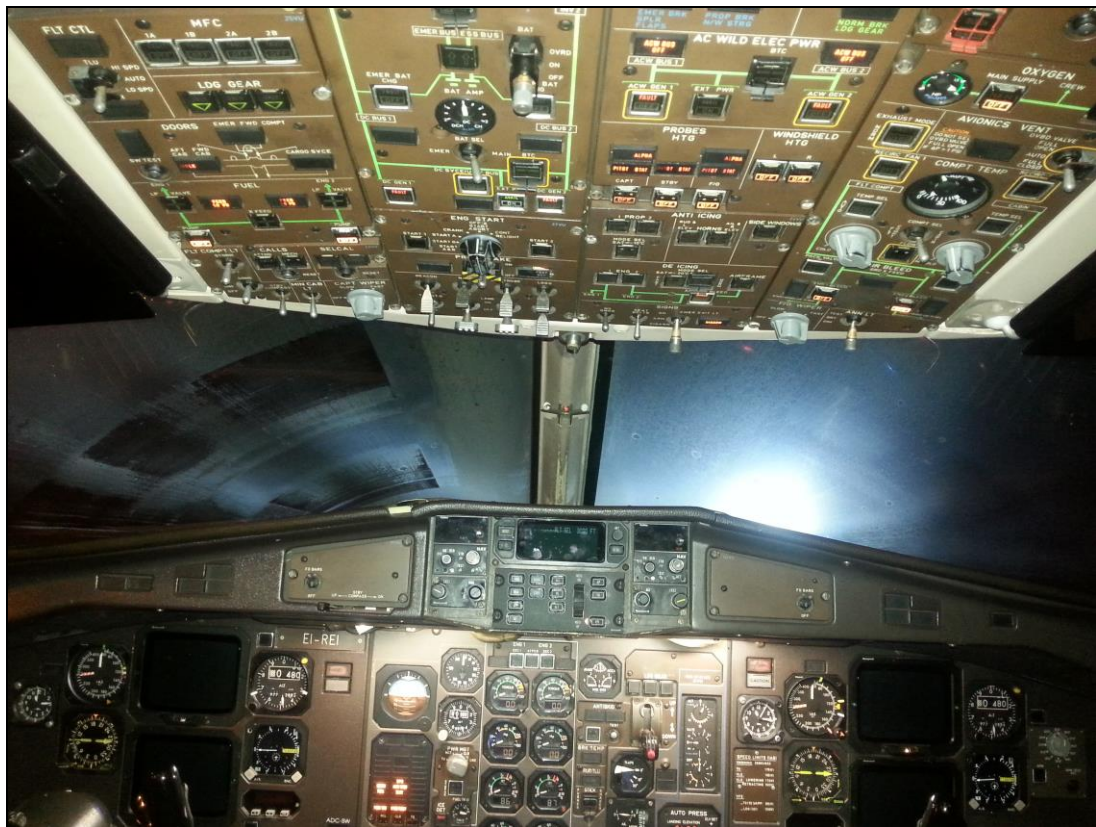
He said that the accretion seemed to be a fast and invisible process. Although the aircraft was VMC, due to the level of turbulence and the type of approach (VOR) being carried out, the Flight Crew's focus was on their instruments rather than on the outside. He felt that the salt accretion occurred during a few minutes, turning the windscreen condition from clear to a blur. The Flight Crew tried to clear the windscreen using both wipers, but to "*absolutely no effect*". The Operator provided photographs of the contamination on EI-REI taken after it had parked, one of which is reproduced as **Photo No. 1**.

The Commander of EI-REL told the Investigation that the salt accretion on her aircraft was thicker than that shown on the photograph of EI-REI.

**Photo No. 1:** Contamination on Windscreen of EI-REI which landed at EICK shortly before EI-REL.

Another ATR 72 landed shortly before EI-REL's second go-around. It also suffered salt contamination on its front windscreens, although to a lesser extent than EI-REL. The other aircraft had not flown at low level over the sea. It is noteworthy that the Flight Crew of EI-REL and the commander of the other ATR 72 both stated that the windscreen wipers were ineffective in clearing the salt residue. The Commander of EI-REL also stated that she believed that the windscreen heat had exacerbated the issue by drying out the salt and enabling a thick layer to form.

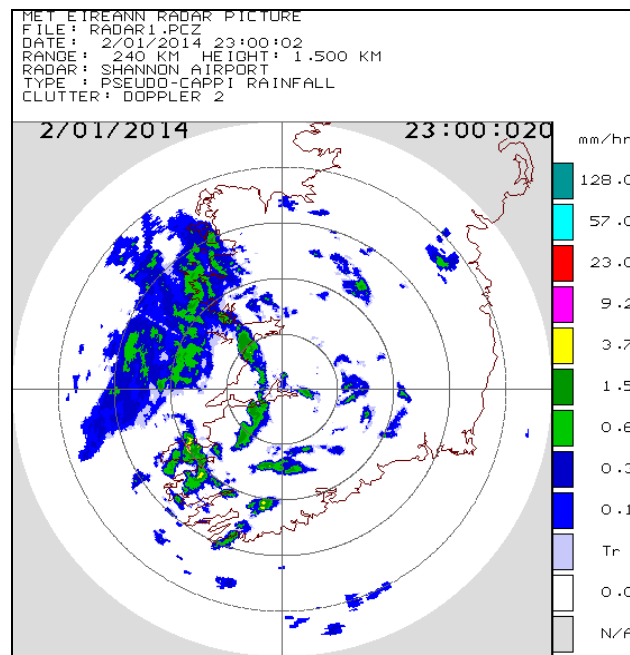
Met Éireann reported that the METAR<sup>11</sup> for EICK at 23.00 hrs suggested NIL weather. However, potential for showers did exist at the time in the vicinity. The Report continued, *"It should be noted that RADAR imagery taken at 23.00 hrs shows the EICK area to be echo free - implying that any showers that may have existed in the region of Cork Airport were very light."*

This radar imagery is reproduced in **Figure No. 2**.

**Figure No. 2:** Radar Imagery at 23.00 hrs.
