# Airbus A321-231, G-MIDJ

<b>AAIB Bulletin No: 6/2004</b>	<b>Ref: EW/C2003/05/03</b>	<b>Category: 1.1</b>
<b>INCIDENT</b>		
<b>Aircraft Type and Registration:</b>	Airbus A321-231, G-MIDJ	
<b>No &amp; Type of Engines:</b>	2 V2533-A5 International Aero turbofan engines	
<b>Year of Manufacture:</b>	1999	
<b>Date &amp; Time (UTC):</b>	26 May 2003 at 1543 hrs	
<b>Location:</b>	In the cruise at FL340, 70 nm south-east of Vienna	
<b>Type of Flight:</b>	Public Transport	
<b>Persons on Board:</b>	Crew - 8	Passengers - 213
<b>Injuries:</b>	Crew - None	Passengers - None
<b>Nature of Damage:</b>	Significant damage to radome, flight deck windows, stabiliser leading edges and engine nacelles	
<b>Commander's Licence:</b>	Airline Transport Pilot's Licence	
<b>Commander's Age:</b>	42 years	
<b>Commander's Flying Experience:</b>	11,457 hours (of which 262 were on type)	
	Last 90 days - 184 hours	
	Last 28 days - 49 hours	
<b>Information Source:</b>	AAIB Field Investigation

## Synopsis

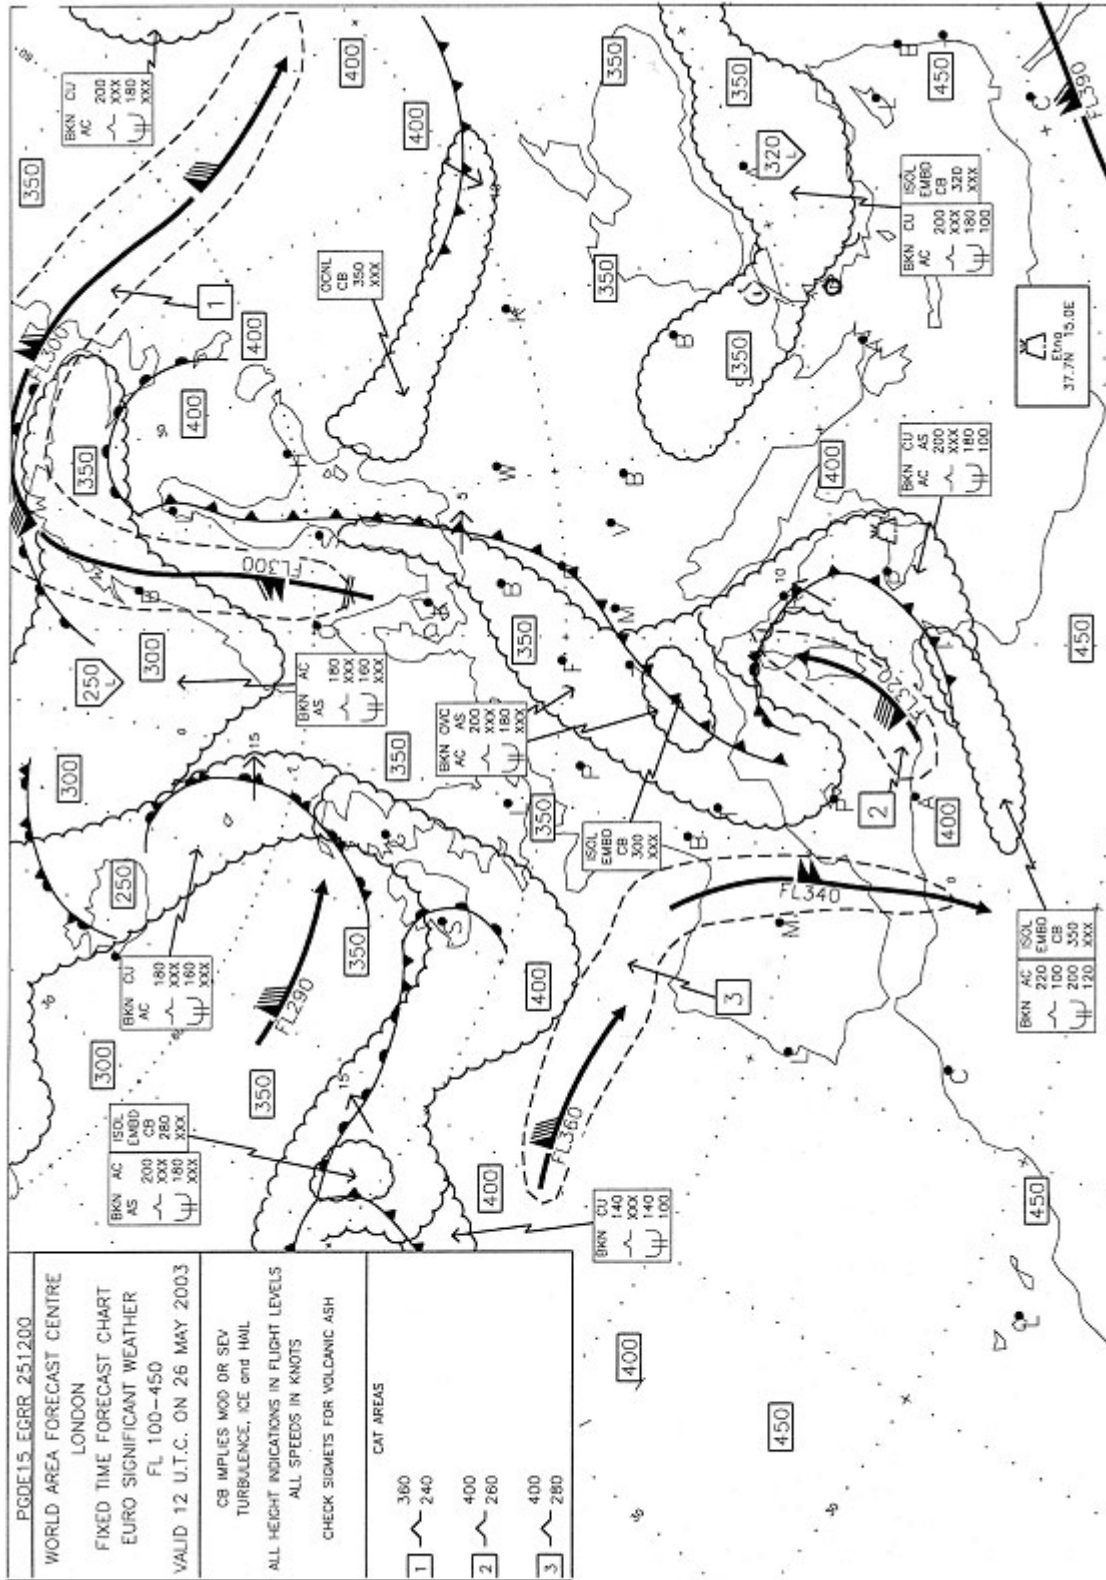
### **Figure 1: Significant Weather Chart**

The original written weather forecast, obtained by the crew prior to the flight, was not required to be retained after landing and was not available for scrutiny. A copy of the relevant Significant Weather chart, obtained from the Meteorological Office, however, is shown at Figure 1. This indicates isolated (ISOL) embedded (EMBD) Cb cloud with tops up to approximately FL300 over the Alps. It should be noted that the International Civil Aviation Organisation (ICAO) standard specifies that only EMBD Cb and occasional (OCNL) Cb or more, but not isolated ISOL Cb, should be depicted on the chart.

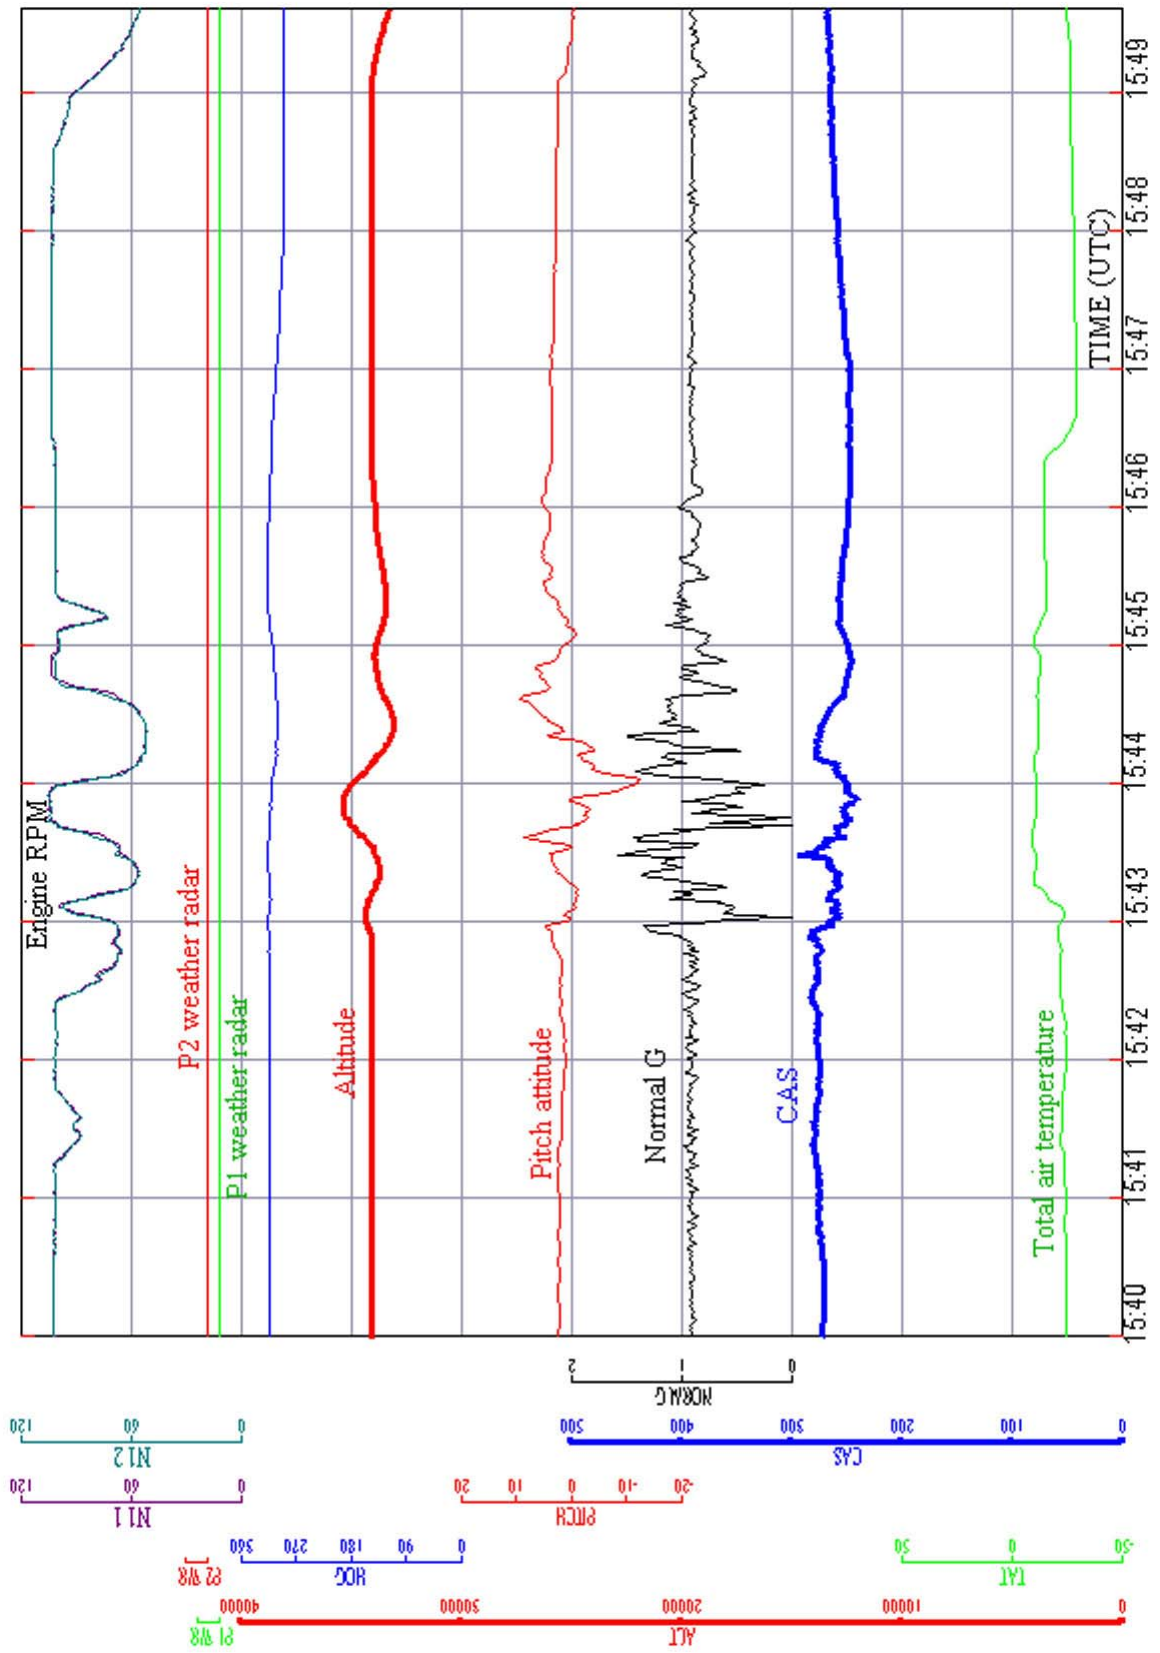
**Figure 4: DFDR Trace for G-MIDJ**

The DFDR contained a time history of the entire flight and showed that the aircraft took off at 1300 hrs and climbed steadily towards its cruising altitude. Two hours and twelve minutes into the cruise the DFDR recorded a severe turbulence encounter (see Figure 3) that lasted in excess of 3 minutes causing disturbances in all aircraft axes. The most severe disturbances were in the 'pitch' and in the 'normal' axes. Recordings during the encounter showed a maximum nose down pitch attitude of -15° and a normal acceleration ranging between +1.5 g and -0.3 g. The aircraft descended to FL230 six minutes after the encounter and remained at this flight level until its descent into Manchester. The aircraft landed normally, with the first officer at the controls, at 1803 hrs.

Recorded data concerning the use of the weather radar (see Figure 4) showed that it was switched on and displayed to the first officer for approximately 12 minutes as the aircraft climbed from 4,700 feet through 23,600 feet. The DFDR did not record any use of the weather radar during the remainder of the flight.

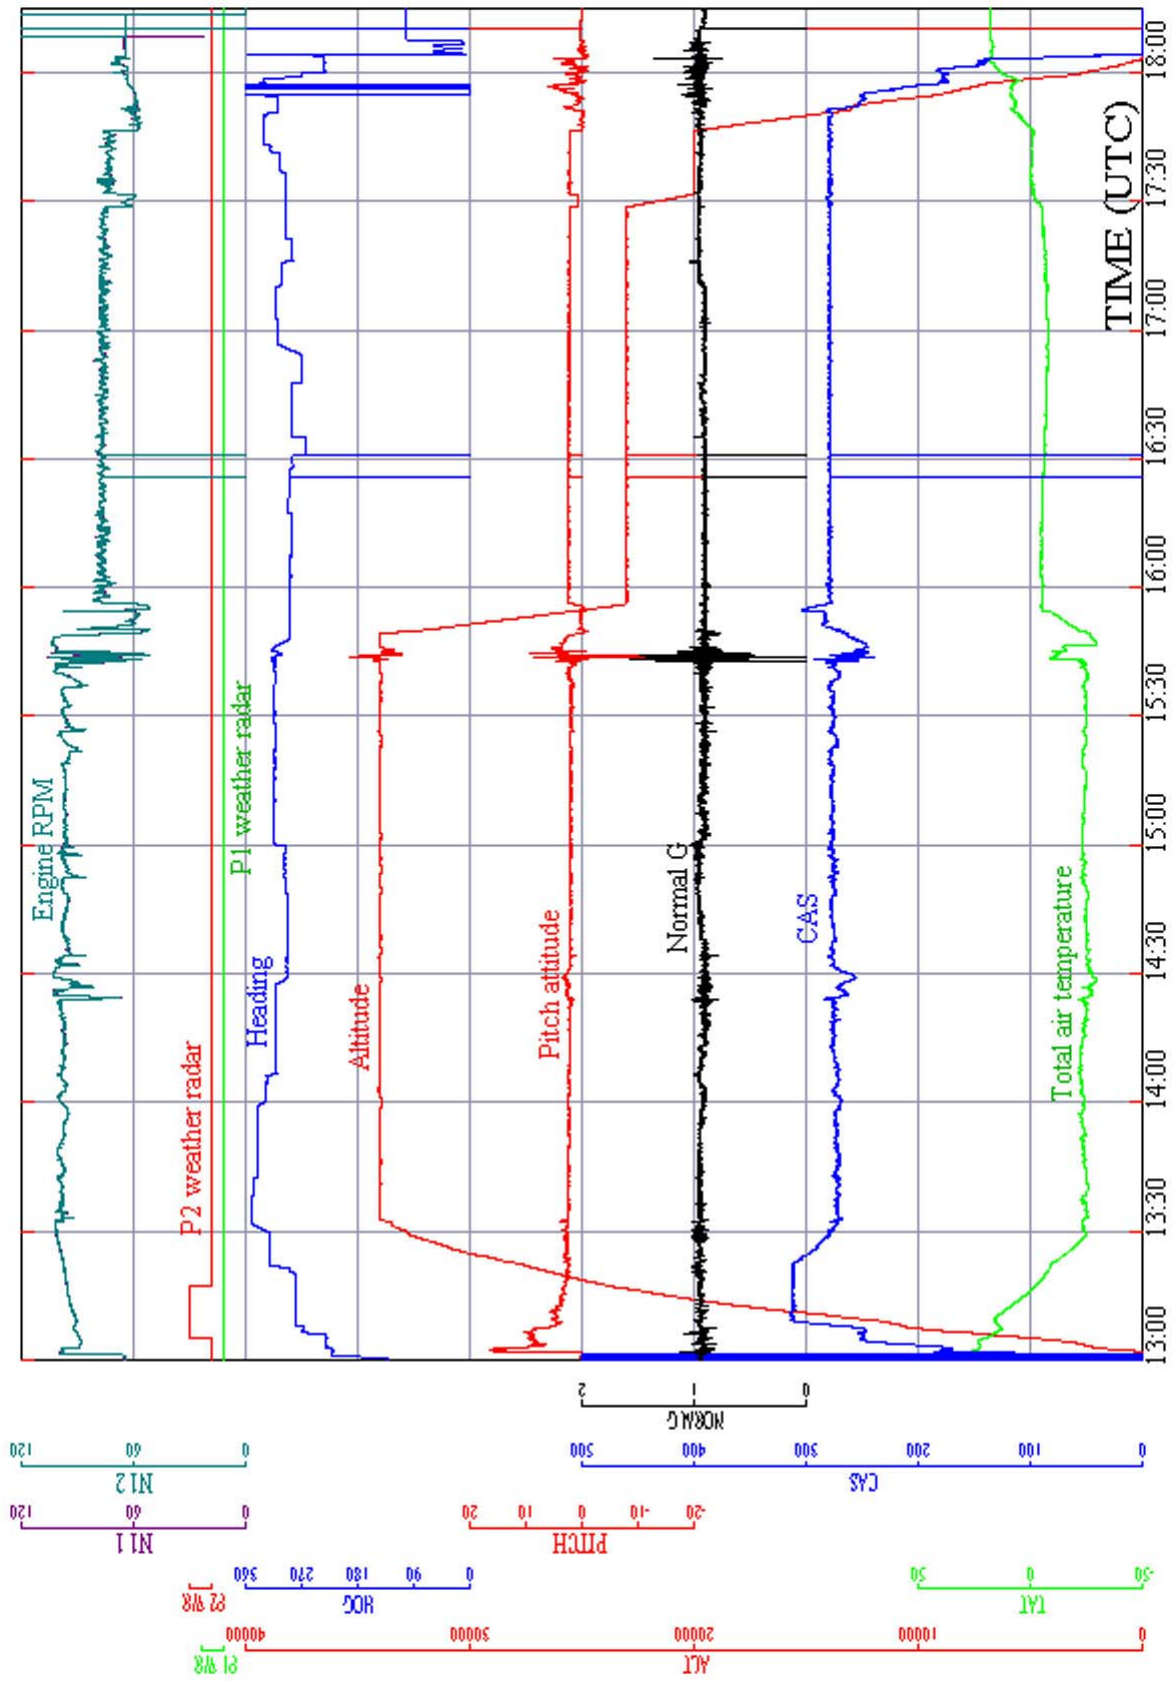
**Figure 5: DFDR Trace for G-MIDJ**

After the aircraft had been repaired AAIB inspectors, with the assistance of the operator's engineers, carried out a full operational check of the weather radar and its recording on the DFDR. The DFDR data was downloaded after the check and analysis confirmed that the DFDR faithfully recorded the use of the weather radar. It should be noted however that the data recording was not confirmed post incident before major repair work had been undertaken and some radar components had been replaced.
