Final Report

BOEING B777-300ER, REGISTRATION 9V-SWD EGPWS INCIDENT

2 SEPTEMBER 2019

TIB/AAI/CAS.190

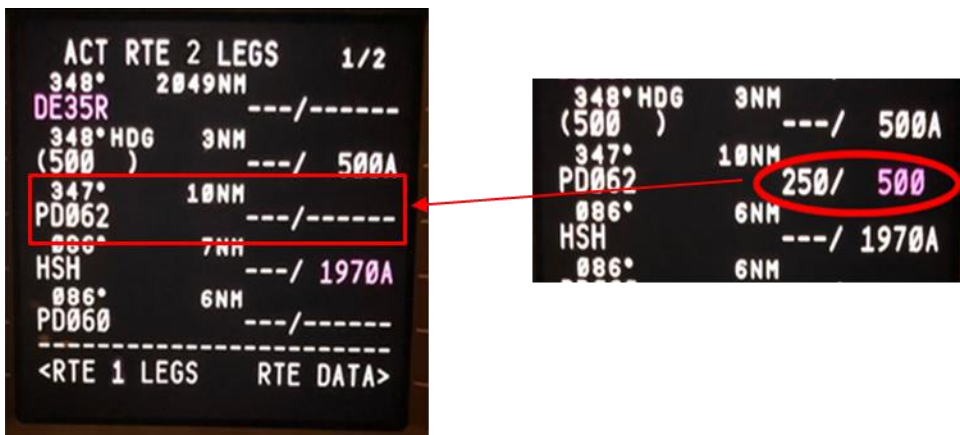
displayed¹⁰, so he decided to input the speed constraint of 250 knots (as published in the Departure Navigation Chart¹¹) into the FMC and he keyed in a speed/altitude constraint of “250/0500”¹² for PD062 using the CDU. The FO observed the PIC’s inputs, as part of the cross-checking process, and accepted the inputs as correct¹³. Upon completion of this verification and briefing, the PIC then activated RTE 2 by pressing the “ACTIVATE” button followed by the “EXEC” (execute) button.

Figure 2. Picture reconstruction (for illustration purpose) – the left picture showing the default speed/altitude constraint of “---/-----” at PD062 on SID HSN 12X and the right picture showing the PIC’s inputs.

¹²On the B777 FMC, a speed constraint input required a corresponding altitude constraint. According to the PIC, he intended to key in “250/0500A”, i.e. the aircraft speed should not be more than 250 knots and the aircraft altitude should be above 500 feet when crossing PD062. The PIC told the investigation team that he had pressed the “A” button twice. The first time he pressed, the “A” was not captured by the FMC. He pressed the “A” button a second time and did not notice that the “A” was not captured by the FMC. Thus, the PIC’s input into the FMC was captured as “250/0500”. This meant that the FMC would, up to PD062, limit the aircraft altitude to no more than 500 feet.

1.6.2.1 The B777 FMC was programmed to only display a speed constraint when there was an associated altitude constraint at the waypoint. Although the speed constraint of 250 knots for waypoint PD062 was programmed in the database, it was not displayed on the FMC LEGS page as there was no altitude constraint programmed for waypoint PD062.

- 2.1 It was clear that the events encountered by the flight crew were the result of the FMC having registered a speed/altitude constraint of “250/0500” for the waypoint PD062. The PIC had inadvertently keyed in “250/0500” instead of the intended “250/0500A”. This meant that, when the armed VNAV mode became active at 400 feet AGL, it would provide guidance commands to the A/P to maintain the programmed altitude of 500 feet. Given the high rate of climb and aircraft inertia, it was not possible for the auto-flight system to immediately capture 500 feet. Hence the aircraft climbed through this altitude before commencing a descent in an attempt to maintain the programmed altitude until PD062.
